**Report Number :**  
2016010402

## PROPERTY INSPECTION REPORT

**Concerning:** Somewhere, Austin, TX 78726  
(Address or Other Identification of Inspected Property)

**By:** Scott Leppin, Lic #2825 01/04/2016  
(Name and License Number of Inspector) (Date)

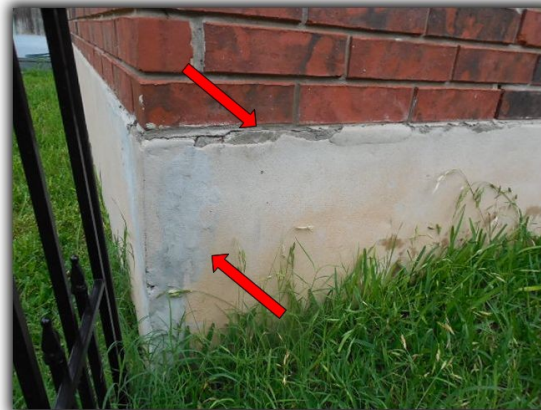
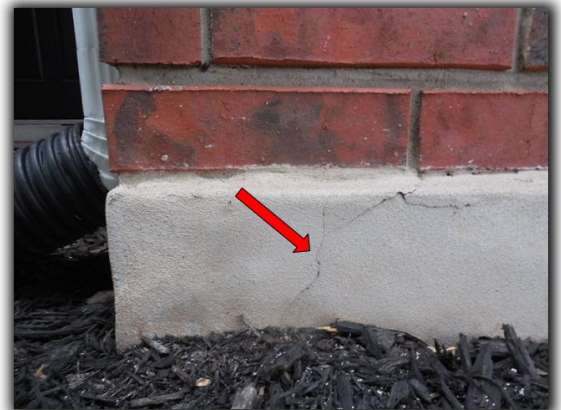
**Note:** Foundation corner pops, spalling or cracking at masonry ledge were observed at one or more location. Although unsightly, conditions do not typically compromise the integrity of foundation. These conditions are usually caused by thermo expansion at the foundation / masonry wall junctures.

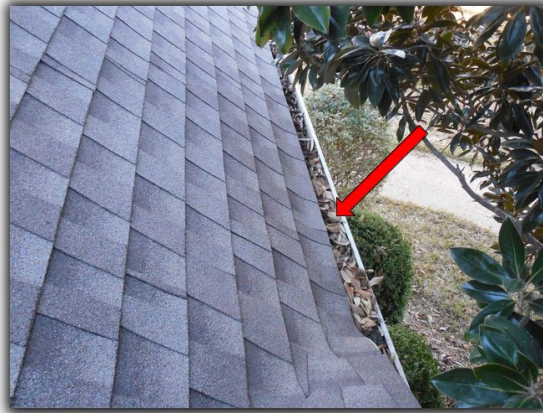
- The gutters are dirty and require cleaning at one or more location.

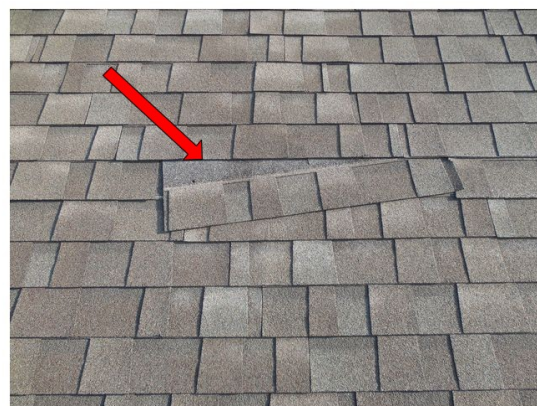
- Loose shingle(s) were observed at one or more location.

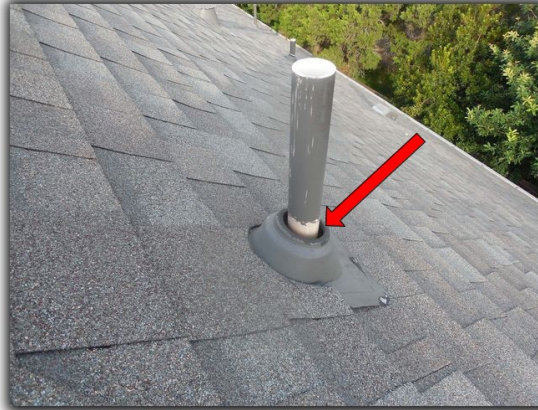
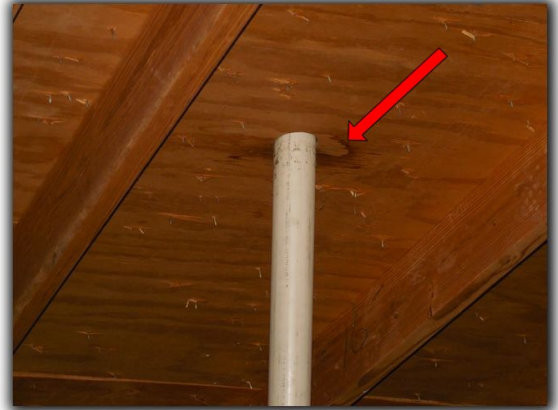
- The neoprene flashing located at one or more of the roof level plumbing vent stacks has some deterioration and/or damage around the stack. This condition is conducive to moisture penetration. Notice moisture stains on roof deck in attic below.

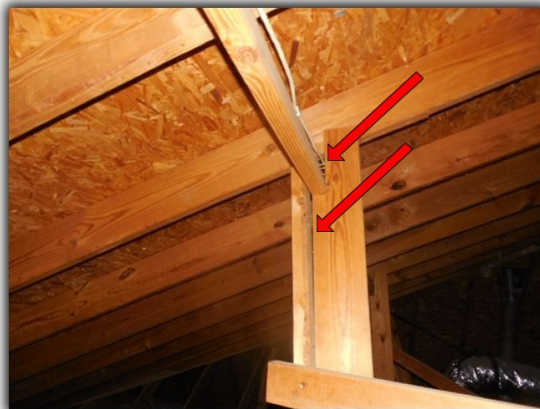
- Purlin bracing and/or "T" backer fasteners are not properly installed. Notice voids between the framing & fasteners at one or more attic location.

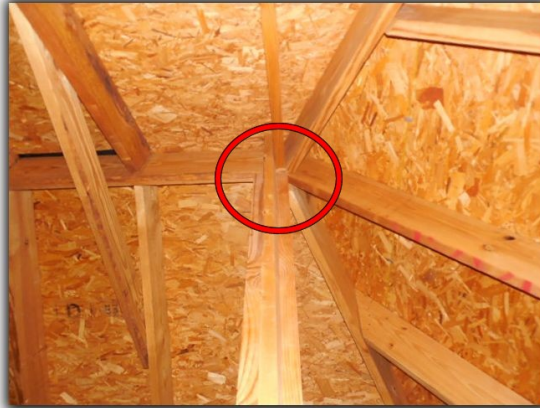
- Although no roof deflection was observed, some hip and/or valley rafters were not blocked/braced at ridge board connection points.

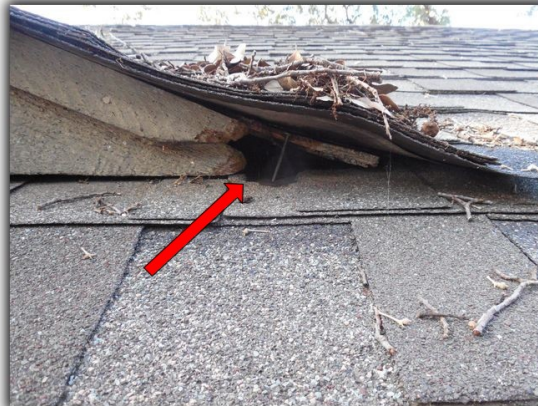
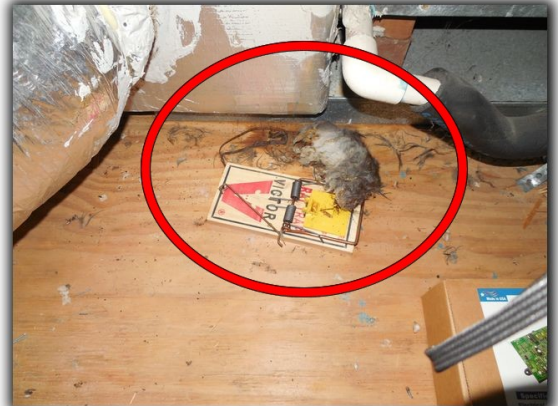
- The fascia board material has some deterioration and/or damage. Condition has apparently been caused by rodent activity. Notice dead rodent in attic.

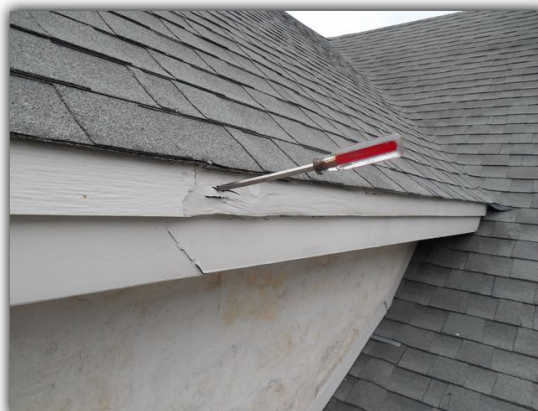
- The fascia board material has some deterioration and/or damage at one or more location. Condition should be self-evident to a qualified carpenter.

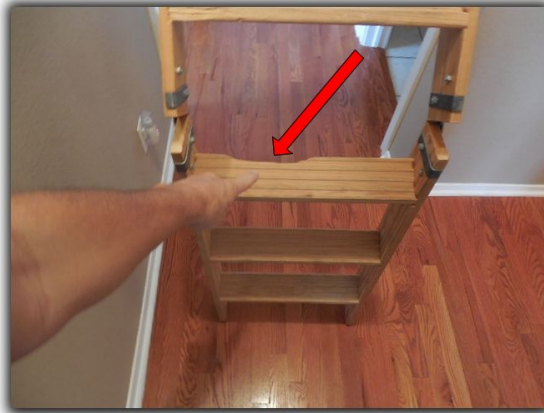
Attic Ladder

- The attic access pull down ladder has damaged tread, which may be hazardous.

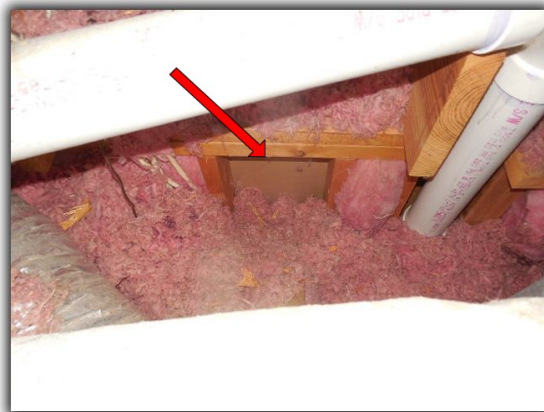
Attic Insulation

- Vertical insulation batts are not properly supported by netting and/or insulation batts are missing at one or more attic location leading to un-insulated space between the attic and interior conditioned spaces of home.

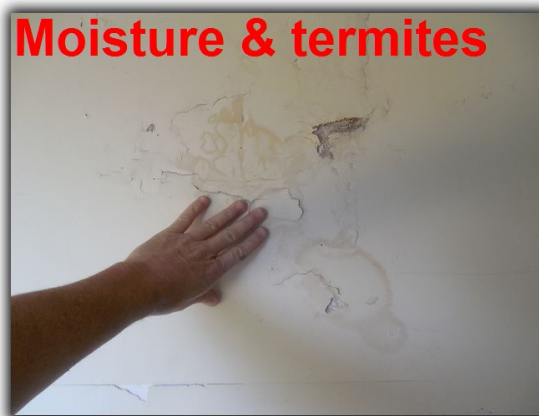
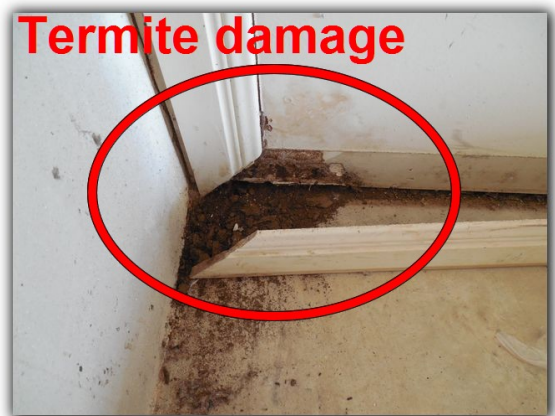
- Moisture stains & termite damage were observed at the garage wall.

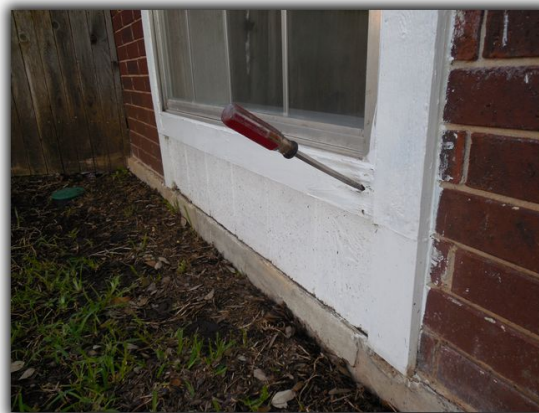
Exterior Walls

- Trim deterioration and/or damage was observed at one or more location. Find example at the right side elevation formal dining room.

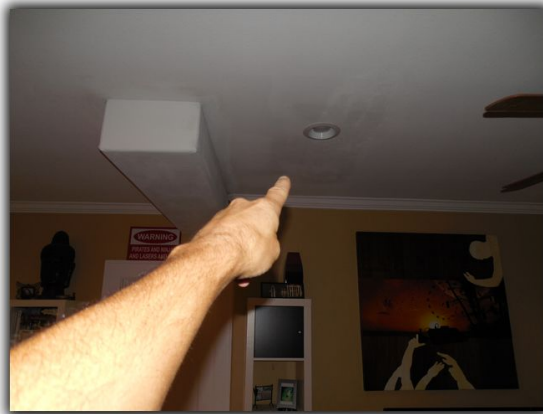
- There is evidence of painting and/or patching to the ceiling located in the living room. The attic area above was not accessible. I recommend consulting with seller for possible disclosure as a preliminary option.

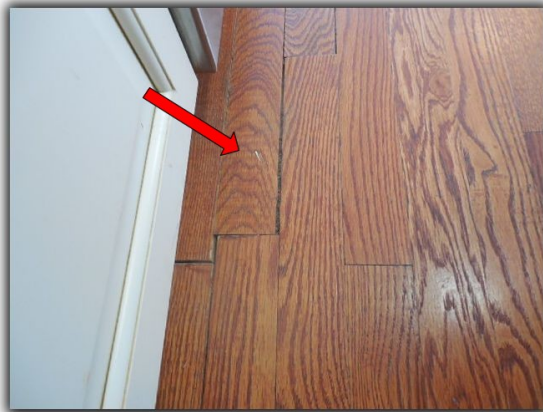
Floors

- Wood flooring is moisture damaged in the kitchen near the dishwasher area. Cause and remedy should be further investigated and corrected as necessary.

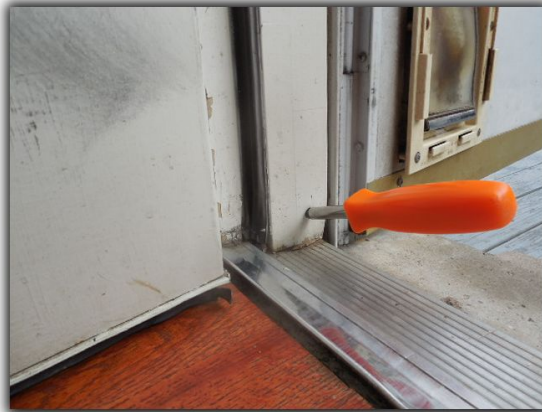
- Door lower casing is moisture damaged or decayed, which is conducive to moisture intrusion at the back deck / breakfast dining room entry.

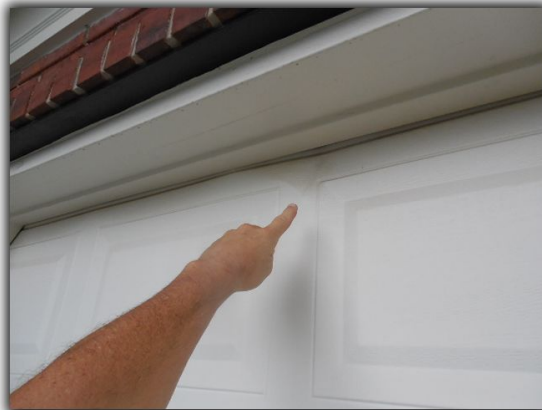
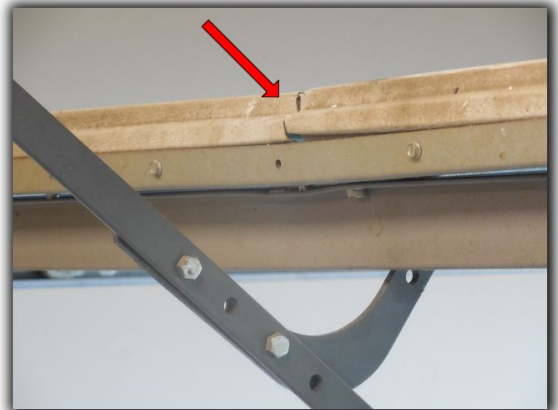
Overhead Garage Door(s)

- For safety reasons, overhead garage door torsion springs or coils need adjusting.
- The single-bay overhead garage door top panel is damaged near operator connection point.

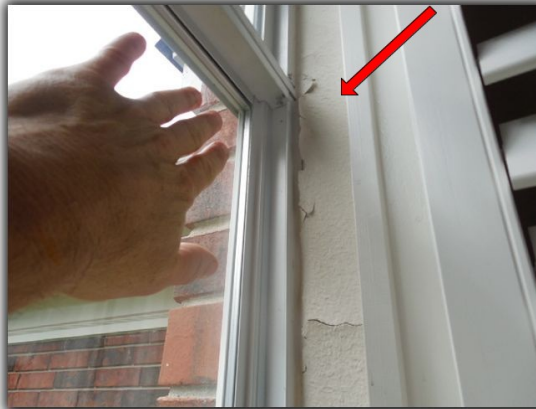
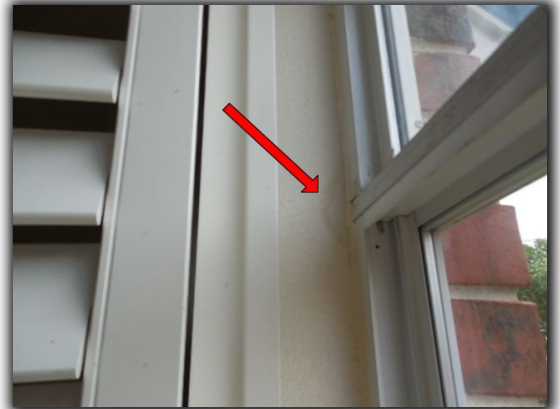
- Moisture stains and/or damage observed at one or more window location. Cause and remedy should be investigated and corrected as necessary.

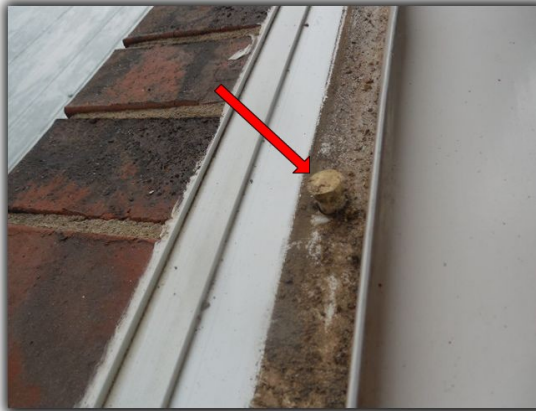
- The security sensor tabs located at the bottom portion of window frames should be sealed to help prevent moisture intrusion into the wall cavity at one or more location. It should also be noted that holes drilled in window frames for security system sensors typically voids window warranty.

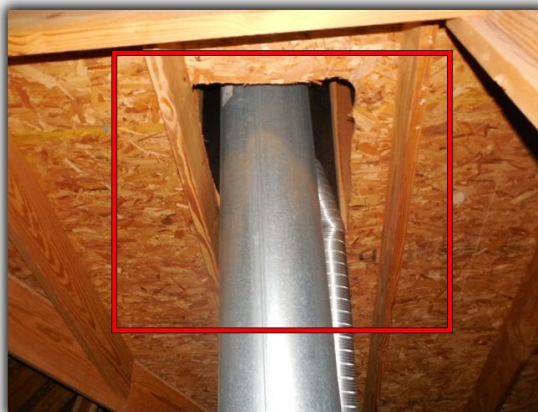
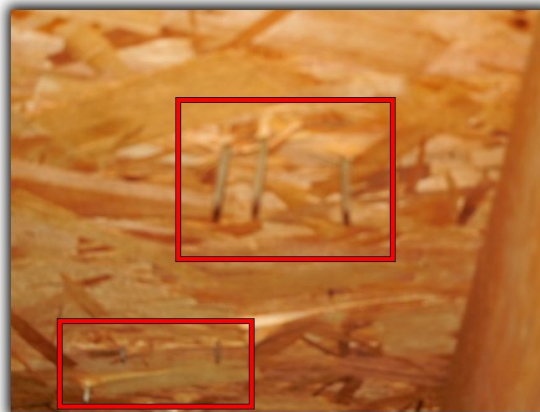
- The chimney structure is not properly secured to the roof structure framing. Notice that some if not most of the nails have been driven into the roof deck only.

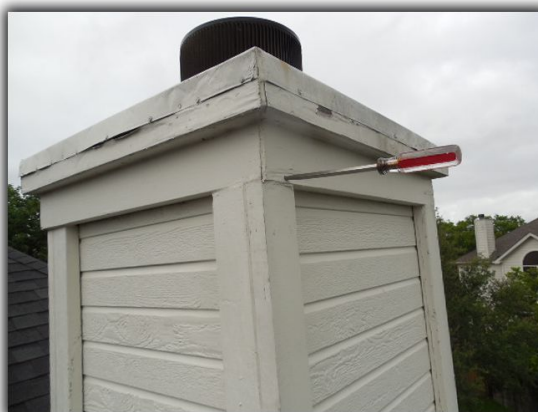
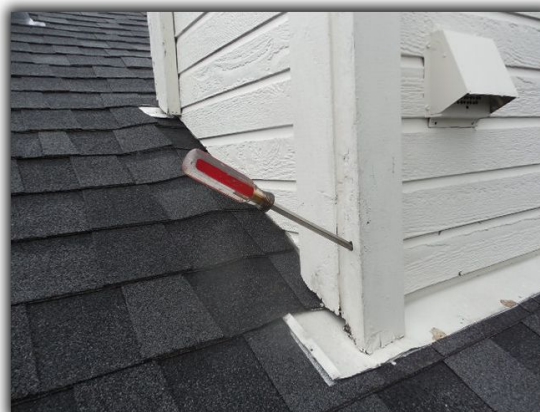
- Deteriorated and/or damaged trim was observed at chimney structure.

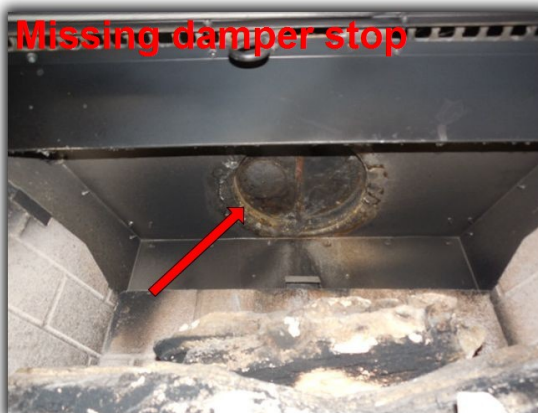
- When artificial gas logs are installed in a firebox with a damper; the damper should be permanently blocked open with a damper clamp to prevent accidental spillage of carbon monoxide into the living space, which can be *hazardous*.

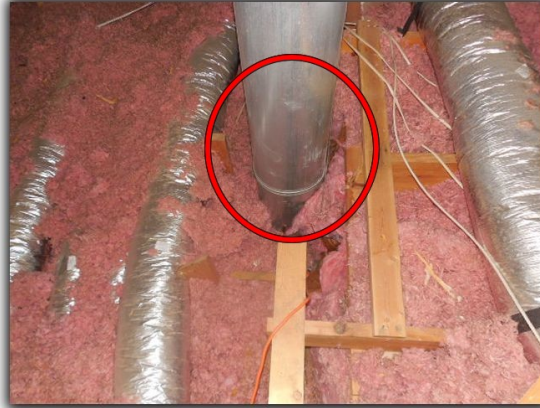
- The chimney flue pipe is lacking 2” minimum clearance from insulation or other building materials as specified, some of which may be combustible.

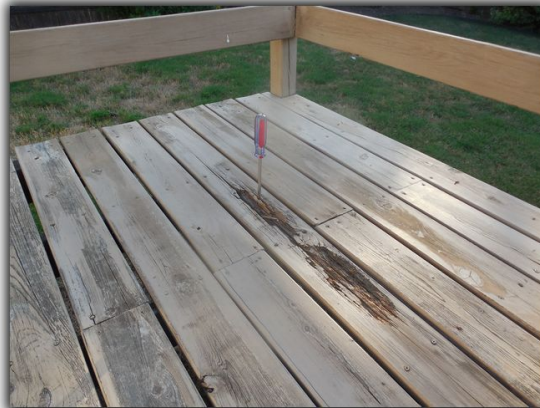
- Wood deterioration and/or rot were observed at deck structure.

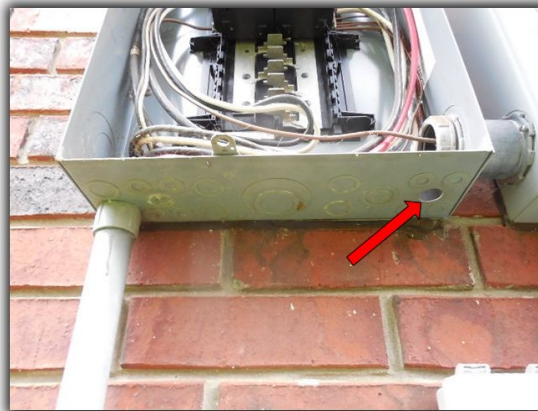
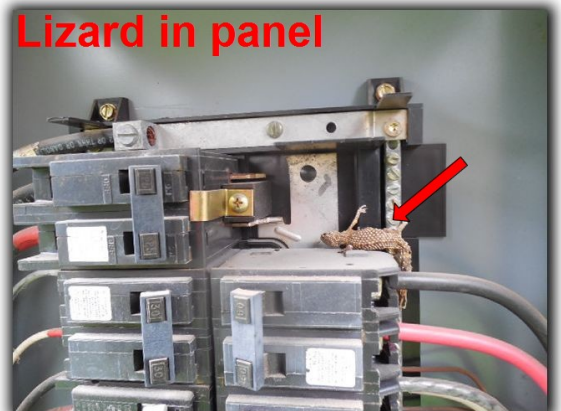
- Knock-out missing at panel base. This may allow insects and/or other entry into panel or notice electrocuted lizard found in panel.

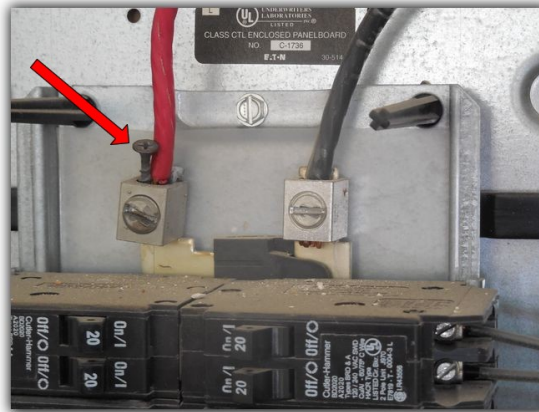
- Hazardous electrical conductor connection was evident in panel. For whatever reason a dry-wall screw has been placed at conductor lug.

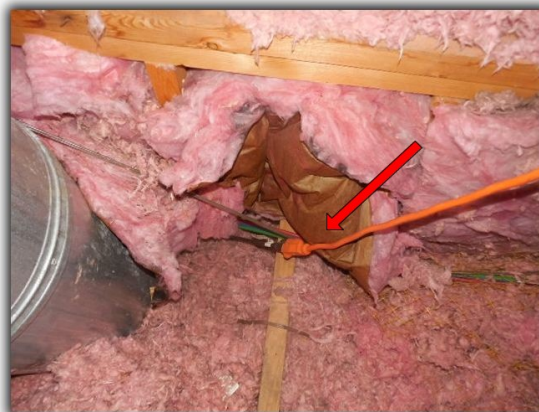
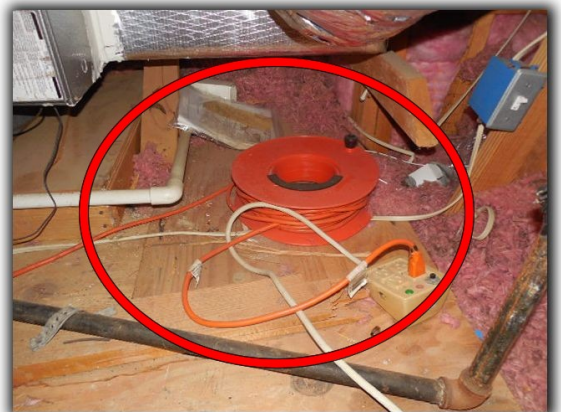
- Electrical extension cords should not be used for permanent wiring. Improper use of extension cords observed at one or more attic location.

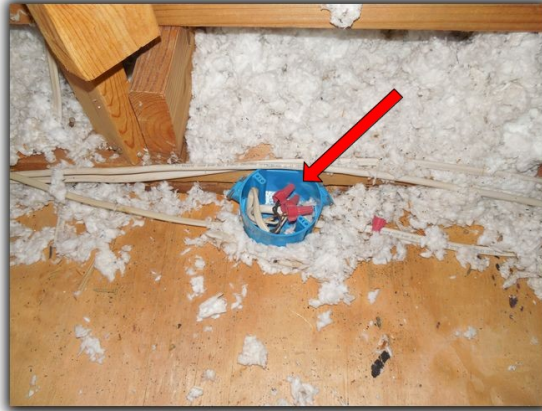
- Junction box not fitted with cover-plate at one or more location attic location, which should be addresses for safety reasons.

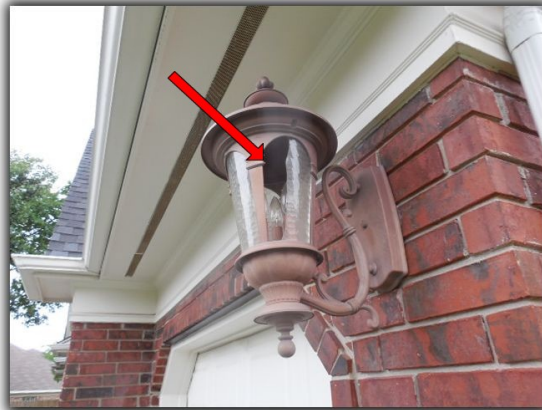
- The light fixture located at exterior front right corner house wall has broken glass lens.

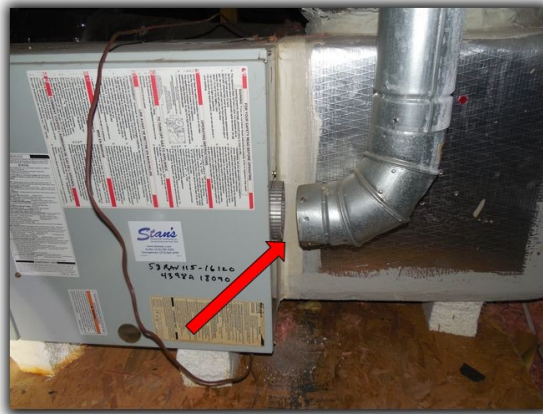
- The furnace vent pipe is not properly attached to the equipment. This configuration will emit system exhaust and/or Carbon Monoxide into the attic creating a hazardous condition. This issue should be dealt with immediately.

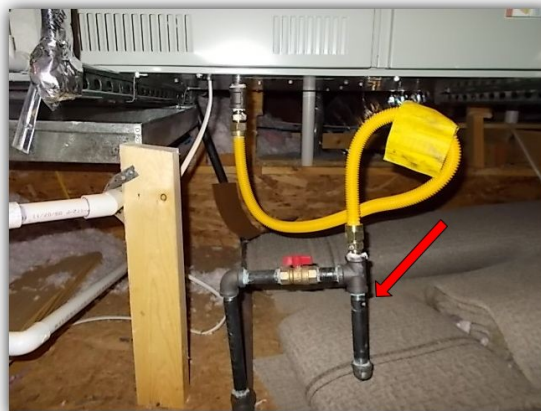
- The heater gas supply line is not equipped with a sediment trap just before the gas appliance connector. This condition does not meet current installation requirements. See correct installation at example picture below.

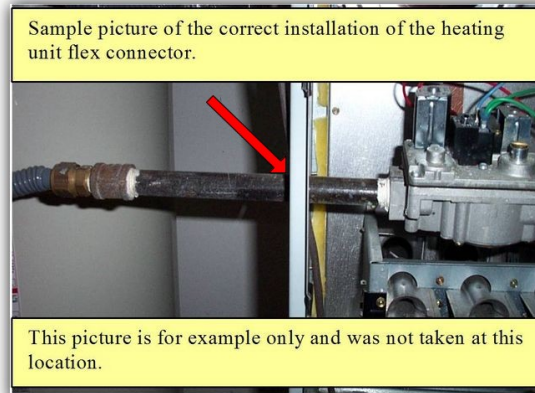
- The gas supply flex connector was observed to be passing through the heating unit cabinet. Under current mechanical installation standards, this is no longer an accepted practice. Only rigid black gas pipe is allowed to pass through the heating unit cabinet. See example picture of correct installation below.

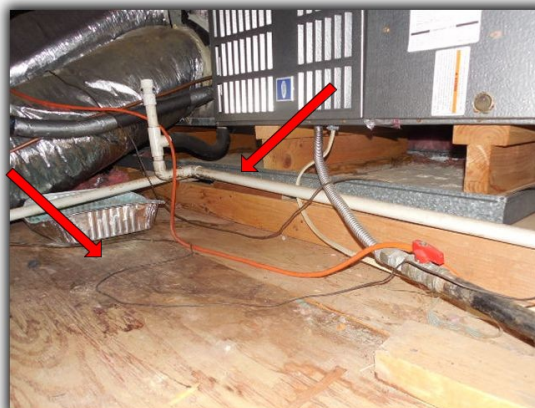
- Improvements to the insulation on the refrigerant and drain line(s) recommended. Insulation helps prevent moisture formation. Notice moisture stains at decked platform.

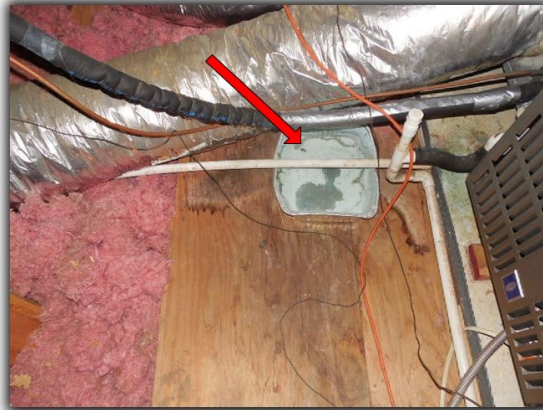
- Notice moisture stains on decked platform and/or that a container has been placed on decked platform to catch water and/or unit condensation.

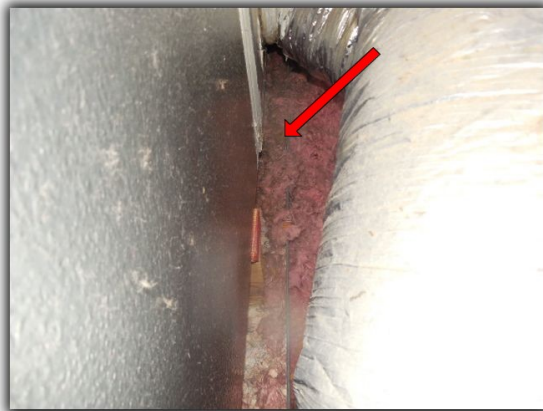
- The insulation in the overflow drain pan located under the coil housing should be removed. The insulation could clog the pan drain line and cause water to leak to the interior of the house.

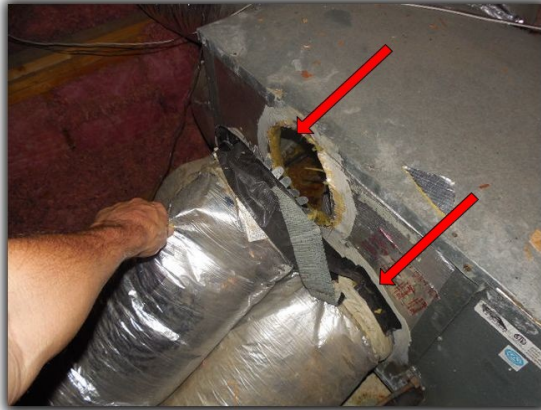
- Supply air duct one or more is loose and/or detached from plenum creating conditioned air leak into attic.

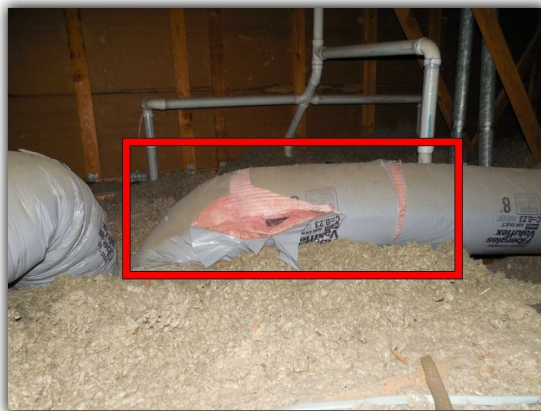
- Portion of flex duct located in attic has damaged and/or deteriorated lining. The lining keeps the insulation in place and is also used as a vapor barrier to help prevent condensation issues. Duct replacement recommended.

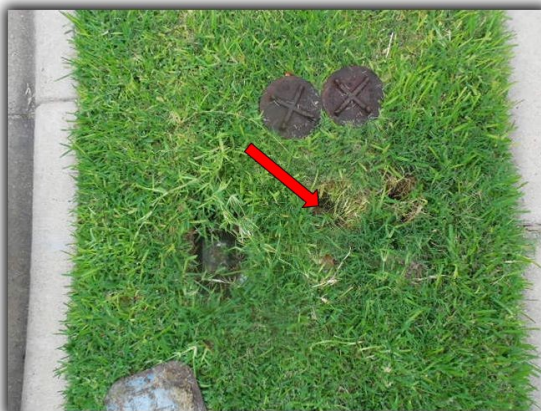
- The home-owners water supply line cut-off valve handle is located at soil grade in the valve box making it susceptible to deterioration due to moisture exposure from damp soil.

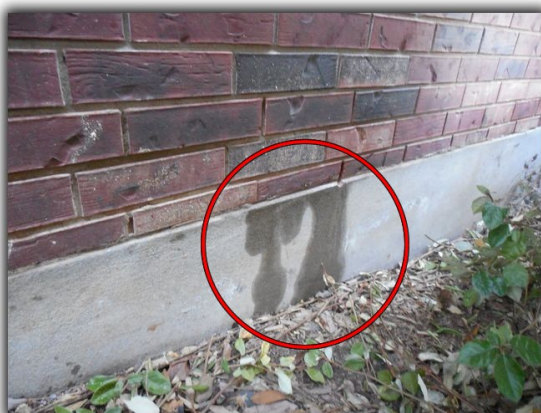
- Moisture was observed exiting the building at the lower left side elevation masonry wall / foundation area. Cause and remedy should be further investigated and corrected as necessary.

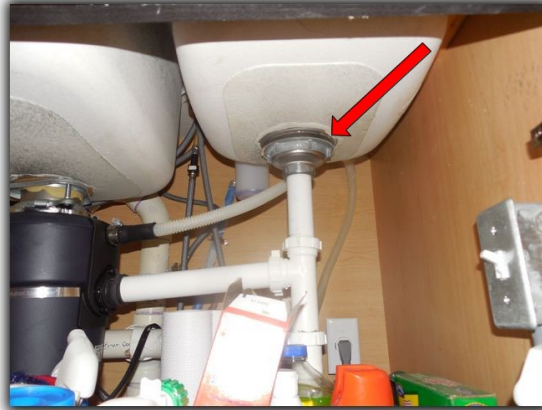
- The drain leaks at the right side kitchen sink / disposer connection. See example picture below.

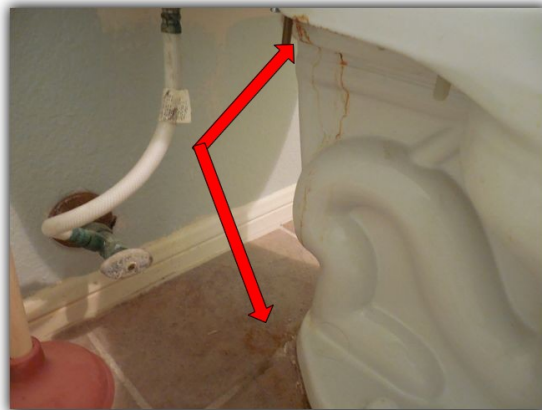
- The toilet tank leaks at bowl mount in the hall bath. Notice moisture and related rust stains.

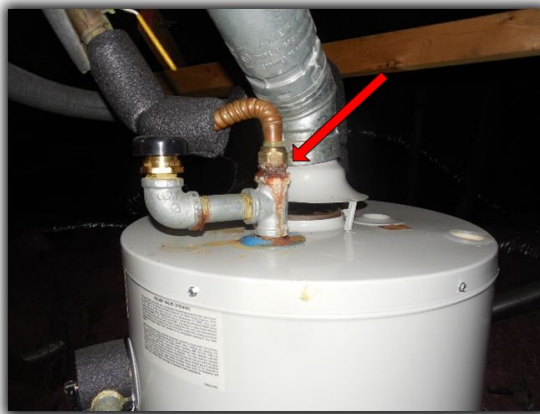
- The temperature setting is too high or water temperature is above 120°, which increases the potential for scalding especially with infants and/or children. This condition is a “Recognized Safety Hazard”.
- The water supply connection at the top of the water heater is rusting & leaks.

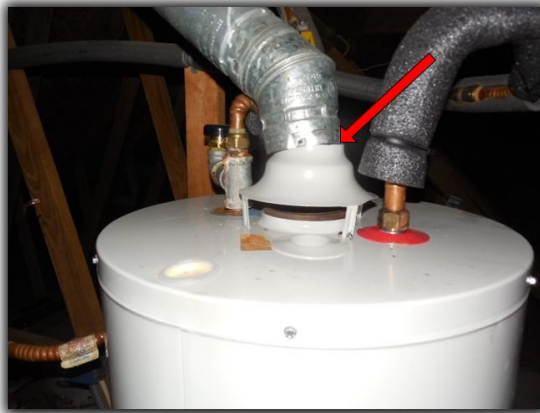
- The vent pipe is not properly mounted at the top of the water heater. This configuration will emit Carbon Monoxide into the heater compartment, which is a known safety hazard.

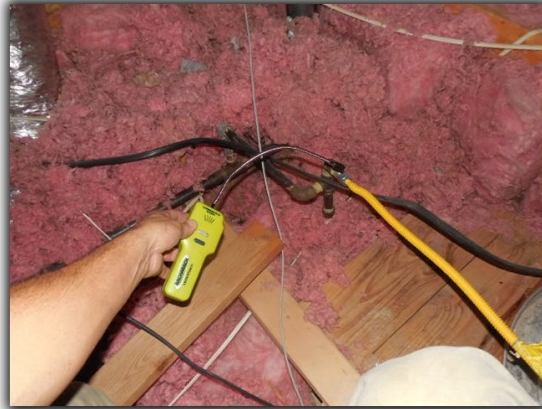
- There was a gas leak detected at or around the gas flex connector, which creates a safety hazard.

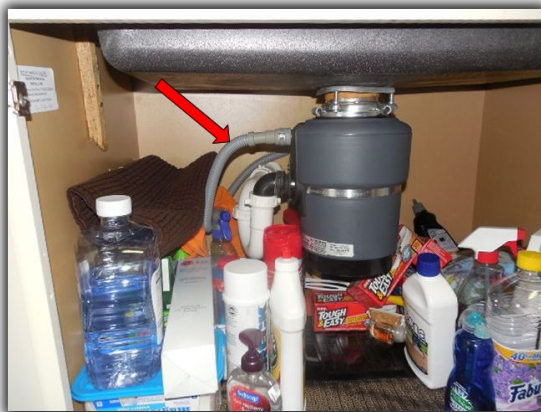
- The dishwasher drain hose is not properly installed to prevent back flow or anti-siphoning. It is recommended that an air gap device or high drain loop be installed in the drain line.

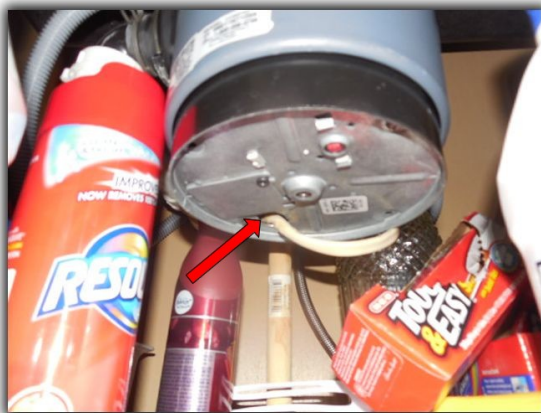
- The electrical wiring to the food waste disposer is not properly secured to the disposer housing.

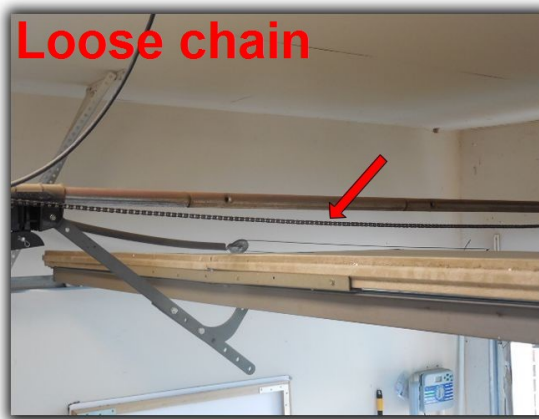
- The single-bay garage door opener chain is loose and needs to be better secured and/or adjusted.

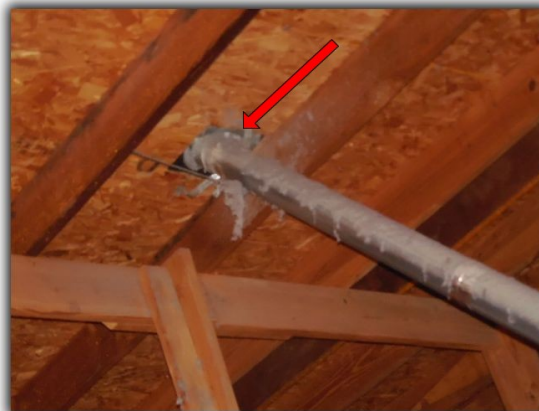
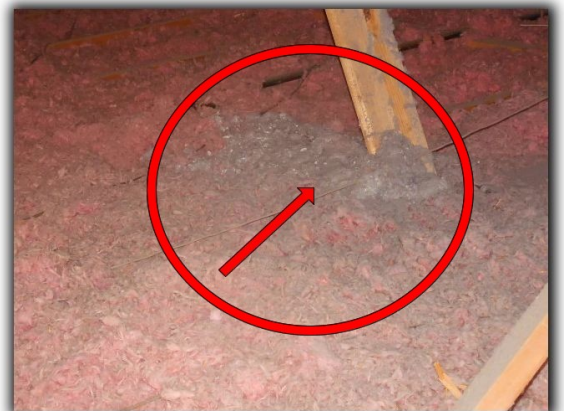
- The dryer duct termination is not properly sealed on the attic side of the roof structure penetration and is allowing dryer lint to fall back into the attic area. The dryer vent pipe may also be dirty.

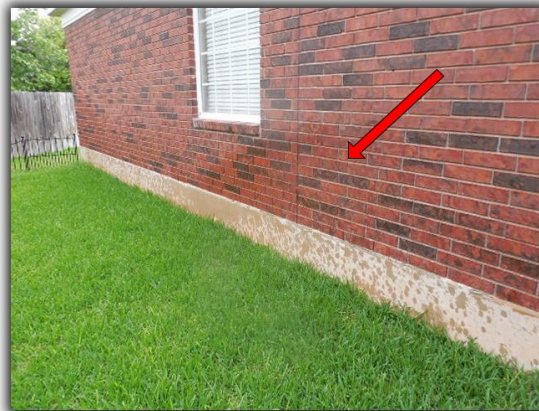
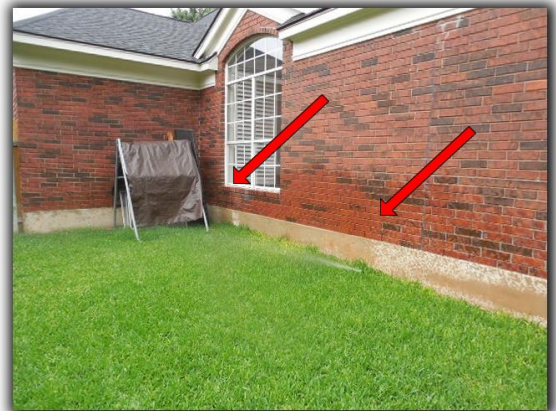
- One or more sprinkler head needs adjustment or over-spray onto building observed, which may promote undesirable “wet wall” conditions.
