Report Number :
2019121301

PROPERTY INSPECTION REPORT

Concerning: Not Disclosed, Austin, TX 78727
(Address or Other Identification of Inspected Property)

By: Scott Leppin, Lic # 2825 12/13/2019
(Name and License Number of Inspector) (Date)

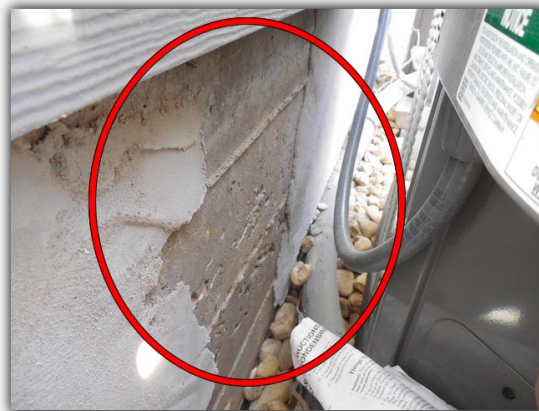
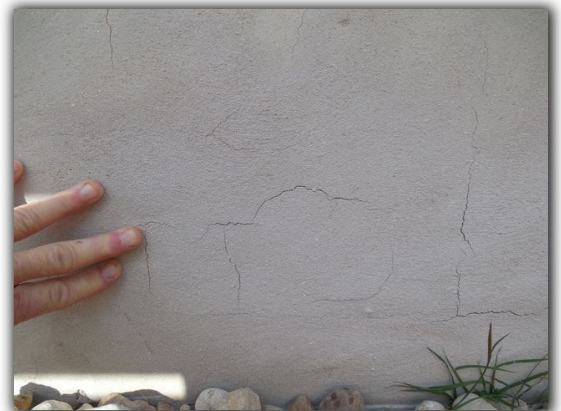
- Although condition does not negatively impact foundation performance, portions of parge-coating on exposed foundation wall is cracked, loose or has not been applied at more than one location. Find examples at the right side elevation. Cosmetic repairs recommend.

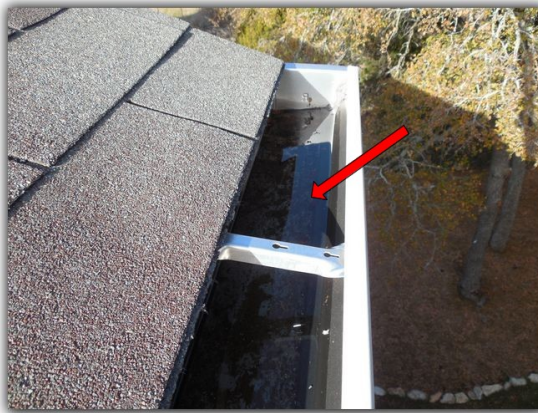
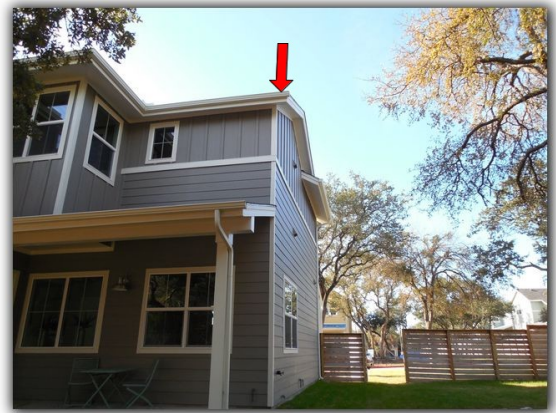
- The guttering does not appear to have sufficient slope to properly drain and/or notice that water is pooling in the gutter located near the back left corner house 2nd story roof.

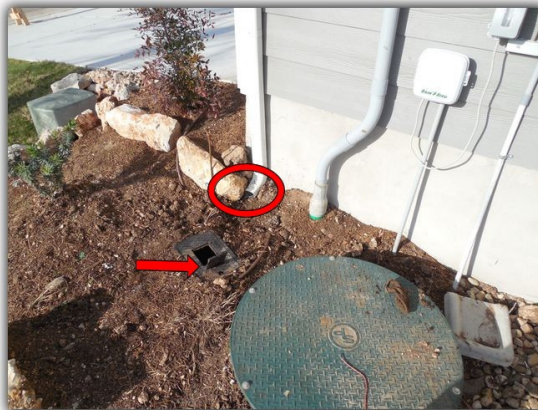
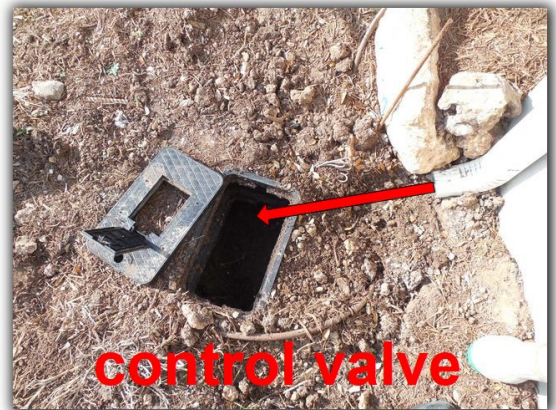
- The gutter down-spout located near front right corner house should be extended to divert run-off away from the plumbing system grinding pump control valve box.

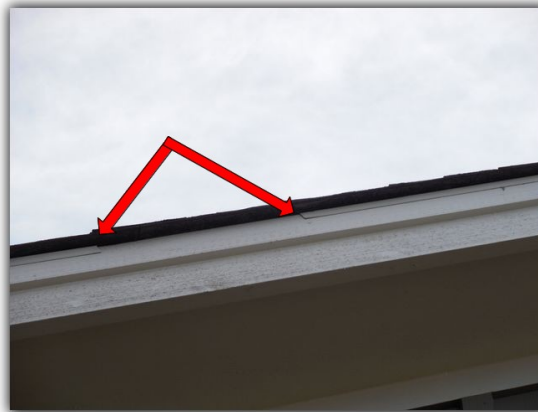
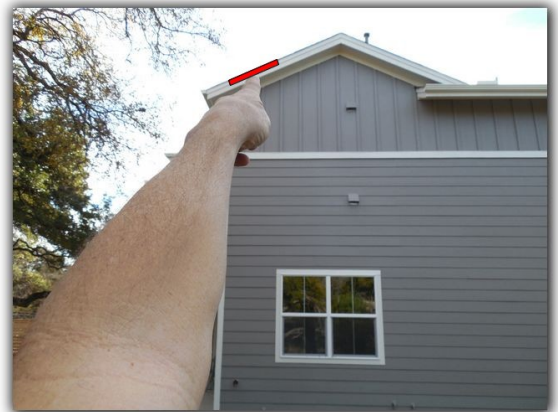
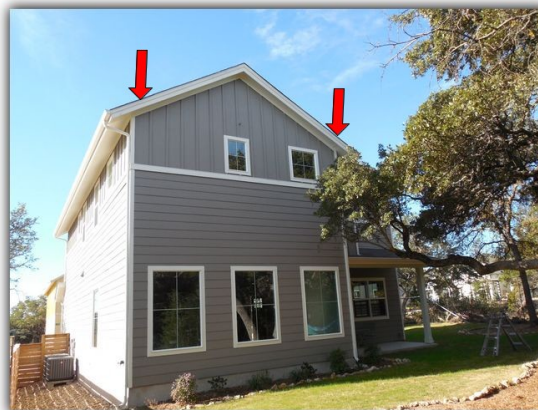
- Drip edge flashing is missing and/or has not been installed at more than one location. Find some examples at the left & back elevations. Although condition does not impact performance, portions of drip edge flashing has also not been painted. See some examples of missing flashing.

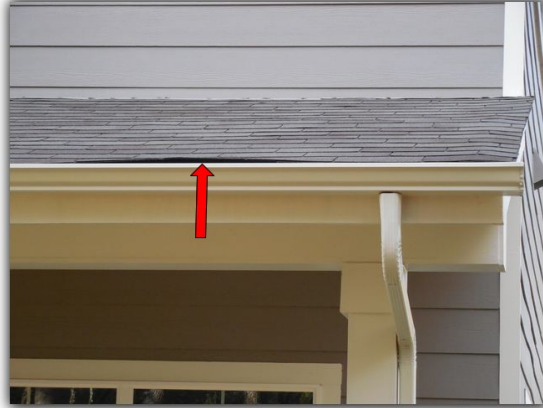
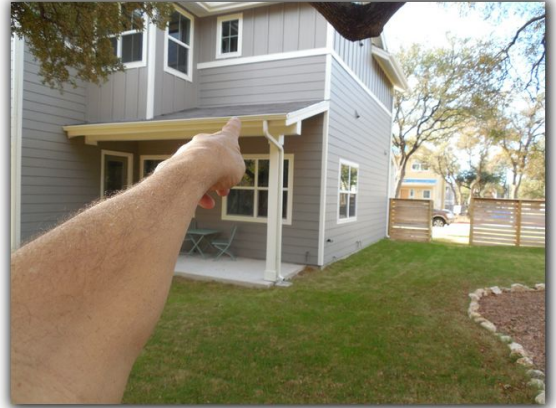
- Drip edge flashing is loose and/or is lifting shingles at the back elevation 1st story roof starter-course.

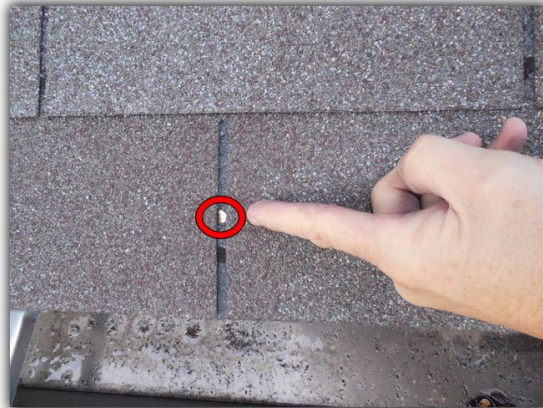
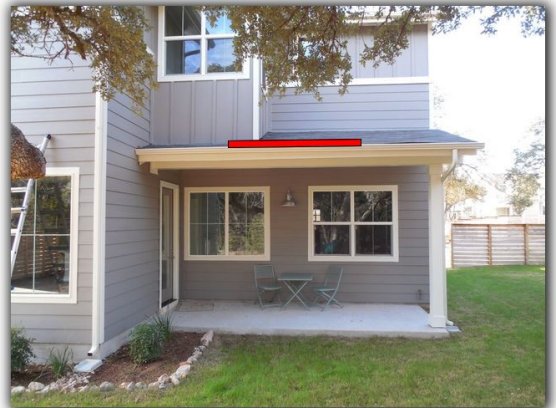
- Due to improper placement, more than one exposed shingle fastener head was observed. Find some examples at the back elevation 1st story roof starter-course.

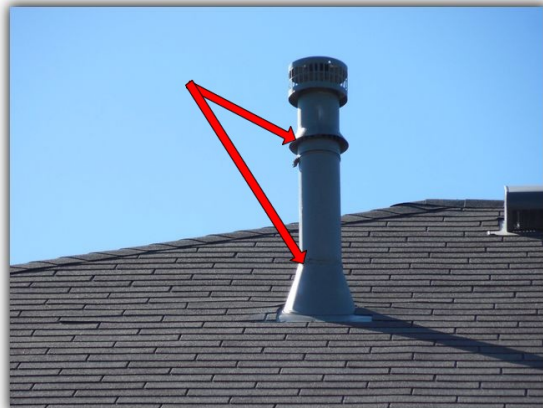
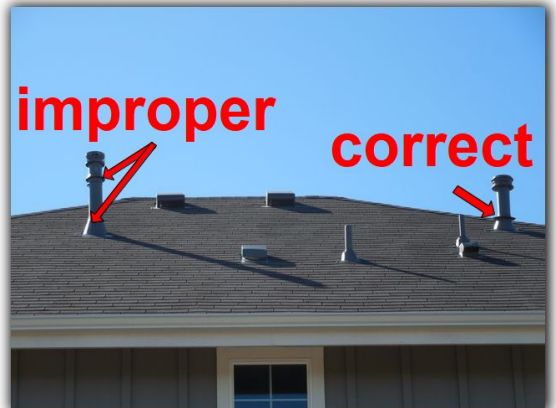
- The storm collar is not properly positioned over the roof jack at the roof level furnace flue pipe. The storm collar needs to be properly positioned and sealed to help prevent water intrusion within the roof structure.

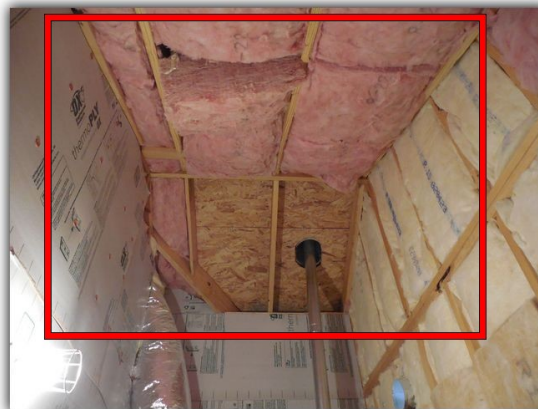
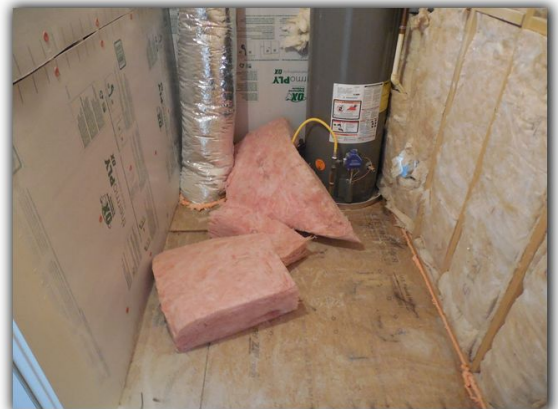
- Insulation batts are not supported by netting at the back left corner house 2nd story closet to prevent the insulation from falling.

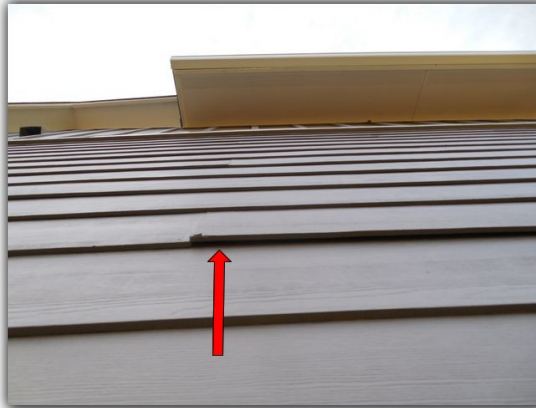
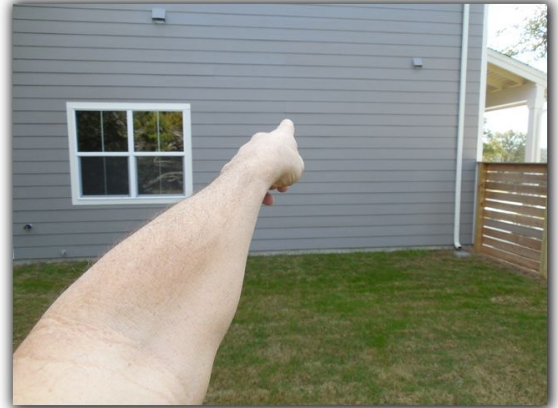
- Loose siding panel was observed at the left side elevation wall.

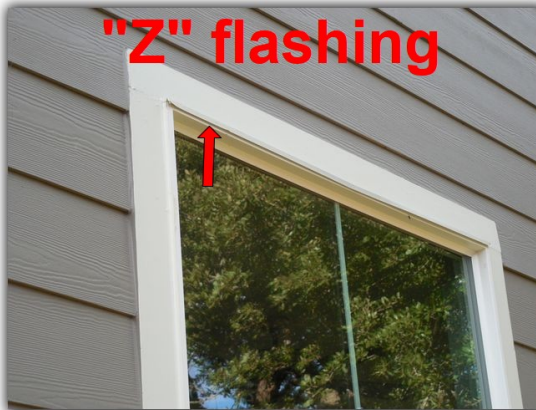
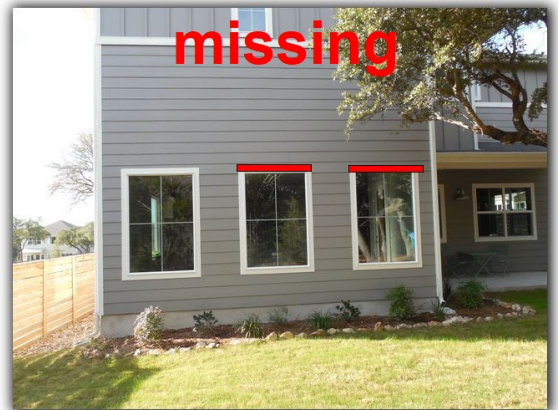
- I did not observe the installation of "Z" flashing above (2 of 3) of the back downstairs living room windows, which helps to prevent potential moisture intrusion..

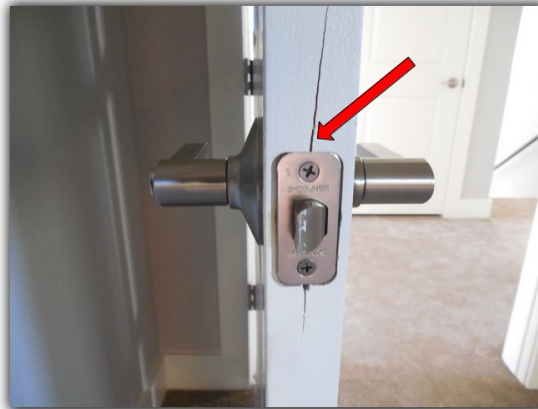
- The master bedroom entry door is cracked at hardware installation.

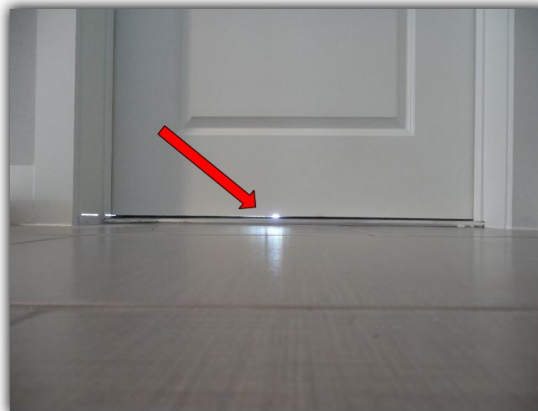
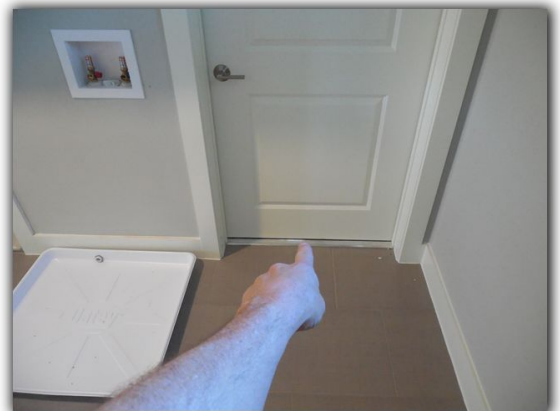
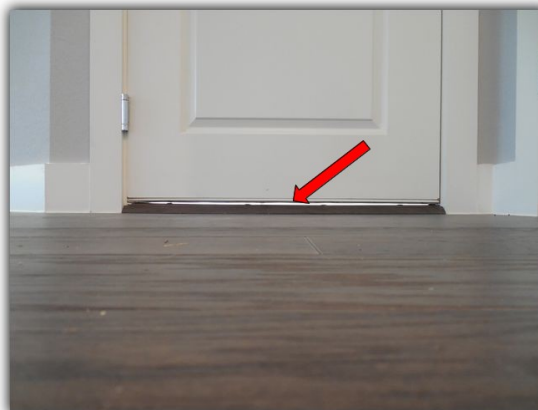
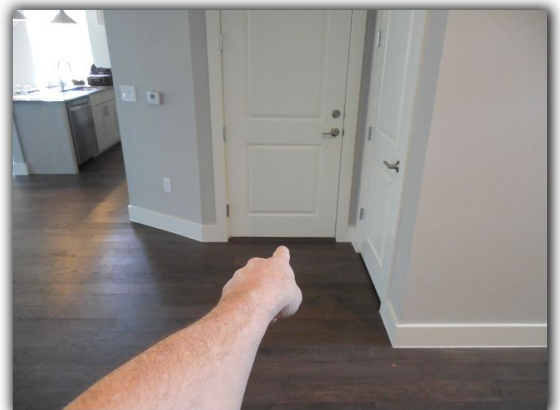
- Doors located at 1st story attic as well as garage pedestrian entries do not seal at threshold plates. Doors must be weather-tight to prevent moisture, draft or insects from entering home.

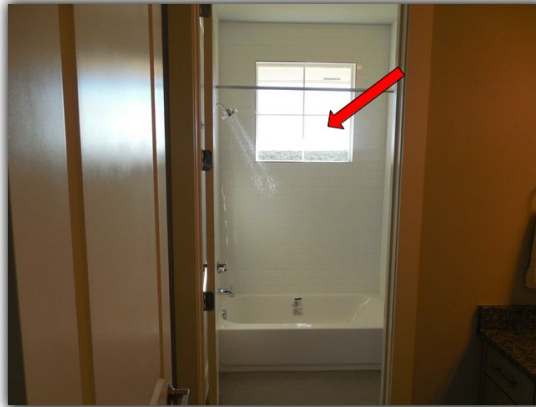
Note: Windows located in shower and/or tub surrounds such as the upstairs walk-through bath will be subject to long term water exposure issues due to location and methods of construction. Ensure windows stay well sealed at all times to prevent water penetration of wall assemblies.

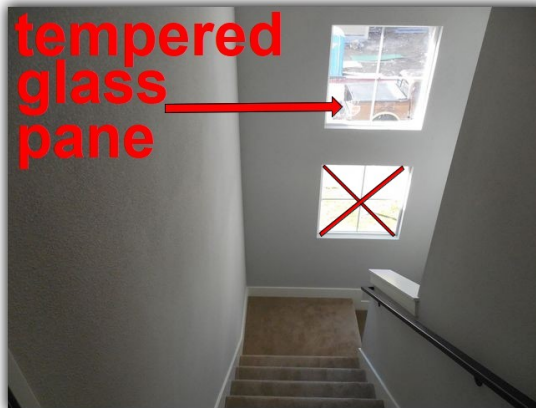
- Tempered glass (special safety glass) is lacking in window located at the steps landing and/or notice that the tempered glass pane has been improperly installed at wrong location or window above.

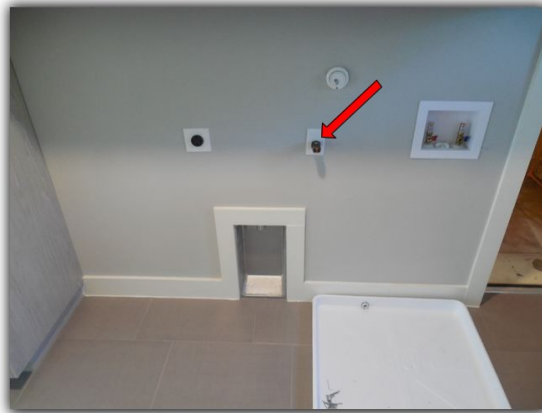
- Not all of the 110 volt electrical outlets located in the laundry room are (GFCI) ground fault circuit protected as required by current standards.

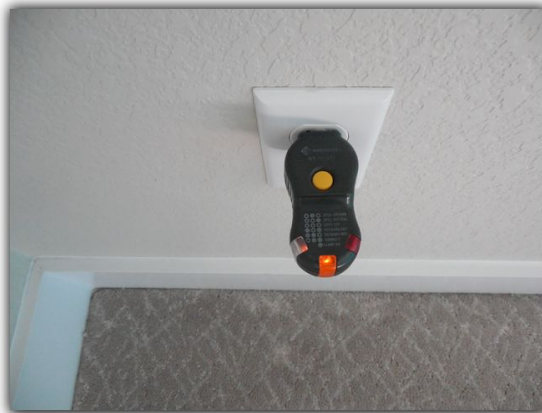
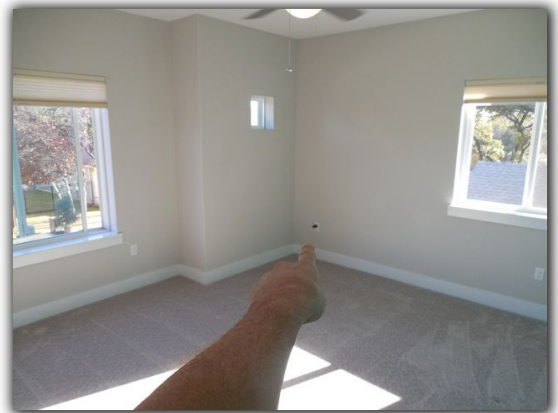
- One or more outlet was observed to have the hot and neutral conductors reversed. Find example at upstairs bedroom #3.

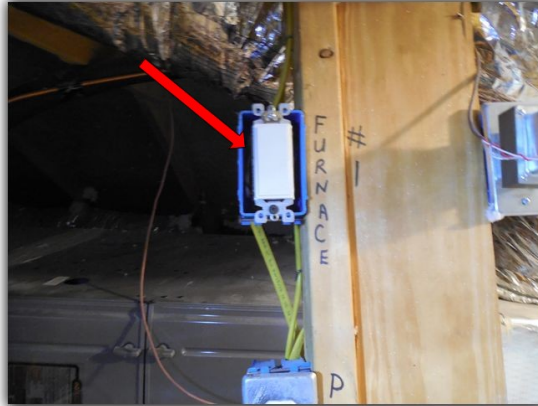
- Switch to HVAC equipment in attic is missing its cover-plate.

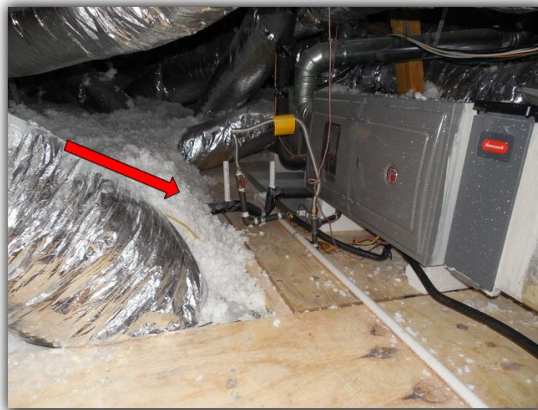
- The catwalk and service platforms are inadequate and/or missing at (1 of 2) HVAC systems located in attic. Catwalks should be provided in attics containing mechanical equipment to help provide safe access to the equipment. The catwalk passageway should be clear, unobstructed and large enough to allow removal of the equipment. The catwalk passageway shall have continuous solid flooring with a minimum thickness of ¾" plywood or 1" OSB and not less than 24 inches wide. A service platform of at least 30 inches deep and 30 inches wide should be present along all sides of the mechanical equipment where access is required. The platform flooring should have a minimum thickness of ¾" plywood or 1" OSB.

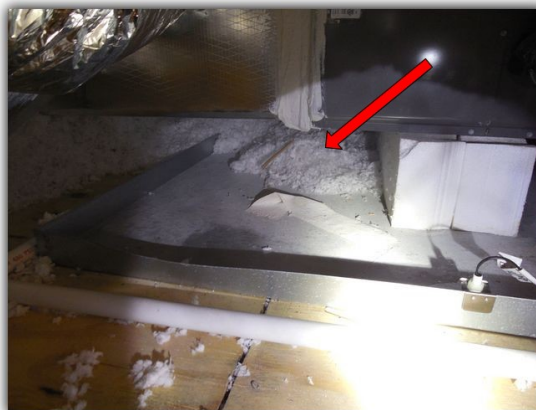
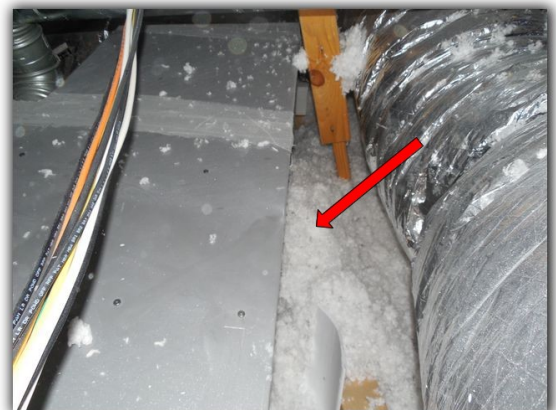
- The insulation in overflow drain pans located under both systems coil housings should be removed. The insulation could clog the overflow pan drain lines or interfere with the operation of overflow pan shut-off switches leading to moisture damaged within the home.

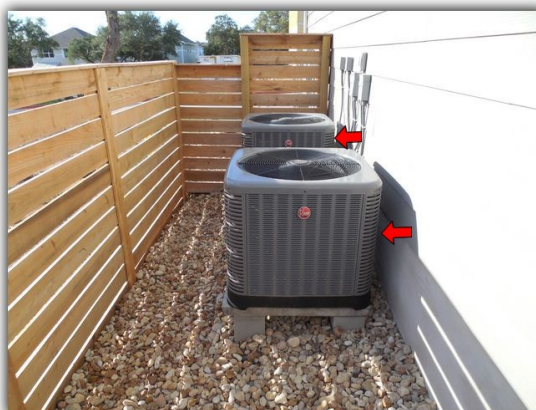
- The condenser units lack adequate clearances for air circulation. The units should be provided with 12" of clearance from fences, walls or enclosures and 24" between units.

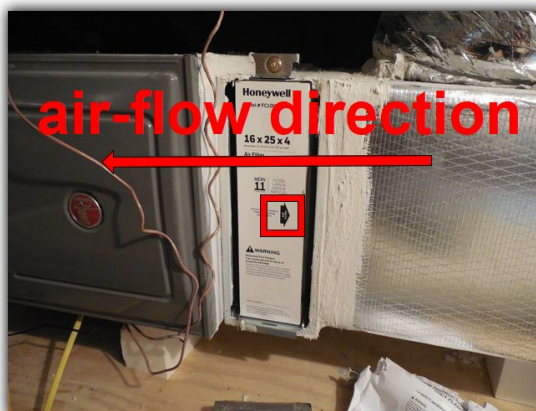
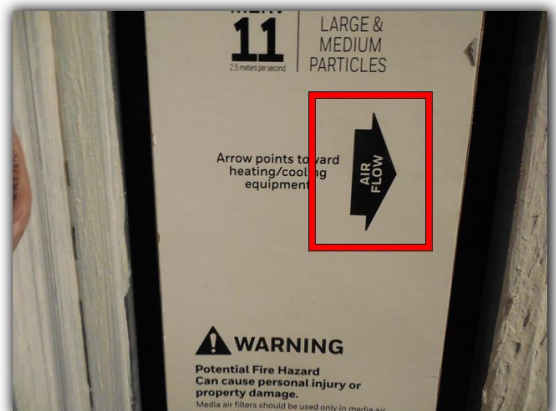
- The HVAC system return air filtes are improperly installed and/or lack proper directional air flow.

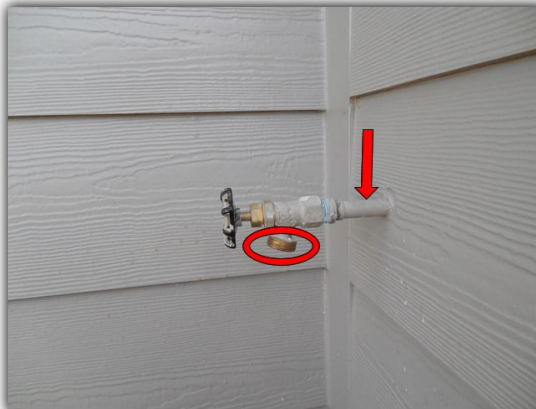
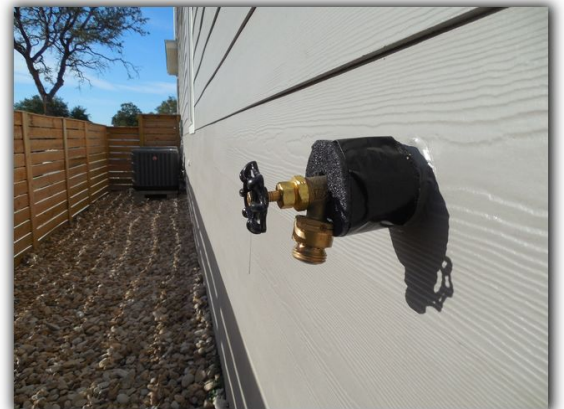
- The exterior front elevation wall water hose bibb does not have a back-flow or anti-siphon device (Vacuum Breakers) in place. The exposed copper water supply line at hose bib also lacks freeze protection.

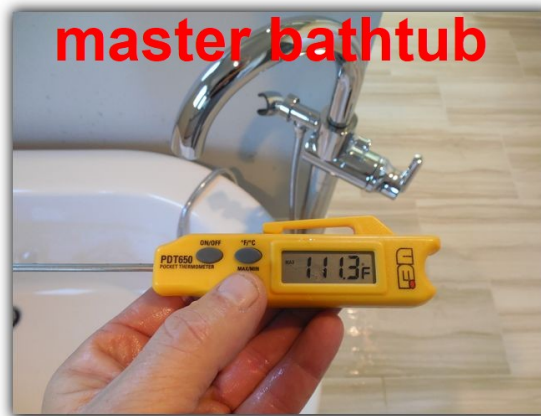
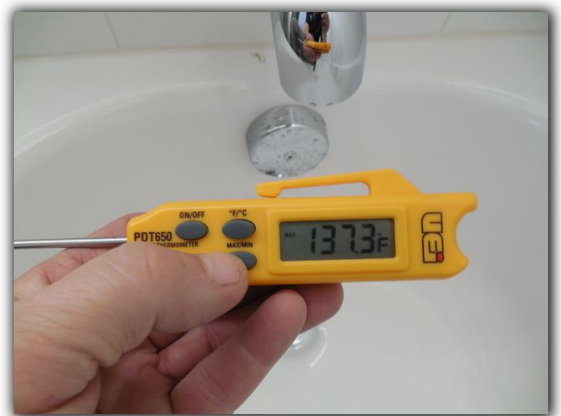
- The hot water discharge temperature at the master bathtub is significantly lower than that of other plumbing fixtures in home. Cause and remedy should be further investigated and corrected as necessary.

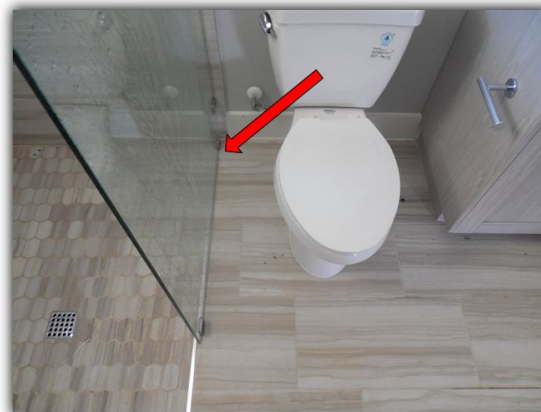
- The shower enclosure is not water tight and leaks to the adjacent area at the downstairs hall bath.

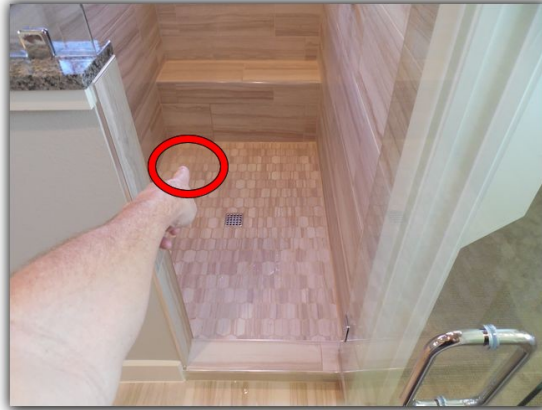
- The master shower floor is inadequately sloped towards the drain and/or notice that water pools on master shower floor well after the plumbing fixture has been turned off.

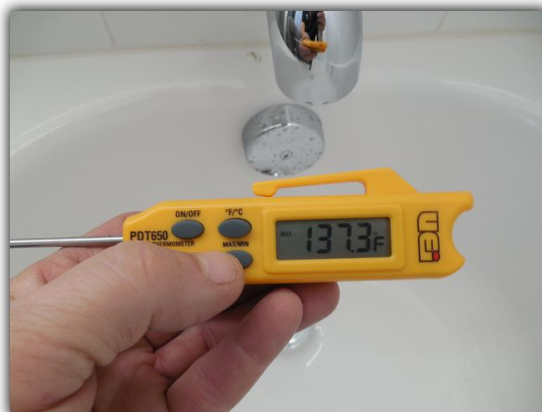
- The temperature setting is too high or water temperature is above 125°, which increases the potential for scalding especially with infants and/or children. This condition is a “Recognized Safety Hazard”.

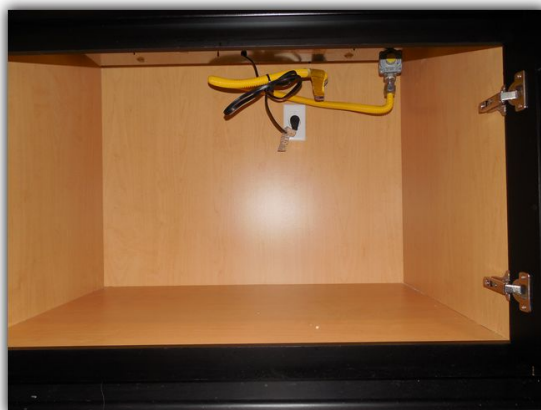
- There is no visible gas shut-off valve in place for the cook-top. There should be a gas shut-off valve within 6'.

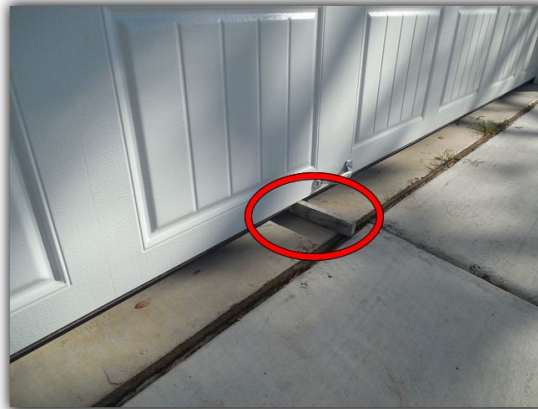
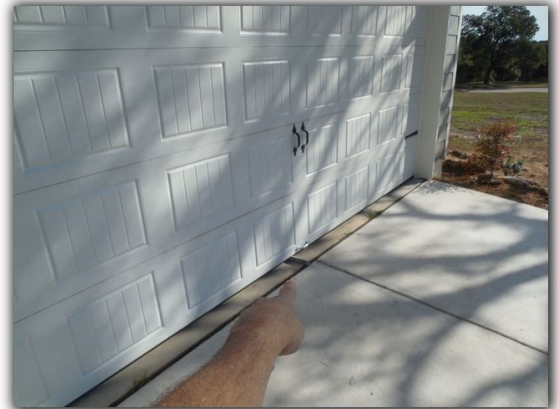
- The garage door opener did not automatically reverse under reasonable resistance to closing. There is a serious risk of injury, particularly to children, under this condition. Improvement may be as simple as adjusting the sensitivity control on the operator. For safety reasons, cause and remedy should be further investigated and corrected as necessary.

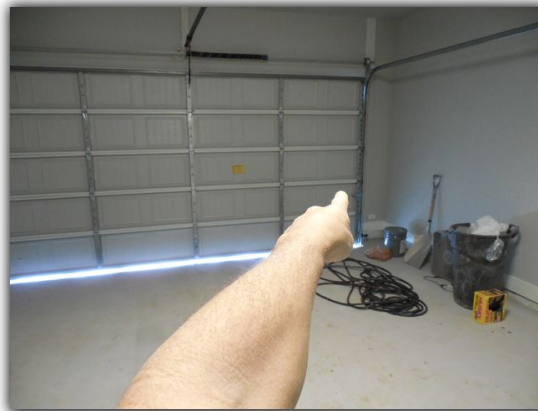
- For safety reasons, manual locking mechanisms should be removed or disabled on overhead garage doors that are equipped with an automatic garage door opener to prevent inadvertent actuation of the opener while lock is engaged and subsequent overhead garage door damage.
