**Inspection Date :**  
December 20, 2024

**Report Number :**  
2024011002

**Report Prepared By :**  
Leppin Inspection Services  
12411 Painted Bunting Drive  
Austin, TX 78726  
Office : (512) 658-7989  
Email : scott@leppininspects.com

# PROPERTY INSPECTION REPORT FORM

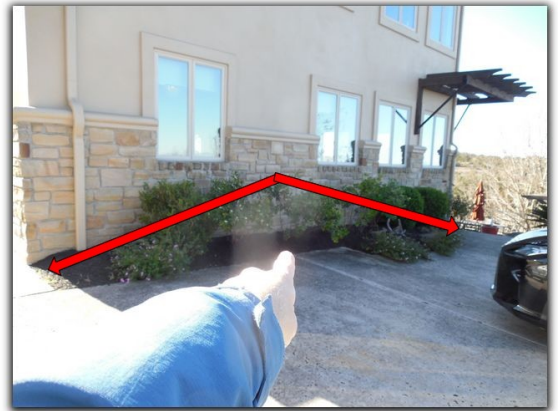
- The lot grade is too high at portions of all four elevations. Current standards require at least 4-inches of foundation visible below masonry veneer and 6-inches of foundation visible below wood type veneer. The grade away from the foundation wall should fall a minimum of six inches (6") within the first ten feet (10'). Improper grade is conducive to moisture intrusion, undesirable wet wall conditions as well as infestation of wood destroying insects and/or organisms. See examples.

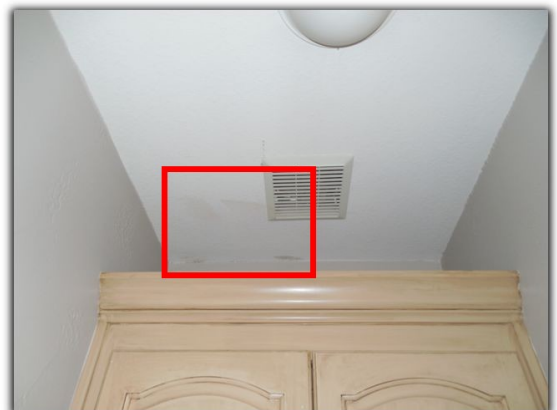
- Moisture stains, damage and what appears to be repairs to such were observed at various interior ceiling and attic locations. Some conditions are likely associated with roof leaks or other undetermined reasons. A roofing contractor should be retained for remedial action. See examples.

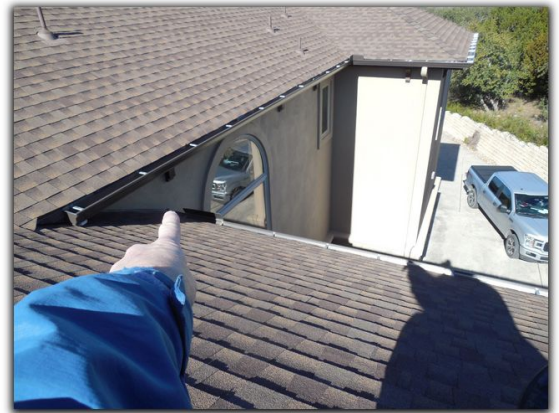
- Kick-out flashing has not been installed at the lower bottom edge of the roof line interface and the sidewall that continues past the edge of the roof at one or more. The lack of this kick-out flashing may allow water to penetrate at these points. A roofing contractor should be retained for remedial action. See example.

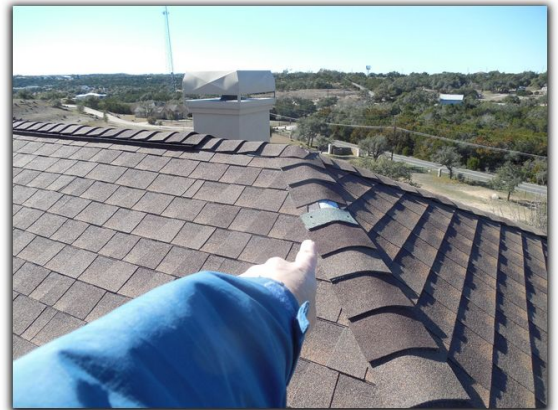
- Missing ridge shingle was observed near the back left corner house roof, which is conducive to water intrusion. A roofing contractor should be retained for remedial action.

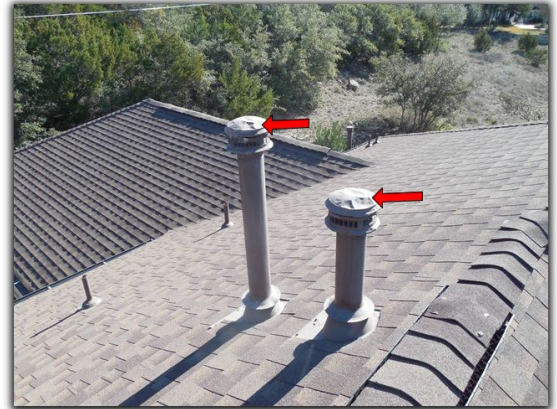
- Both furnace rain caps are damaged and should be replaced.

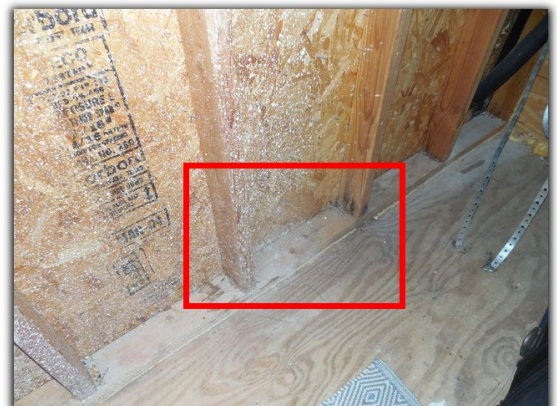
- Moisture stains were observed on wall located at right side house 1st story attic. A roofing contractor should be retained for remedial action.

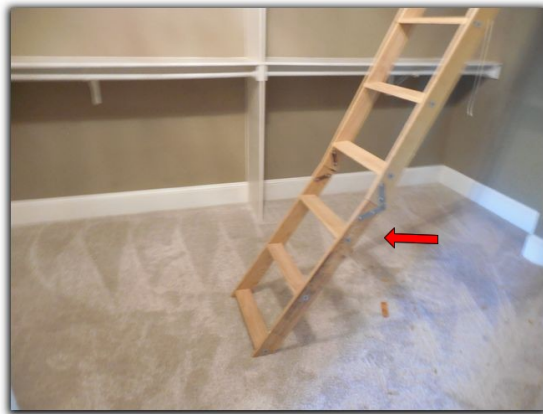
- The attic access pull down ladder located in closet off master bath strikes chandelier.
- The attic access pull down ladder is not properly installed to the manufactures installation instructions. The manufacture requires the attic ladder to be installed with 16d nails or ¼” x 3” lag bolts in conjunction with listed fastener pattern locations and ladder properly shimmed to fit snug in opening. Current ladder installation is deficient in one or more of the above listed and should be corrected for safety reasons. Conditions should be self-evident to a qualified carpenter.

- The attic access pull down ladder hardware has some loose nuts & bolts. Repairs recommended for safety reasons.
- The pull down access ladder is not cut to fit properly from ceiling to floor, which puts undue stress on the ladder and/or causes the ladder to bend at the hinges making it unsafe to navigate, which may cause bodily injury.

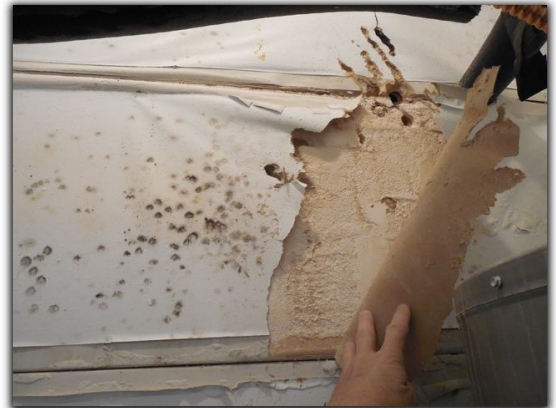
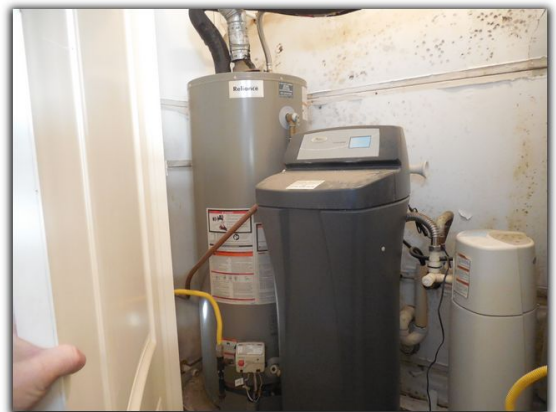
- Walls in water heater closet are moisture stained and significantly damaged. The extent to such at concealed areas or near water heater closet is unknown. It should also be noted that a mold like substance was observed on water heater closet walls. I advise further investigation necessary repairs by qualified service specialist. See examples.

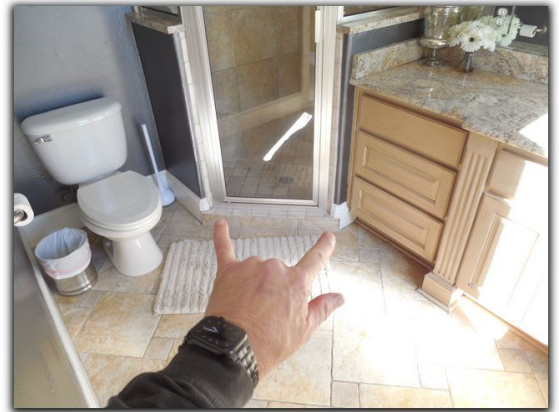
- The lower walls and base-boards are moisture stained near shower located in guest bathroom. Cause and remedy should be further investigated and corrected as necessary. This report makes no determinations or representations regarding the presence of any environmental pathogens that may be related to any moisture conditions identified in this report. Testing for such is beyond the scope of this inspection. These services may be provided by other “Qualified Specialist”.

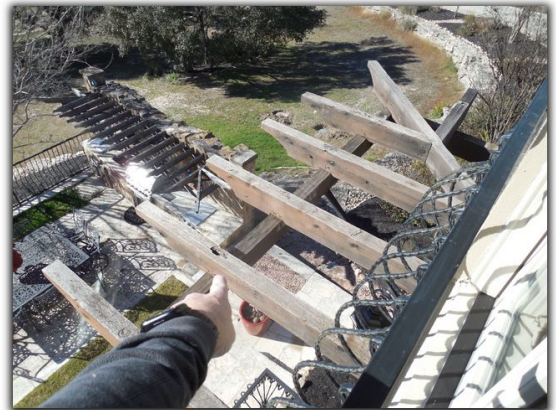
- Wood decay or rot were observed at various trellis locations. I advise necessary repairs. See example.

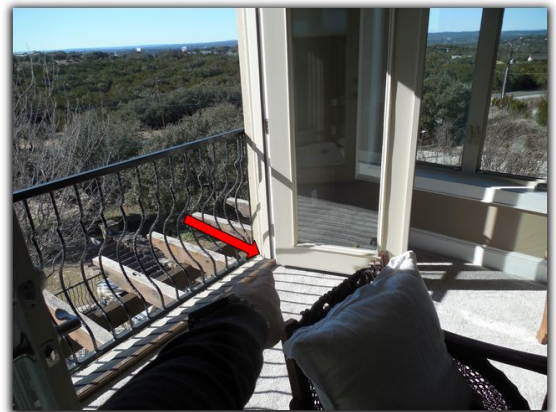
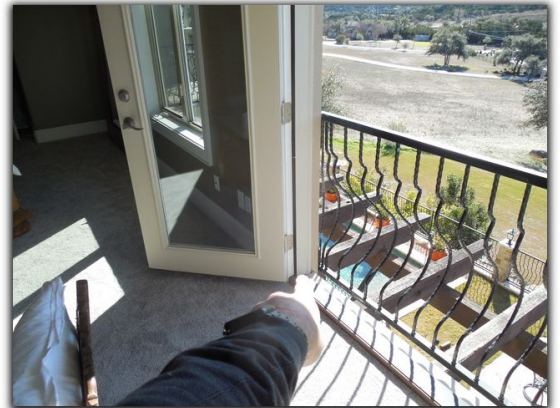
- Damaged and missing stucco creates open voids at the front elevation 2nd story wall near bottom left and right corners of master bedroom Juliet balcony doors. Conditions have likely allowed water intrusion into the wall leading to potential water damage. The extent of any potential water damage is unknown. I advise further investigation and repairs by stucco specialist.

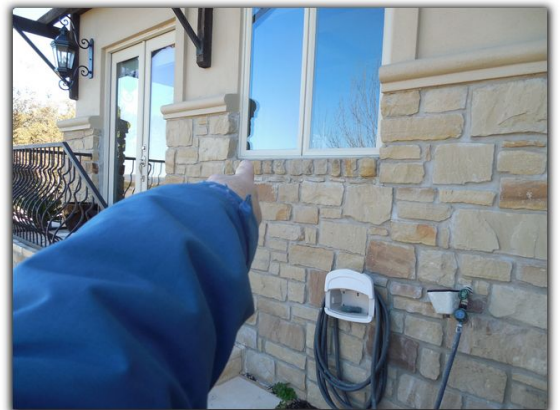
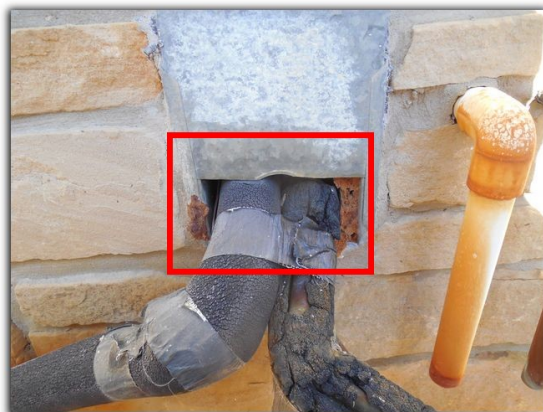
- Exterior wall claddings are not properly sealed at multiple location. These can include caulking or sealing as well as maintaining *all* joints, seams, penetrations and attachments to prevent potential water intrusion and related damage as well as proving pest and rodents a point of entry. Conditions should be self-evident to a qualified carpenter. See some examples.

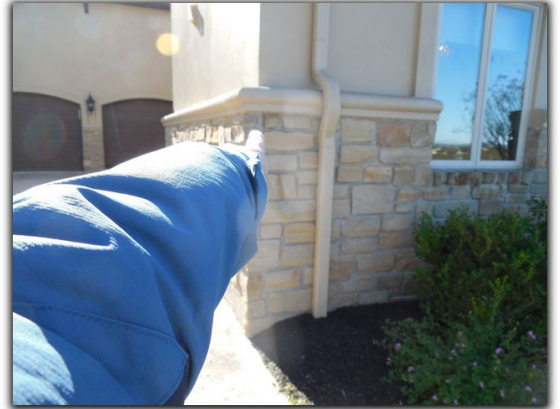
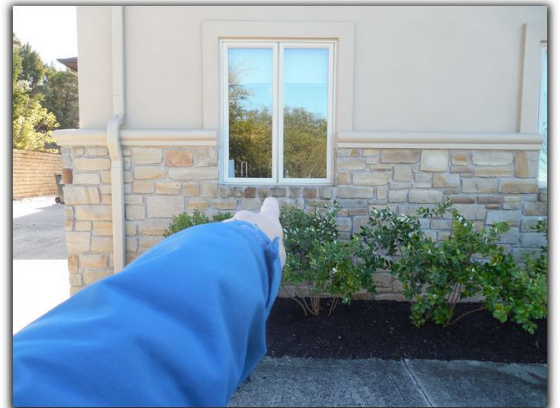
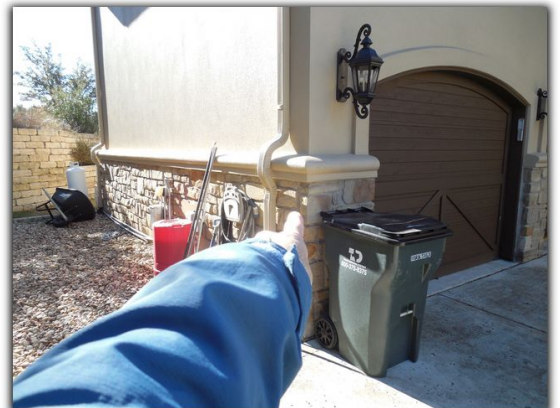
- Cracks in mortar including loose masonry pieces were observed at more than one wall location. This includes the house as well as masonry walls located at pool equipment and A/C condenser unit pads. I advise necessary repairs to restore masonry wall integrity as well as moisture intrusion at house wall locations. See examples.

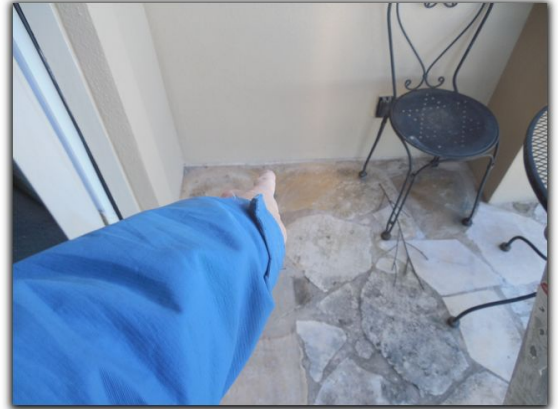
- The stucco wall planes lack a minimum clearance of 2” from abutting horizontal surfaces (i.e. drives, porches, patio's, balconies, ect.). This type of installation does not provide a proper means for drainage and may also allow moisture to be wicked into these areas. Find example at front balconyoff upstairs bonus room.

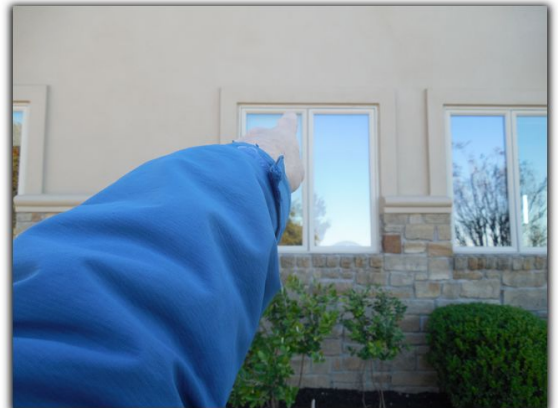
- The installation of "Z" flashing was not observed above window locations to help prevent the potential of water intrusion. Whether there will be any long-term risk of water intrusion is going to depend entirely on the quality and technique of the moisture barrier and flashing located behind the stucco. See example.

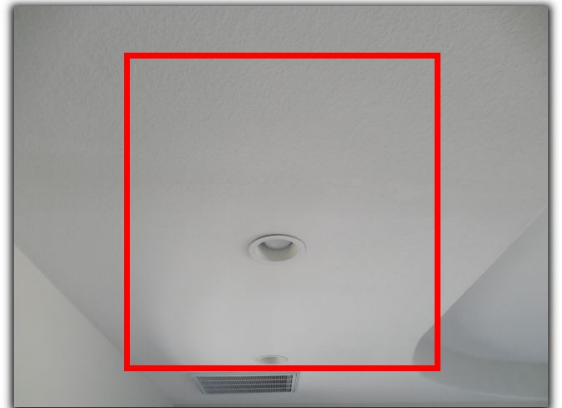
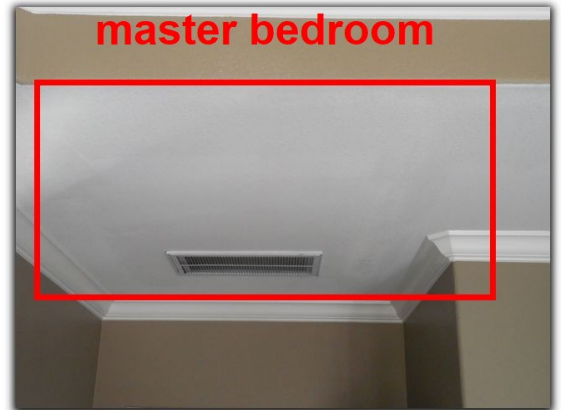
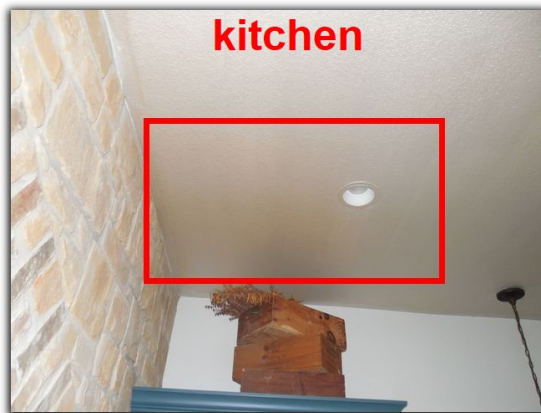
- Ceilings are moisture stained and damaged from undetermined reasons. Evidence of previous repairs and mismatched paint were also observed. These conditions can be found at various home locations, such as the upstairs hall, study nook and master bedroom. Cause and remedy should be further investigated and corrected as necessary. See examples.

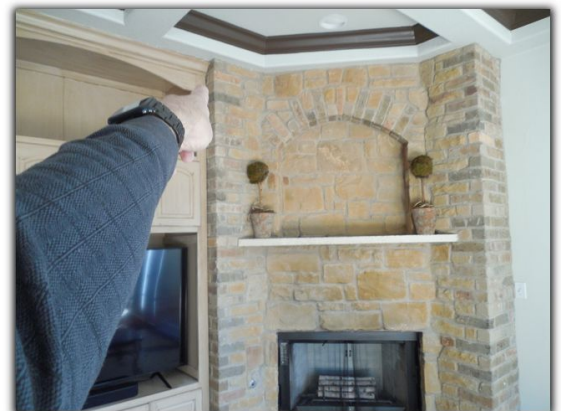
- Moisture related stains were observed on ceiling near top left corner of downstairs living room fireplace. Cause and remedy should be further investigated and corrected as necessary.

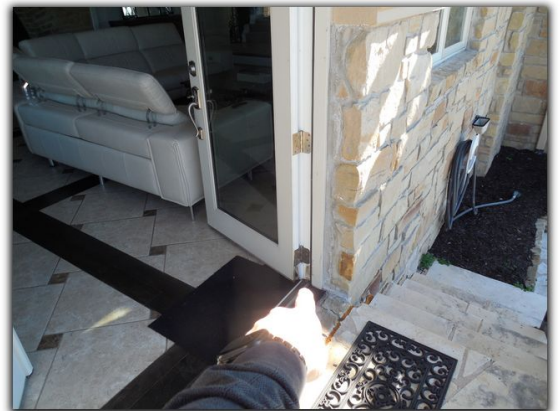
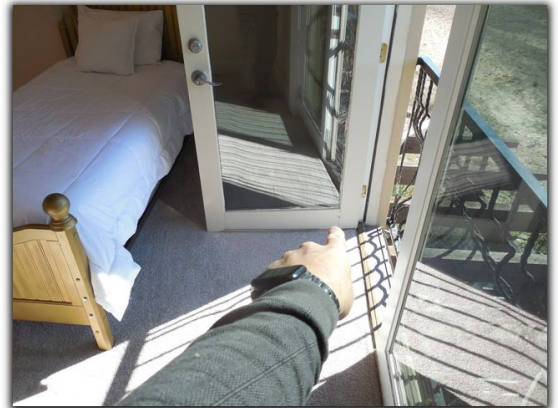
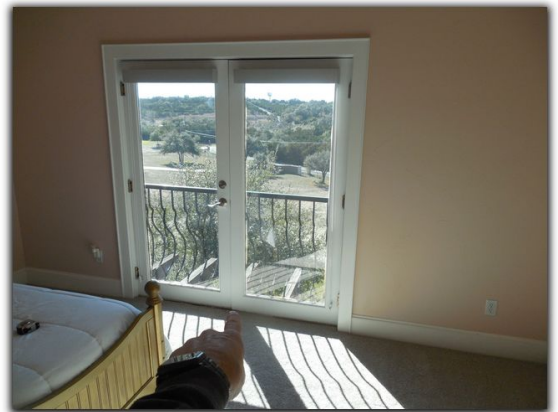
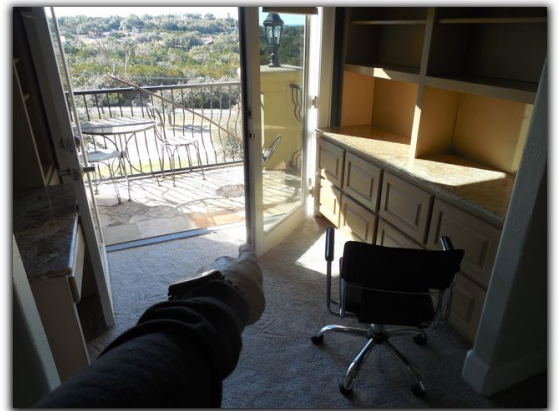
- Handle does not properly function at front right corner house porch/formal dining room entry.
- The garage pedestrian entry door does not properly seal at top of horizontal plane and handle is missing striker-plate installation.
- Wood doors and casings are rotted at most of the front elevation 1st story entry and 2nd story Juliet balcony doors. Evidence of water intrusion was also observed, primarily at the 2nd story Juliet balcony door locations. The extent of water damage related to leaks at doors could not be determined due to concealment. I advise further investigation and repairs by service specialist. See examples.

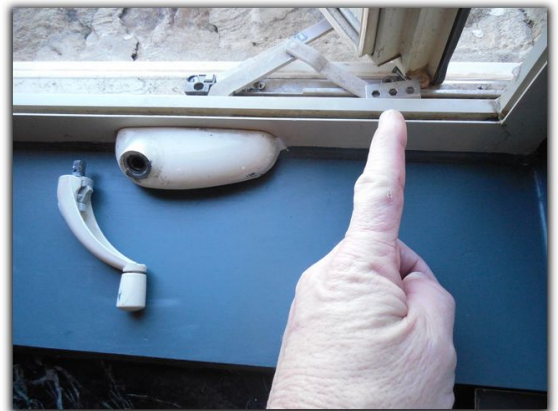
- The mechanical crank opening hardware is loose, missing or damaged at most if not all window locations. Window located at front elevation 2nd story bonus room literally fell out from window frame when opened. I advise you to contact a window specialist to perform a further evaluation of all windows and that they be repaired or replaced as necessary. See examples.

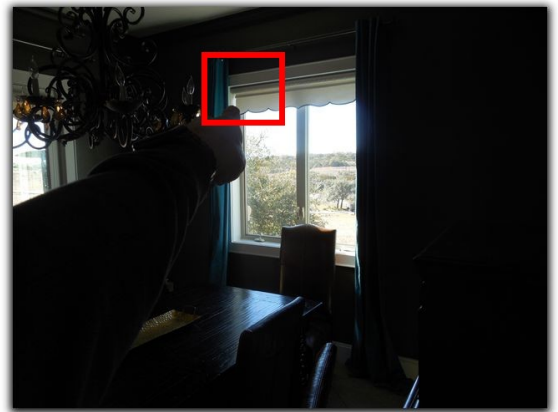
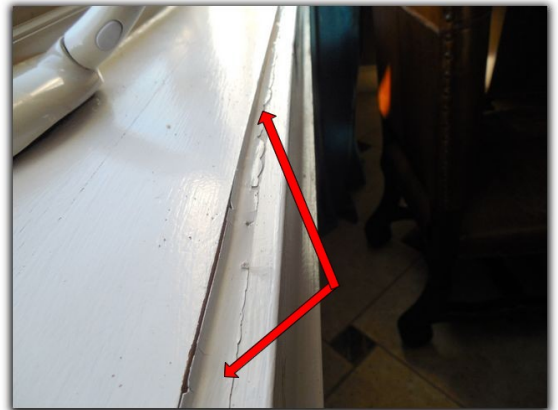
- There are gapped caulk joints, chipped and peeling paint located at front elevation formal dining room window, which is indicative of moisture. I advise further investigation by window specialist. See examples

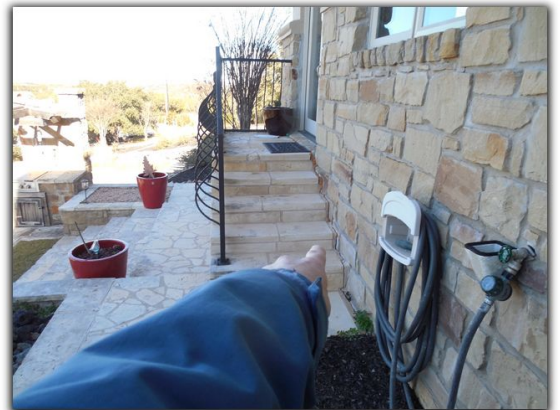
- Steps are settling and pulling away from home at one or more location. Find example at front elevation near the front left corner of house.

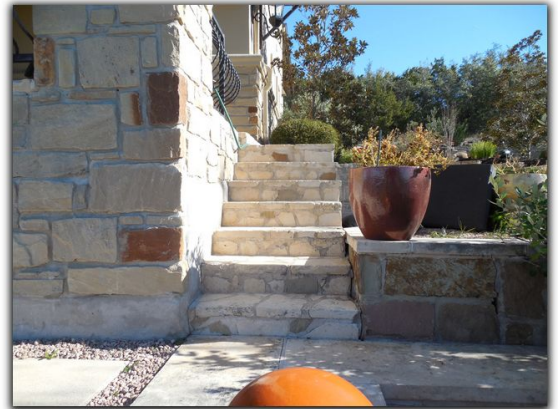
- Exterior yard steps lack handrails at more than one location, creating a potential trip hazard. Find some examples in yard near front right corner of house.

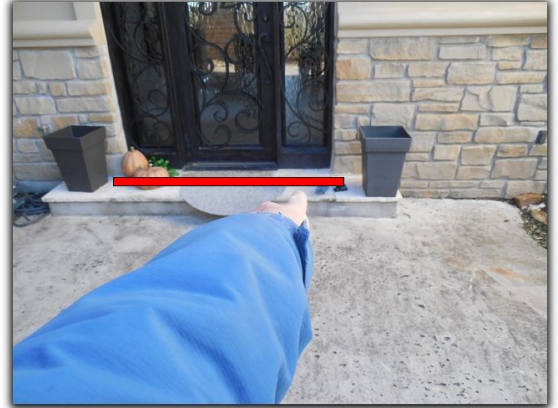
- Landing is cracked at the back garage drive pedestrian entry door.

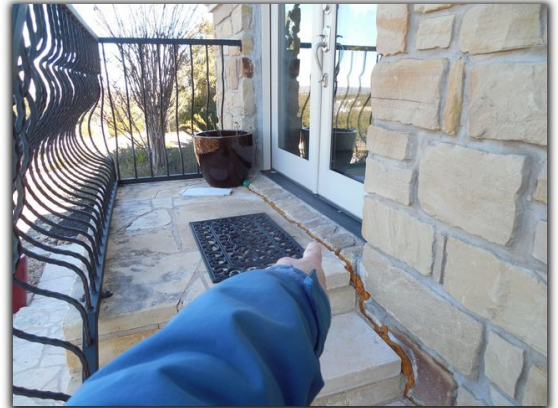
- Cracks in mortar including loose masonry pieces were observed at threshold plate area of front entry porch door.

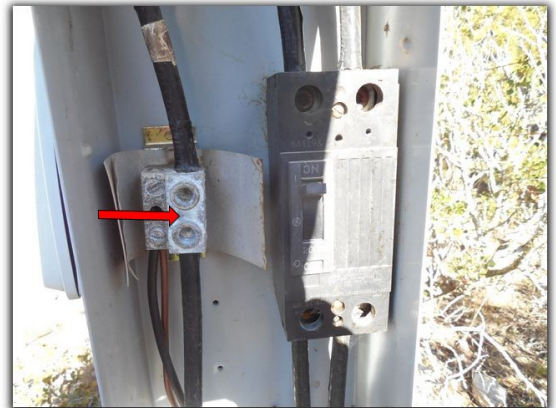
- Wire connection terminal is corroded in the main electrical panel. I advise necessary repairs by service specialist for safety reasons.

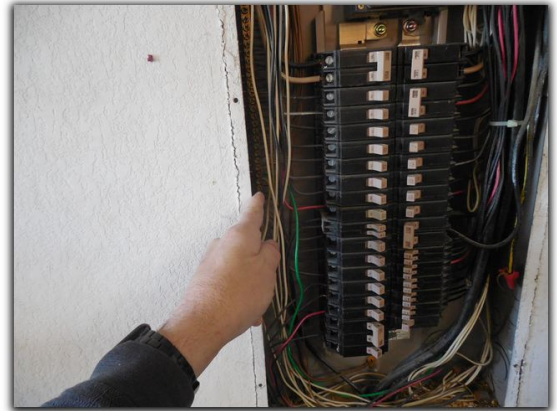
- Although commonly observed, bunched wires at the Sub-panel entry are not consistent with current installation practices.
- Multiple wires are installed under a single lug screw on the neutral bus in the electrical sub-panel. Electrical standards prohibit this practice and it should be corrected. This condition can lead to loose connections and overheating of electrical wires.

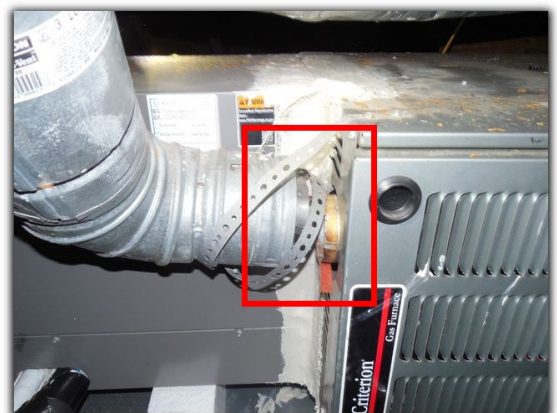
- Both of the furnace flue pipes are damaged and detached at heating units located in 2nd story attic, which will allow Carbon Monoxide into the attic space. For life/safety reasons, I advise the necessary repairs to be performed by service specialist. See examples.

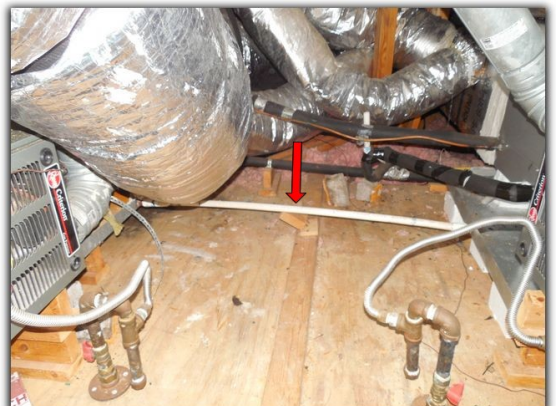
- The upstairs A/C system overflow pan drain pipe lacks gravity flow and/or runs uphill, which will negate performance and may lead to water damage at area below. I advise necessary repairs to be performed by service specialist.

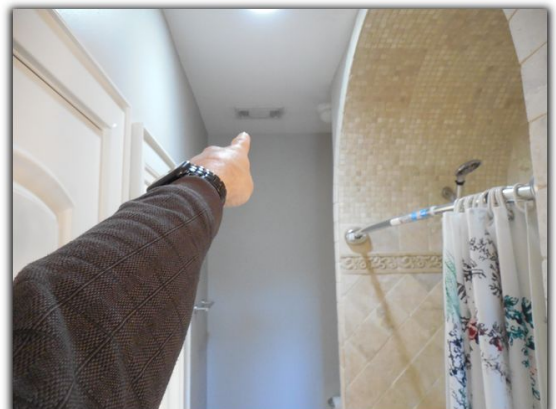
- The majority of both HVAC system supply air discharge registers were closed for unknown reasons. I advise further investigation by a service specialist. See example.
