**Report Number :**  
2016010402

## PROPERTY INSPECTION REPORT

**Concerning:** Somewhere, Austin, TX 78726  
(Address or Other Identification of Inspected Property)

**By:** Scott Leppin, Lic #2825 01/04/2016  
(Name and License Number of Inspector) (Date)

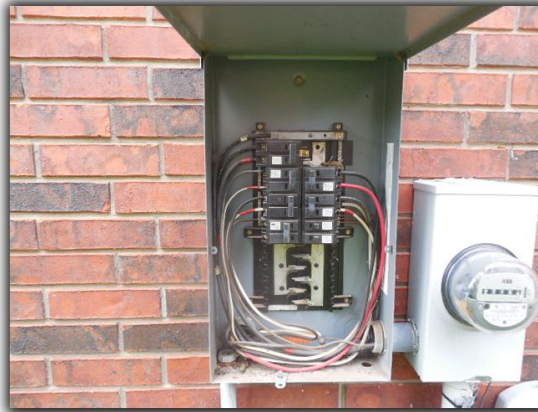
- Knock-out missing at panel base. This may allow insects and/or other entry into panel or notice electrocuted lizard found in panel.
