Report Number :
2019121301

PROPERTY INSPECTION REPORT

Concerning: Not Disclosed, Austin, TX 78727
(Address or Other Identification of Inspected Property)

By: Scott Leppin, Lic # 2825 12/13/2019
(Name and License Number of Inspector) (Date)

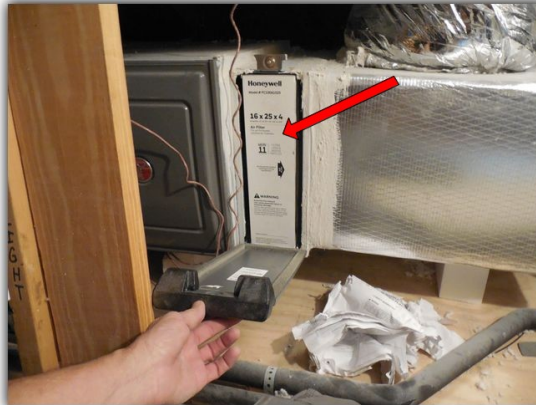
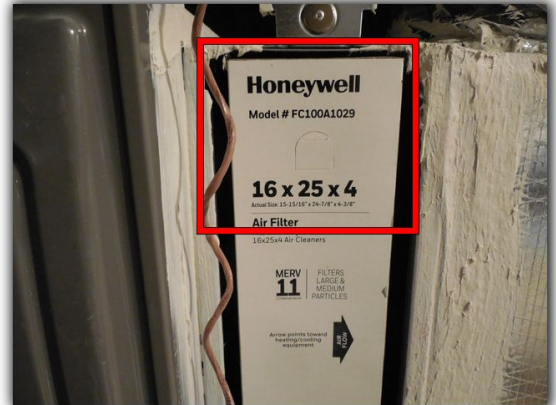
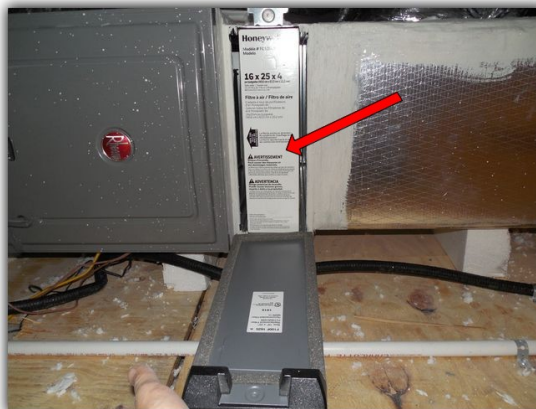
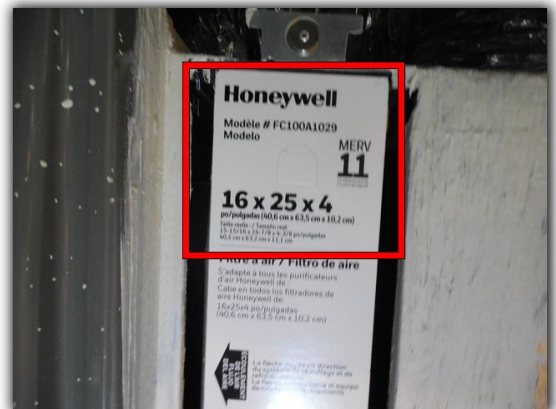
Return Air Filters

- The HVAC system return air filtes are improperly installed and/or lack proper directional air flow.

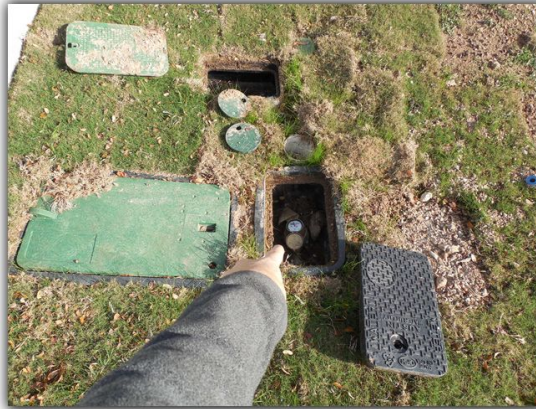
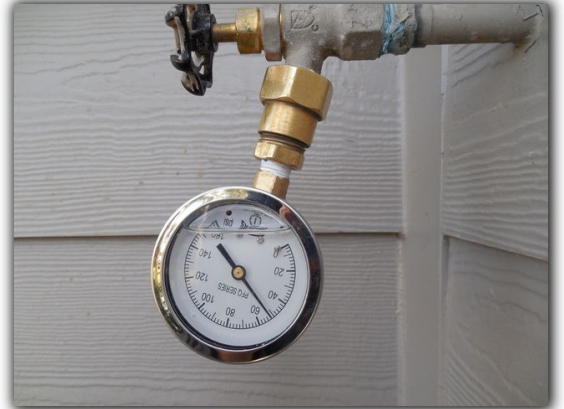
Exterior Faucets/Fixtures

- The exterior front elevation wall water hose bibb does not have a back-flow or anti-siphon device (Vacuum Breakers) in place. The exposed copper water supply line at hose bib also lacks freeze protection.
