**Inspection Date :**  
December 20, 2024

**Report Number :**  
2024011002

**Report Prepared By :**  
Leppin Inspection Services  
12411 Painted Bunting Drive  
Austin, TX 78726  
Office : (512) 658-7989  
Email : scott@leppininspects.com

# PROPERTY INSPECTION REPORT FORM

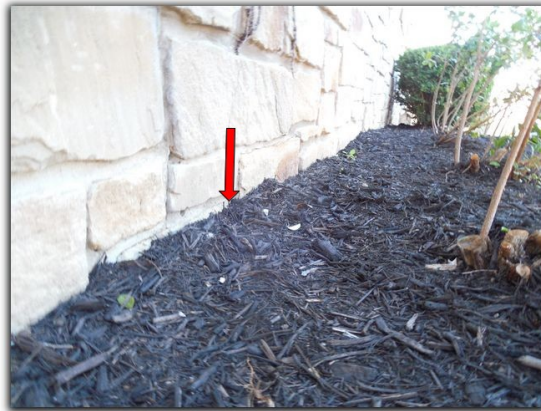
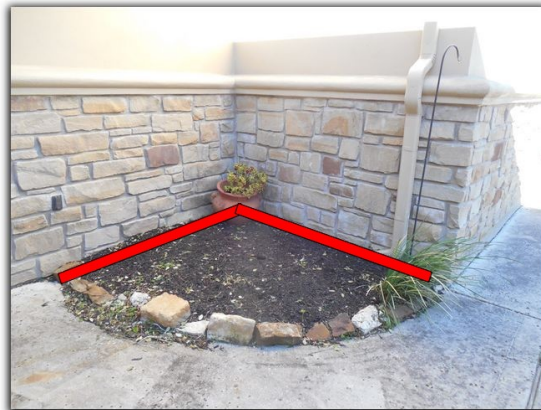
- The lot grade is too high at portions of all four elevations. Current standards require at least 4-inches of foundation visible below masonry veneer and 6-inches of foundation visible below wood type veneer. The grade away from the foundation wall should fall a minimum of six inches (6") within the first ten feet (10'). Improper grade is conducive to moisture intrusion, undesirable wet wall conditions as well as infestation of wood destroying insects and/or organisms. See examples.

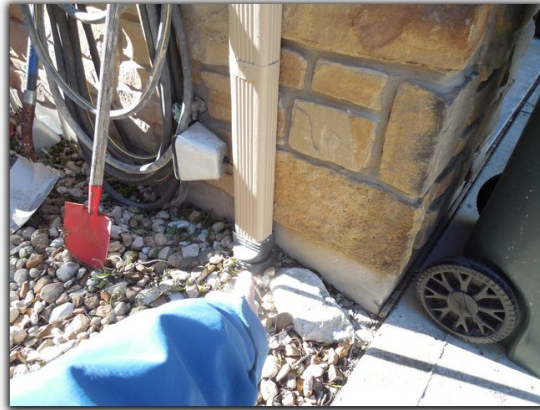
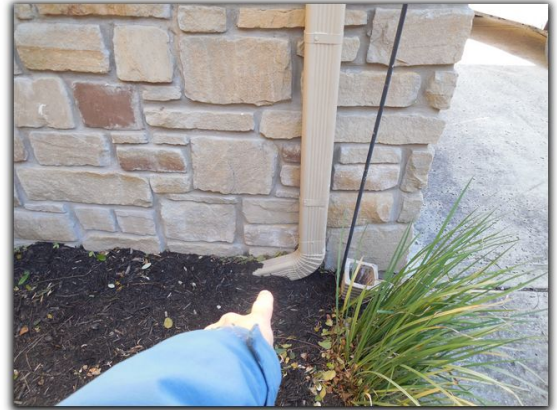
**Note:** The performance of gutter down-spouts that terminate below grade were not verified. See example.

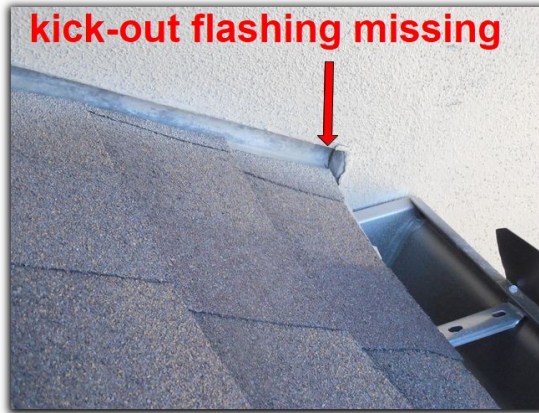
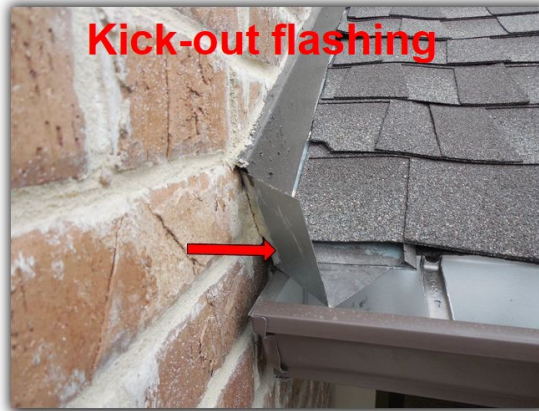
- Kick-out flashing has not been installed at the lower bottom edge of the roof line interface and the sidewall that continues past the edge of the roof at one or more. The lack of this kick-out flashing may allow water to penetrate at these points. A roofing contractor should be retained for remedial action. See example.

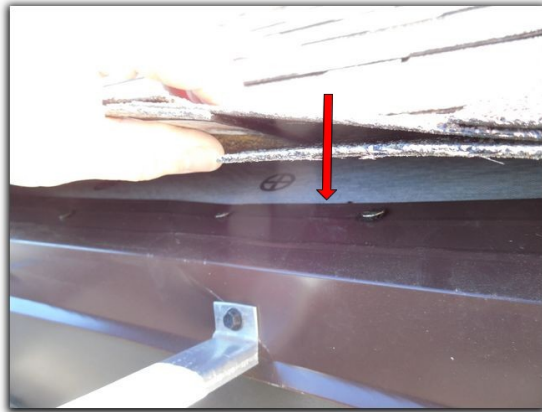
- Random inspection for proper installation of moisture barrier below the shingles at the starter row revealed areas of inadequate coverage and/or improper placement under the metal drip edge flashing. The felt paper should be installed over the top of the metal drip edge flashing in shingle like fashion to help prevent potential water intrusion and/or damage to occur behind the fascia board and soffit areas. A roofing contractor should be retained for remedial action. See example.

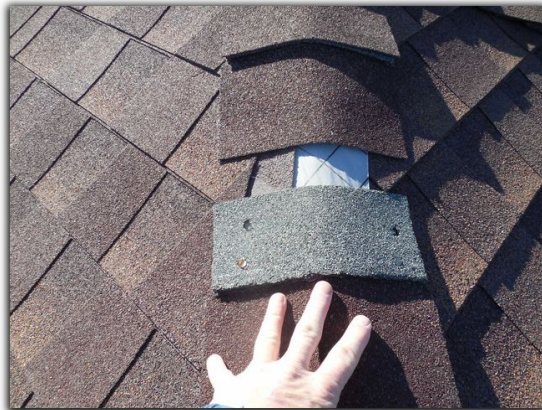
- Missing ridge shingle was observed near the back left corner house roof, which is conducive to water intrusion. A roofing contractor should be retained for remedial action.

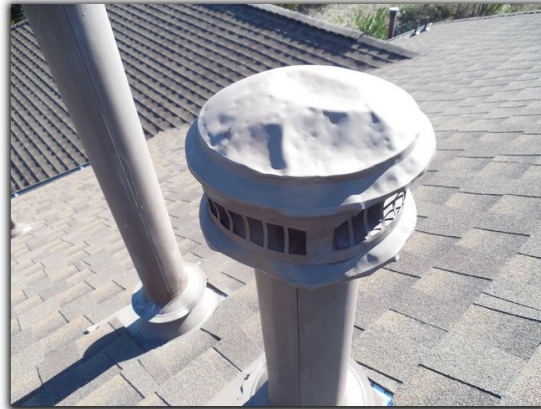
- Both furnace rain caps are damaged and should be replaced.

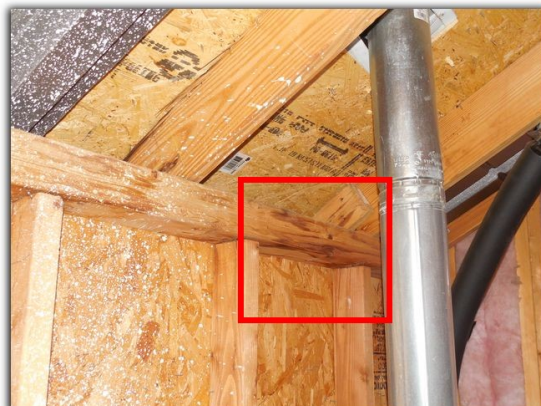
- Moisture stains were observed on wall located at right side house 1st story attic. A roofing contractor should be retained for remedial action.

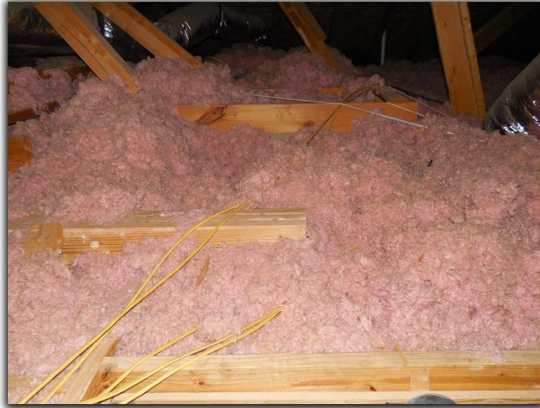
- Portions of the 2nd story attic floor insulation is packed in traffic area's or has been moved. Energy efficiency is optimal when there is an evenly distributed insulation product to achieve an even R-30 to R-38 value. See examples.

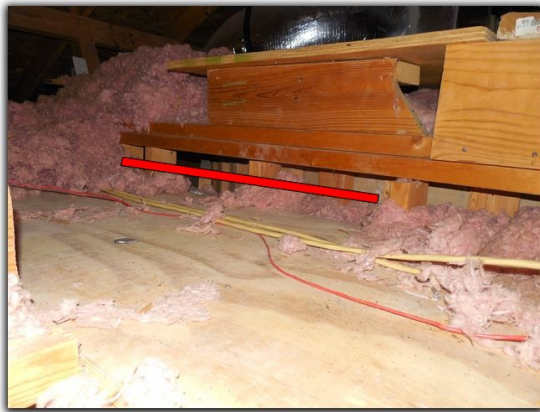
- Draft-stop and/or insulation has not been provided between the 2<sup>nd</sup> story attic flooring and the HVAC equipment platform. This condition creates un-insulated space between interior conditioned spaces of home. See example.

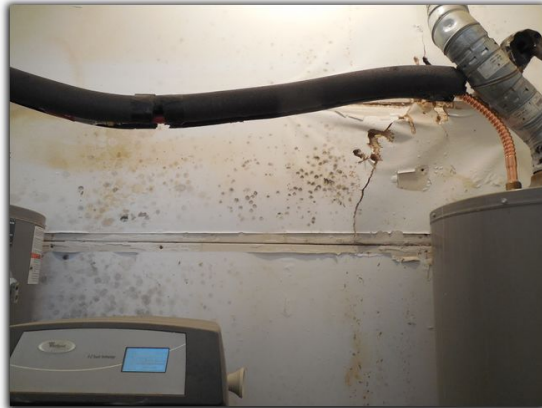
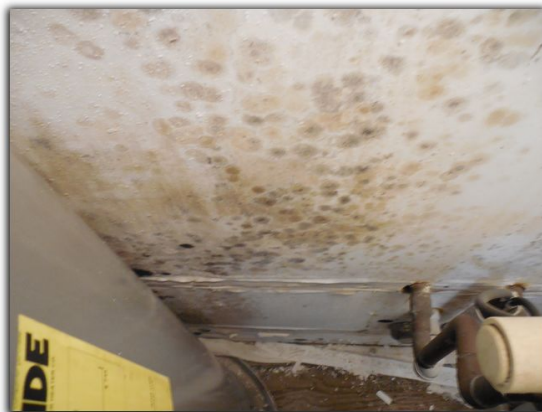
- Walls in water heater closet are moisture stained and significantly damaged. The extent to such at concealed areas or near water heater closet is unknown. It should also be noted that a mold like substance was observed on water heater closet walls. I advise further investigation necessary repairs by qualified service specialist. See examples.

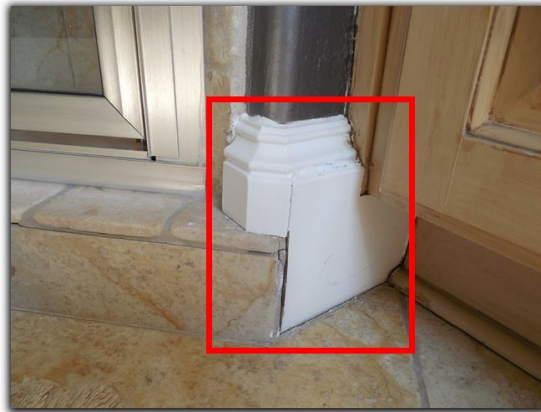
- The lower walls and base-boards are moisture stained near shower located in guest bathroom. Cause and remedy should be further investigated and corrected as necessary. This report makes no determinations or representations regarding the presence of any environmental pathogens that may be related to any moisture conditions identified in this report. Testing for such is beyond the scope of this inspection. These services may be provided by other “Qualified Specialist”.

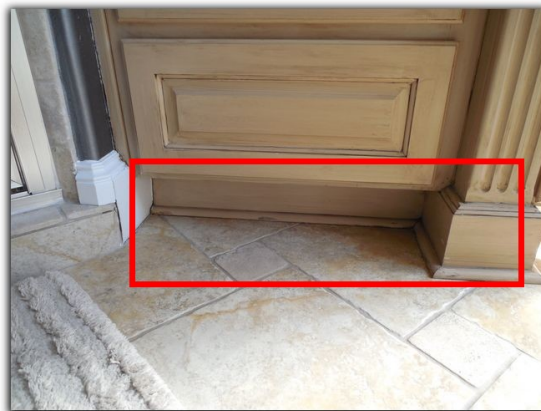
- While no moisture was observed, lower portions of guest bathroom cabinets are moisture stained. Cause and remedy should be further investigated and corrected as necessary. This report makes no determinations or representations regarding the presence of any environmental pathogens that may be related to any moisture conditions identified in this report. Testing for such is beyond the scope of this inspection. These services may be provided by other “Qualified Specialist”..

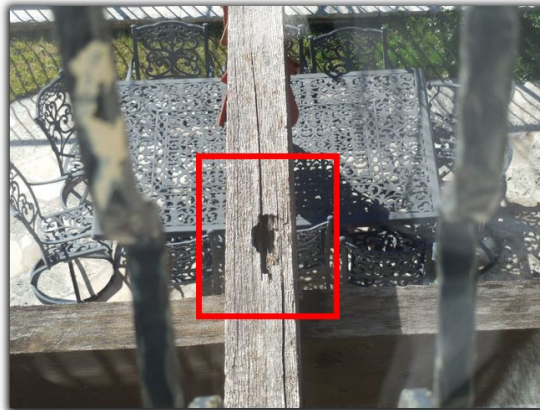
- Wood decay or rot were observed at various trellis locations. I advise necessary repairs. See example.

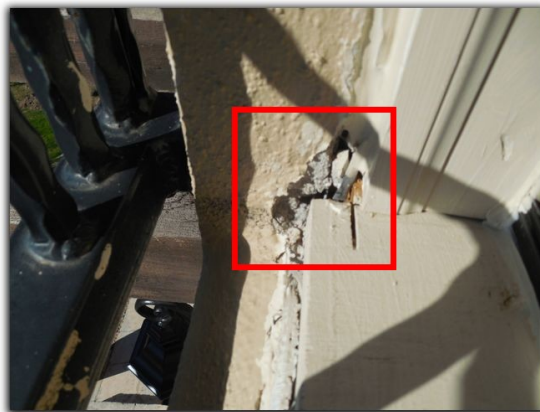
- Damaged and missing stucco creates open voids at the front elevation 2nd story wall near bottom left and right corners of master bedroom Juliet balcony doors. Conditions have likely allowed water intrusion into the wall leading to potential water damage. The extent of any potential water damage is unknown. I advise further investigation and repairs by stucco specialist.

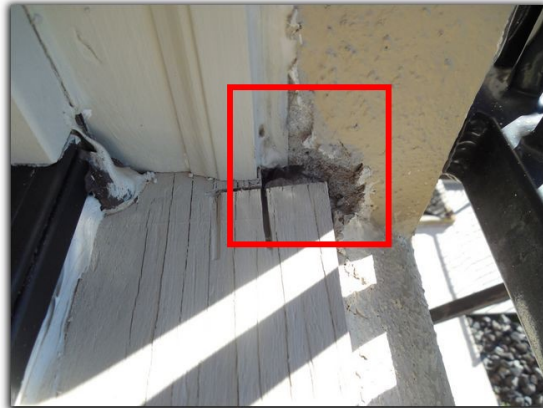
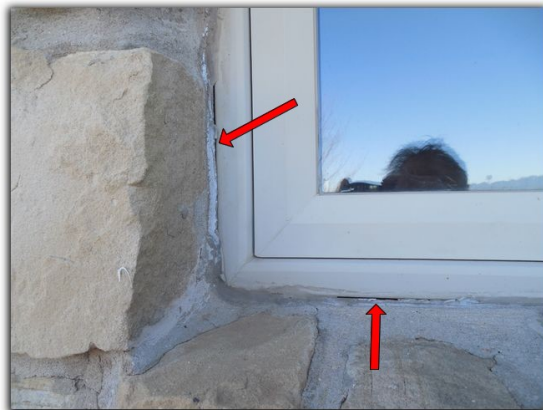
- Exterior wall claddings are not properly sealed at multiple location. These can include caulking or sealing as well as maintaining *all* joints, seams, penetrations and attachments to prevent potential water intrusion and related damage as well as proving pest and rodents a point of entry. Conditions should be self-evident to a qualified carpenter. See some examples.

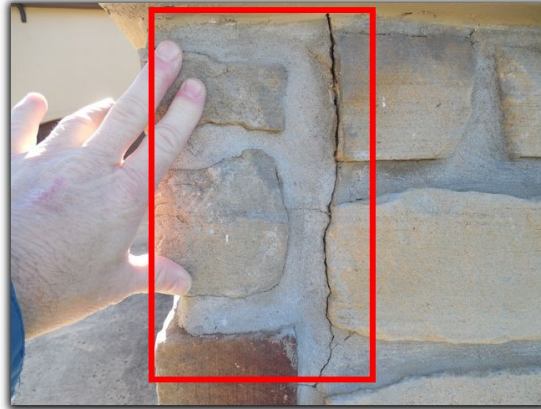
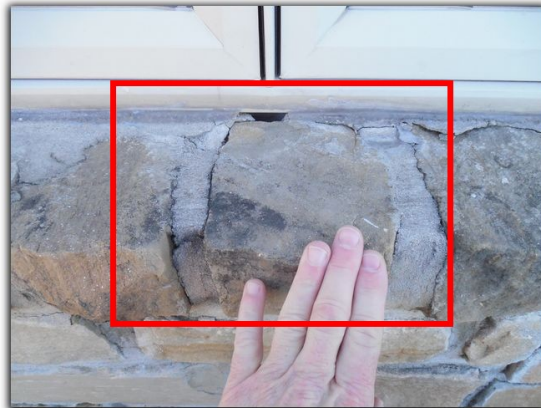
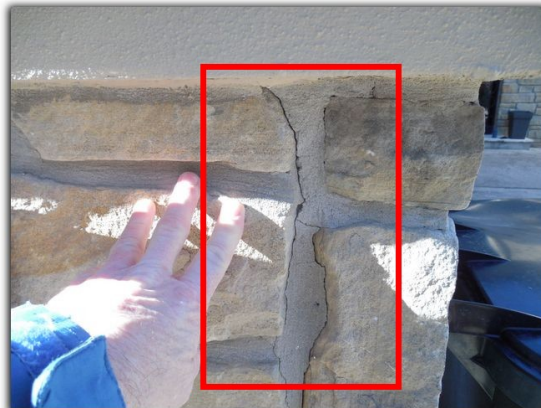
- Cracks in mortar including loose masonry pieces were observed at more than one wall location. This includes the house as well as masonry walls located at pool equipment and A/C condenser unit pads. I advise necessary repairs to restore masonry wall integrity as well as moisture intrusion at house wall locations. See examples.

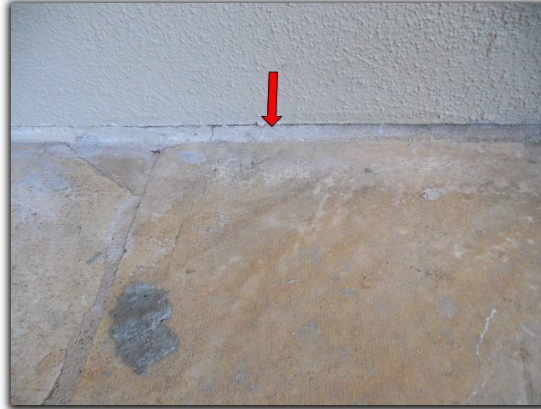
- The stucco wall planes lack a minimum clearance of 2” from abutting horizontal surfaces (i.e. drives, porches, patio's, balconies, ect.). This type of installation does not provide a proper means for drainage and may also allow moisture to be wicked into these areas. Find example at front balconyoff upstairs bonus room.

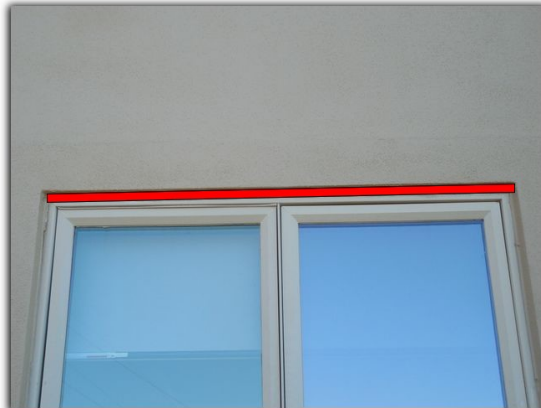
- The installation of "Z" flashing was not observed above window locations to help prevent the potential of water intrusion. Whether there will be any long-term risk of water intrusion is going to depend entirely on the quality and technique of the moisture barrier and flashing located behind the stucco. See example.

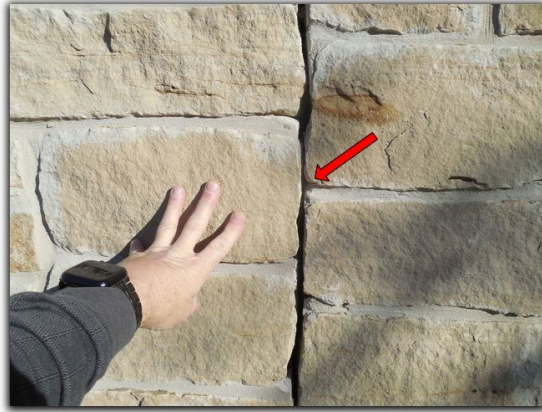
- Expansion joints are not sealed at detached garage masonry walls, which may allow water intrusion. The joints should be sealed with a caulking agent that provides some elasticity to prevent cracks.

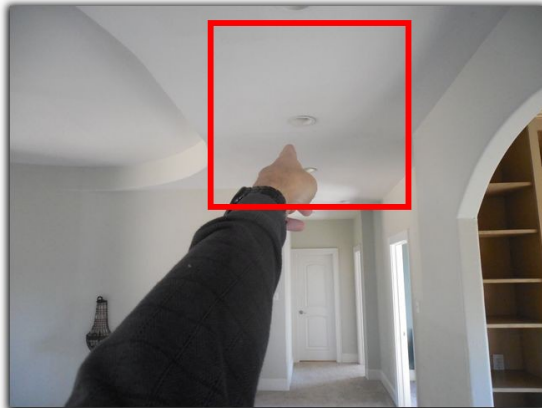
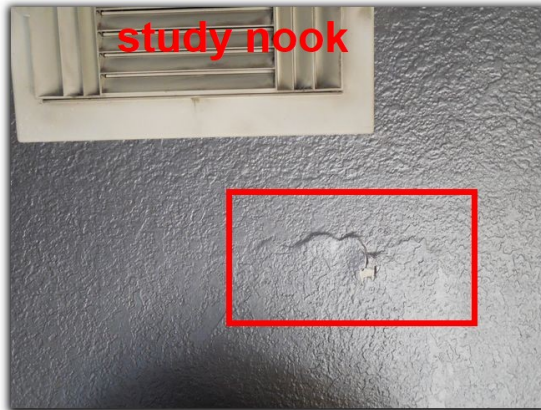
- Ceilings are moisture stained and damaged from undetermined reasons. Evidence of previous repairs and mismatched paint were also observed. These conditions can be found at various home locations, such as the upstairs hall, study nook and master bedroom. Cause and remedy should be further investigated and corrected as necessary. See examples.

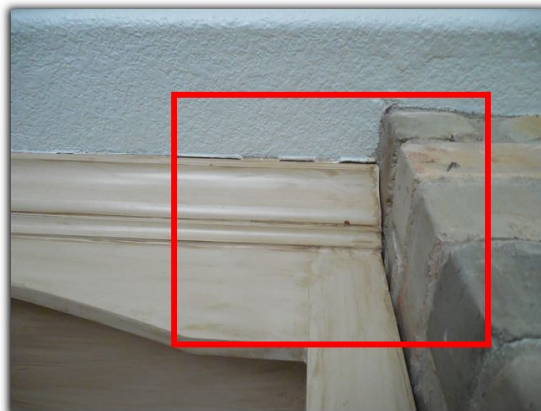
- Moisture related stains were observed on ceiling near top left corner of downstairs living room fireplace. Cause and remedy should be further investigated and corrected as necessary.

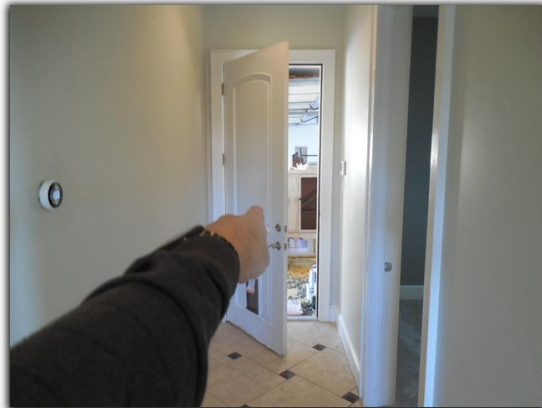
- For life/safety reasons, self-close hinges should be installed at the garage pedestrian entry door.

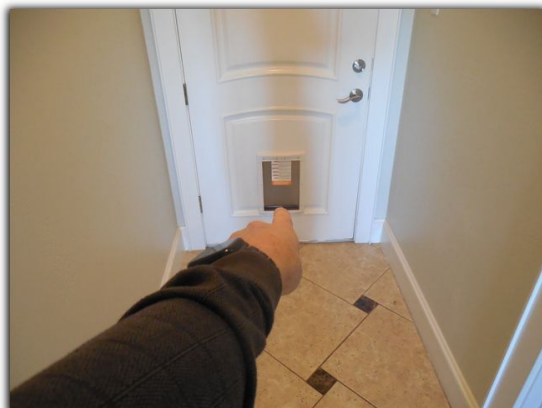
- Pet-door installation at door located between garage and home breaches door fire-separation. For life/safety reasons I advise door replacement.

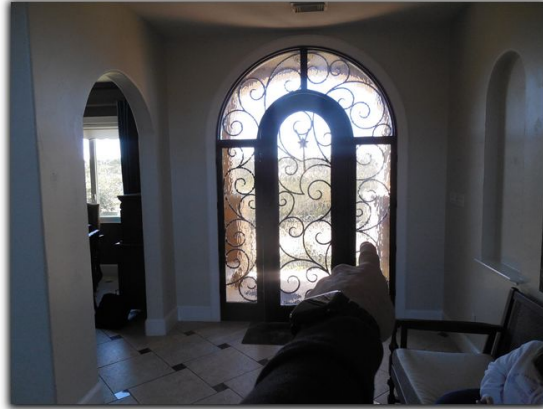
- Glass has bad vacuum seal at the left side panel of front porch entry door. I advise further evaluation by a glass specialist.

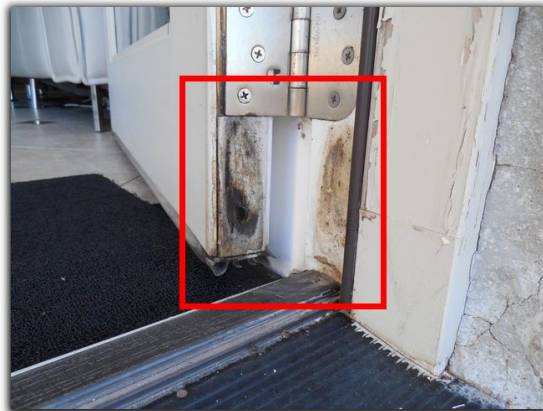
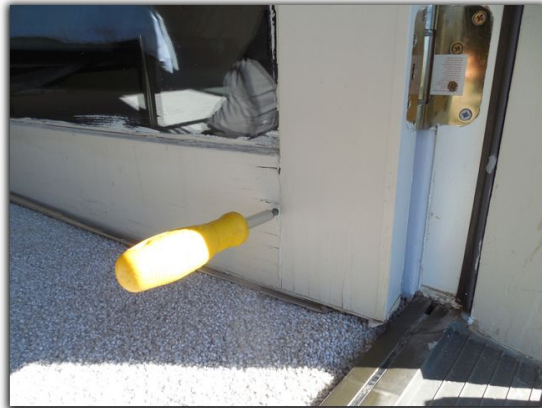
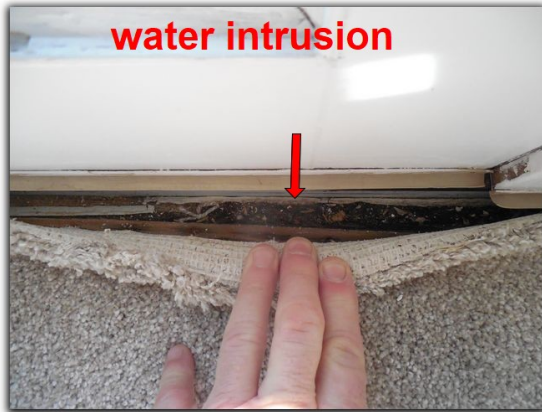
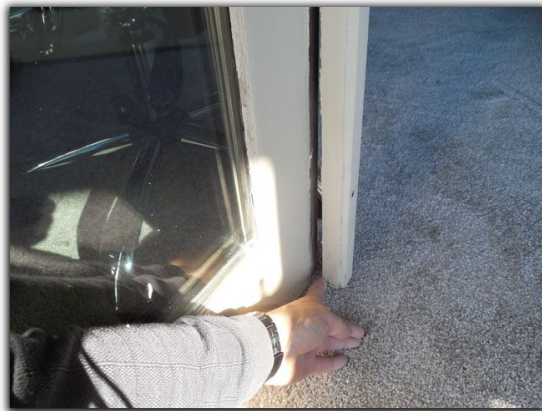
- Handle does not properly function at front right corner house porch/formal dining room entry.
- The garage pedestrian entry door does not properly seal at top of horizontal plane and handle is missing striker-plate installation.
- Wood doors and casings are rotted at most of the front elevation 1st story entry and 2nd story Juliet balcony doors. Evidence of water intrusion was also observed, primarily at the 2nd story Juliet balcony door locations. The extent of water damage related to leaks at doors could not be determined due to concealment. I advise further investigation and repairs by service specialist. See examples.

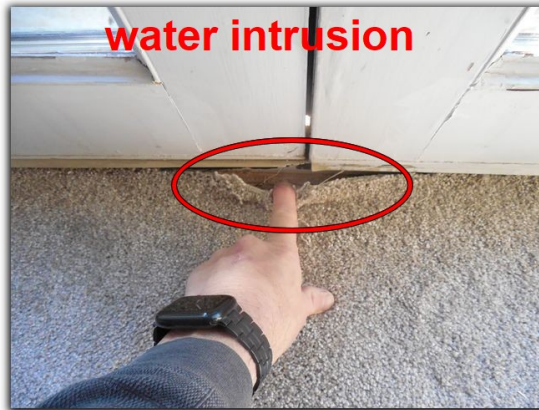
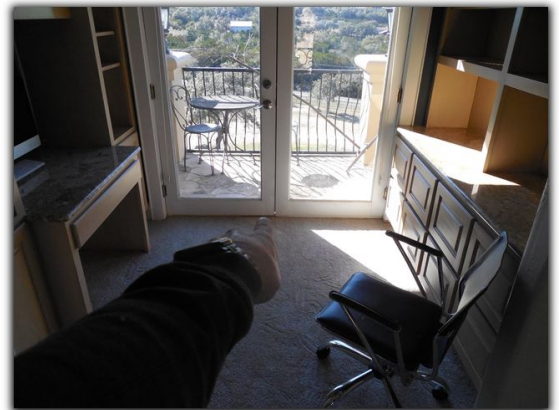
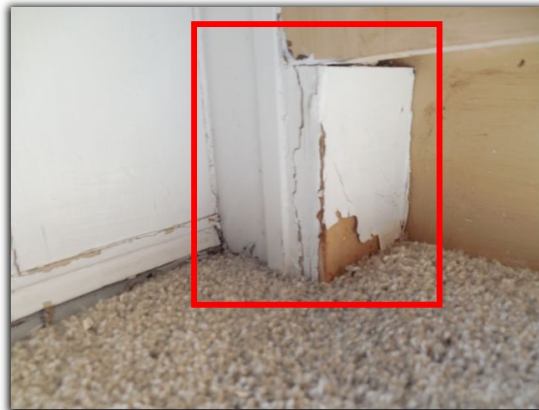
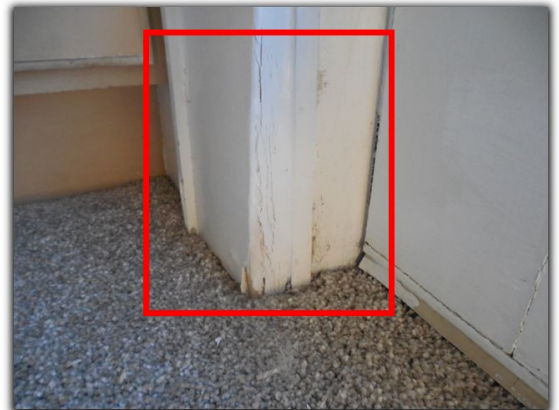
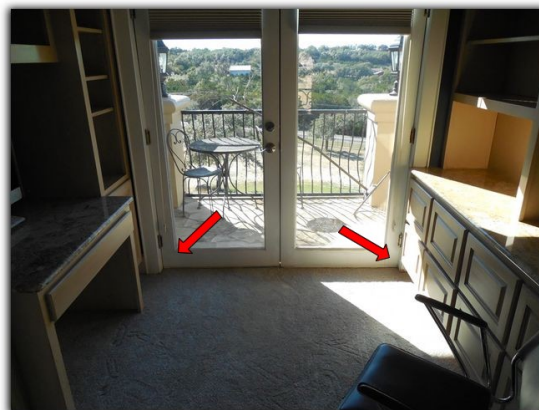
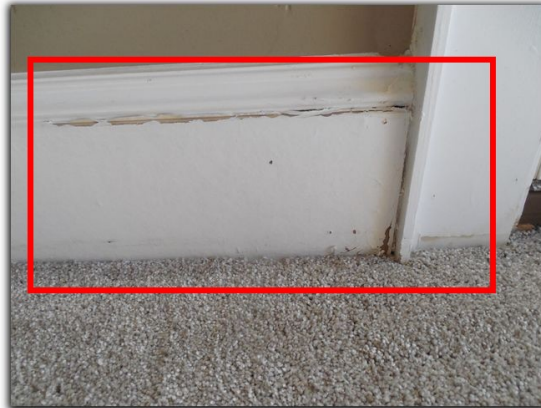
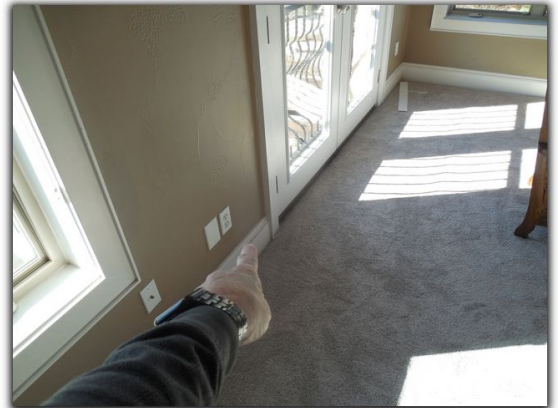
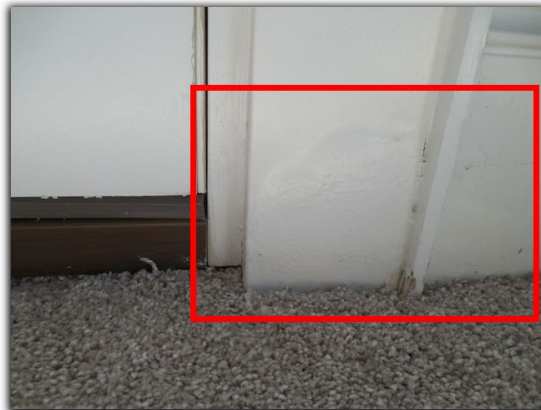
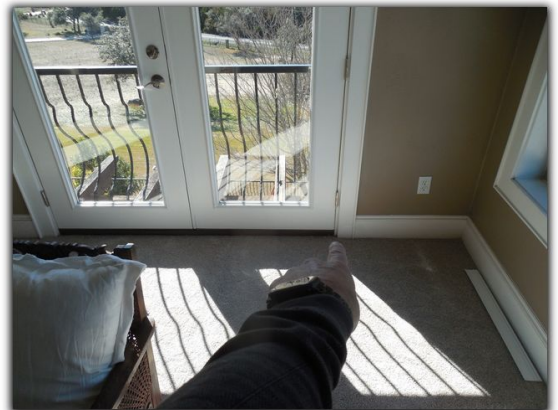
- Weather stripping improvements should be performed at more than one door location. Find examples at most of the front elevation 1st and 2nd story doors. Doors must be weather-tight to prevent moisture, draft or insects from entering home. Evidence of water intrusion was observed at some of these door locations.
- Weather stripping has been pet damaged at the back garage drive area pedestrian entry door. Doors must be weather-tight to prevent moisture, draft or insects from entering home.
- Sweep strips are worn and damaged at the bottom of most of the home entry doors. Repair as necessary to prevent potential water intrusion.

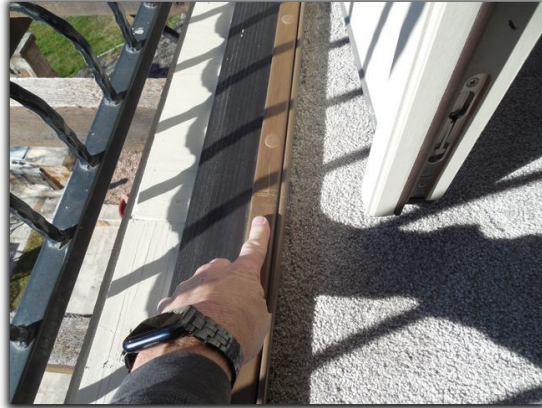
- Bottom slide lock does not function due to lack of drilled hole installation at threshold plate of the left side master bedroom Juliet balcony entry door. Repair as necessary.

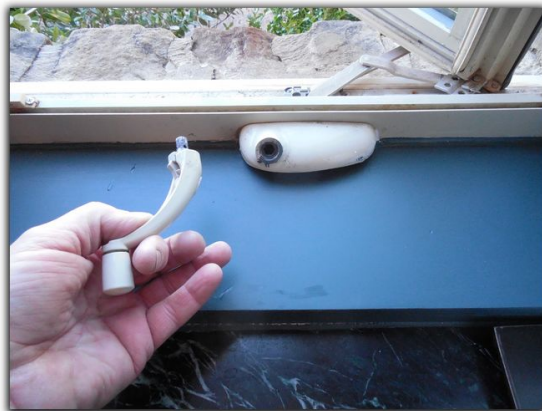
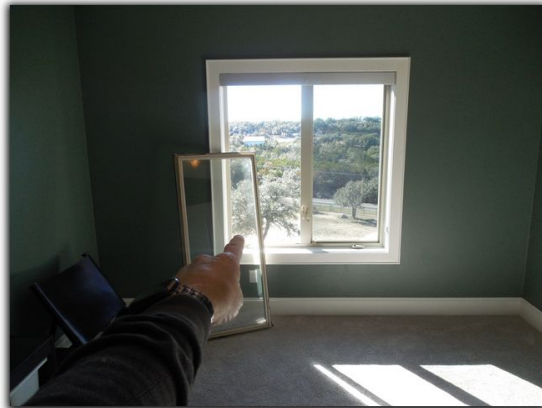
- The mechanical crank opening hardware is loose, missing or damaged at most if not all window locations. Window located at front elevation 2nd story bonus room literally fell out from window frame when opened. I advise you to contact a window specialist to perform a further evaluation of all windows and that they be repaired or replaced as necessary. See examples.

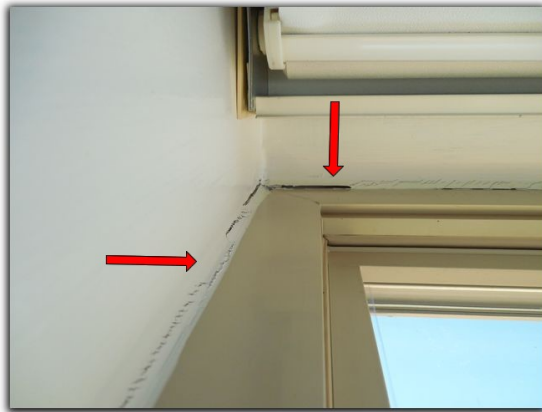
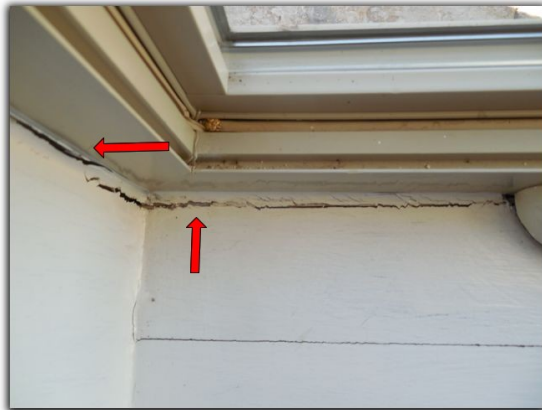
- There are gapped caulk joints, chipped and peeling paint located at front elevation formal dining room window, which is indicative of moisture. I advise further investigation by window specialist. See examples

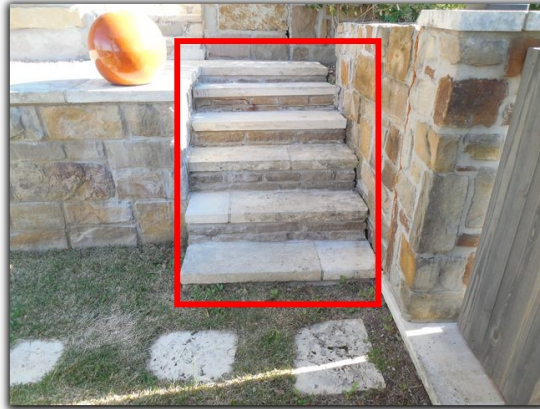
- Steps located at various exterior locations have uneven dimensions of risers (risers greater than 7-3/4” or variations of greater than 3/8” in tread rise in a flight), which creates a potential trip hazard. Find some examples in yard near front right corner of house.

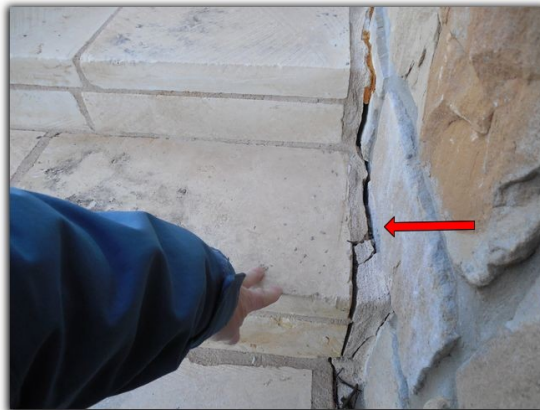
- Steps are settling and pulling away from home at one or more location. Find example at front elevation near the front left corner of house.

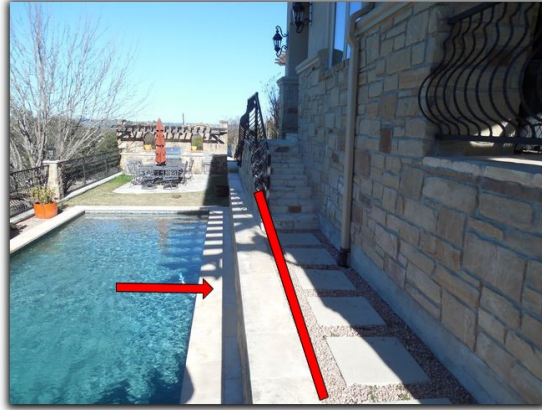
- Lacking fall protection or guardrail at front elevation walk-way between the house and pool. For *safety* reasons, guardrails are required for any drop-off greater than 30”.

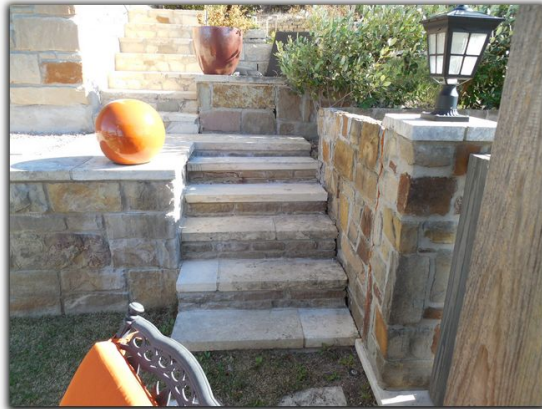
- Exterior yard steps lack handrails at more than one location, creating a potential trip hazard. Find some examples in yard near front right corner of house.

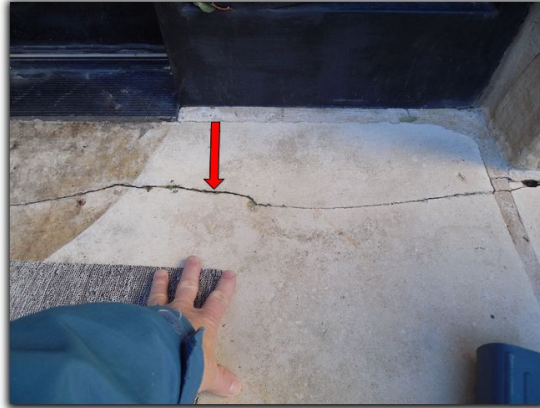
- Landing is cracked at the back garage drive pedestrian entry door.

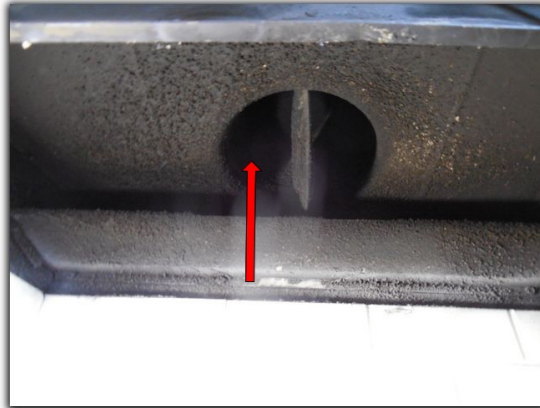
- The chimney flue is dirty and needs to be cleaned by a Qualified Chimney Sweep. A creosote / soot build-up was observed in the visible flue area, which creates a potential fire hazard.

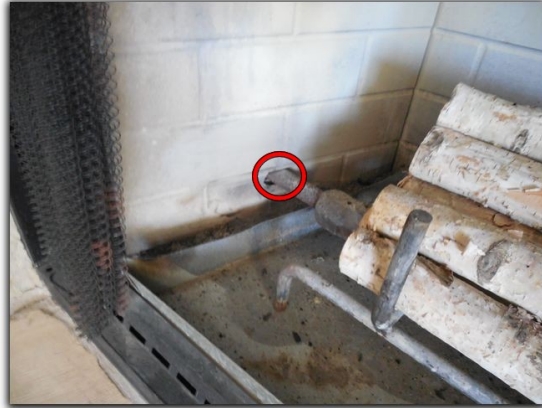
- The gas starter pipe is missing heat resistant caulk at left side firebox entry. This may allow embers to enter adjacent structure. Seal as necessary.

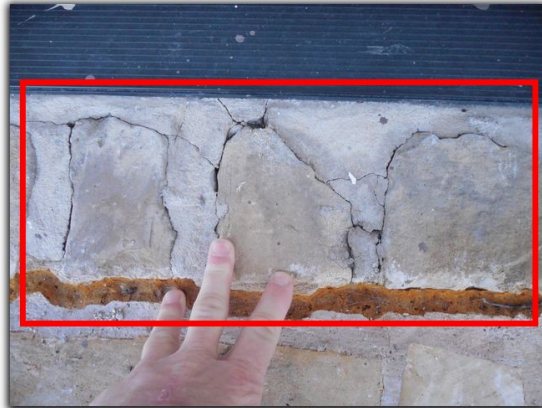
- Cracks in mortar including loose masonry pieces were observed at threshold plate area of front entry porch door.

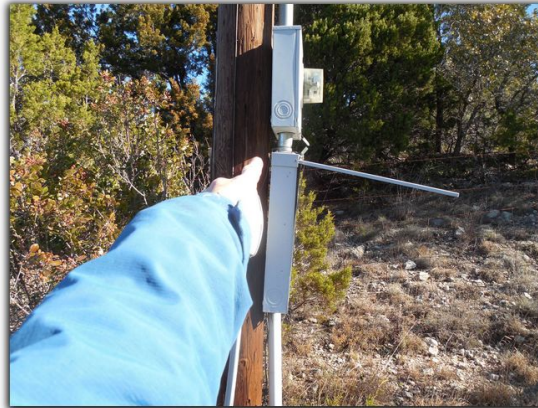
- The electrical meter and main panel are not secured to utility pole, which creates a hazardous condition. I advise necessary repairs by service specialist.

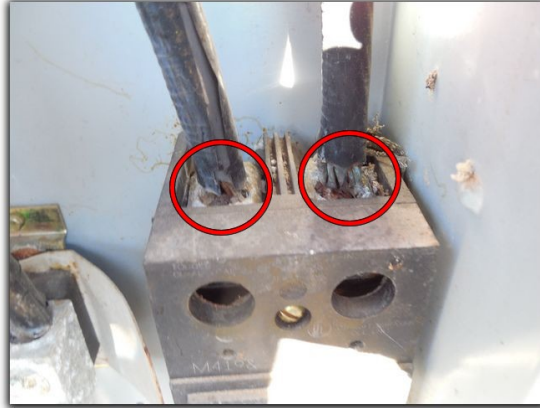
- Electrical wires are corroded at top of main electrical panel disconnect. I advise necessary repairs by a qualified electrician for safety reasons.

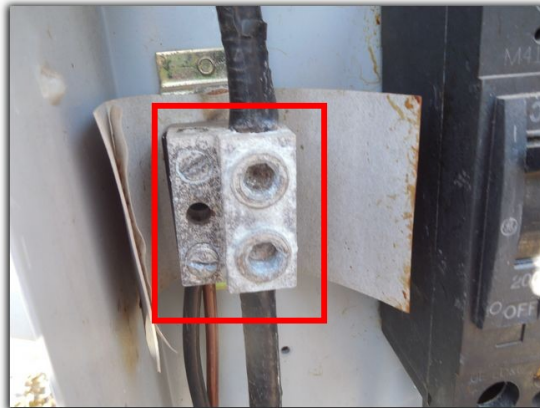
- Wire connection terminal is corroded in the main electrical panel. I advise necessary repairs by service specialist for safety reasons.

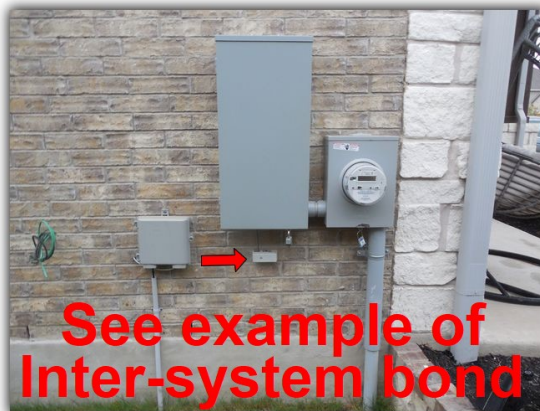
- Electrical standards continue to evolve. Some of the more recent changes require installation of a surge protector in the main electrical panel.
- The main electrical panel lacks an "Inter-system Bonding" bridge as required by current industry standards.

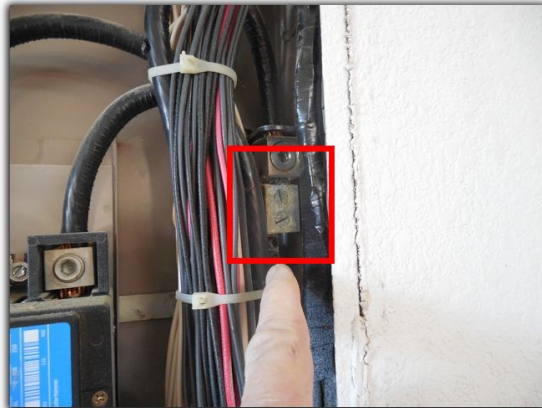
- Wire connection terminal is corroded in the electrical sub-panel. I advise necessary repairs by service specialist for safety reasons.

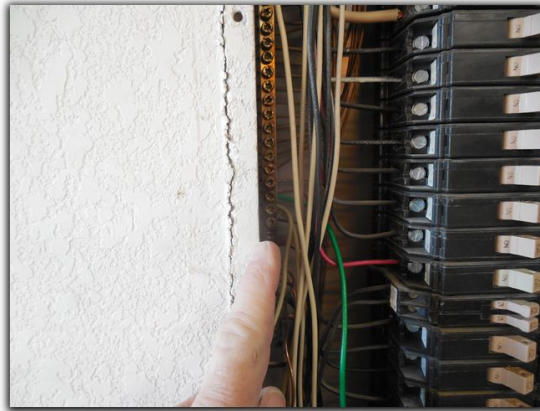
- Although commonly observed, bunched wires at the Sub-panel entry are not consistent with current installation practices.
- Multiple wires are installed under a single lug screw on the neutral bus in the electrical sub-panel. Electrical standards prohibit this practice and it should be corrected. This condition can lead to loose connections and overheating of electrical wires.

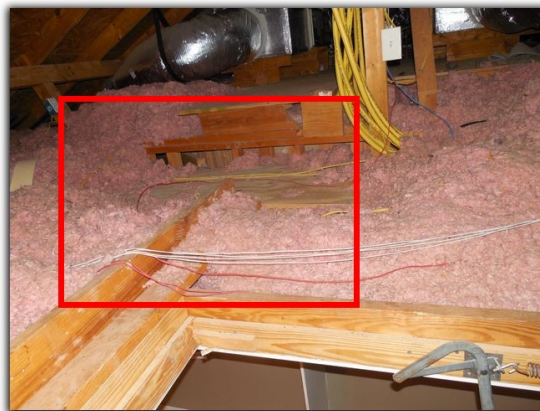
- Portion of catwalk is missing at 2nd story attic entry. Catwalks should be provided in attics containing mechanical equipment to help provide safe access to the equipment. The catwalk passageway should be clear, unobstructed and large enough to allow removal of the equipment. The catwalk passageway shall have continuous solid flooring with a minimum thickness of 3/4" plywood or 1" OSB and not less than 24 inches wide.

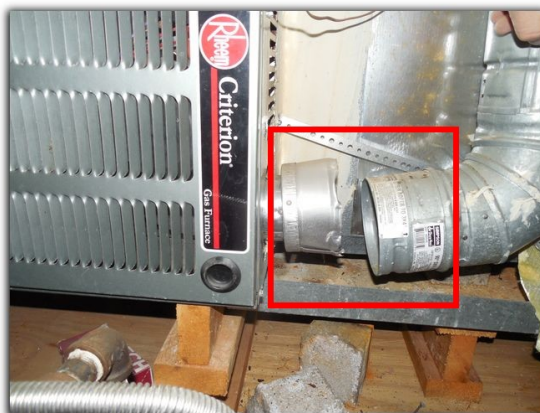
- Both of the furnace flue pipes are damaged and detached at heating units located in 2nd story attic, which will allow Carbon Monoxide into the attic space. For life/safety reasons, I advise the necessary repairs to be performed by service specialist. See examples.

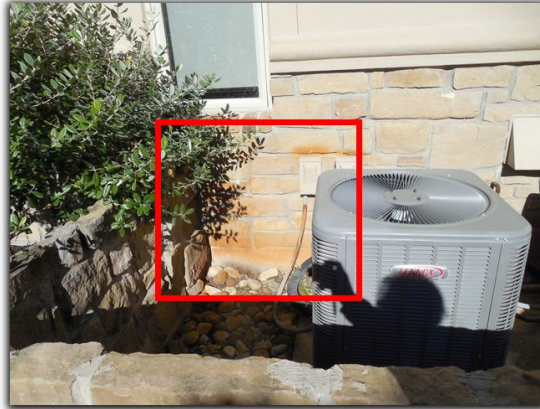
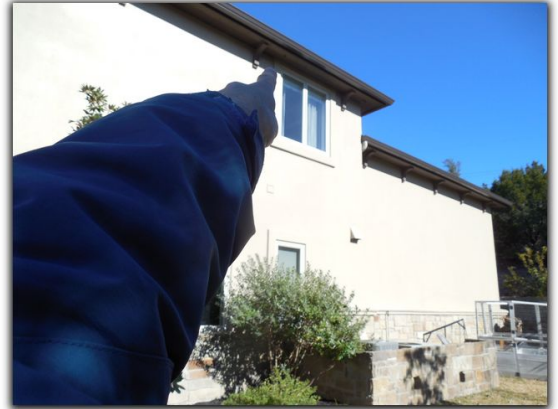
- Moisture related rust stains were observed on the exterior right side elevation wall located beneath the overflow pan drain pipes. Condition is indicative of condensate problem with system (past or present current condition unknown). I advise further investigation by qualified service specialist.

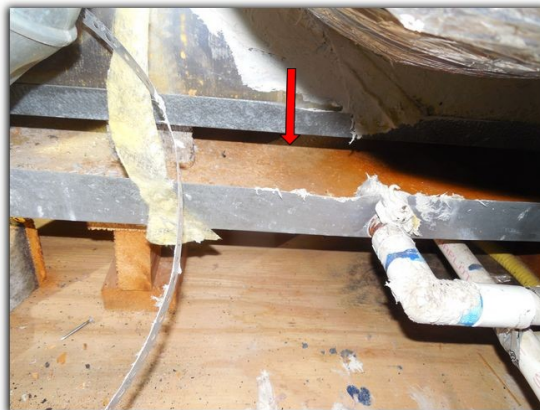
- Moisture related rust stains or rust formation were observed in the overflow pan located beneath the downstairs HVAC unit located in attic. Condition may be indicative of condensate problem with system (past or present current condition unknown). I advise further investigation by qualified service specialist.

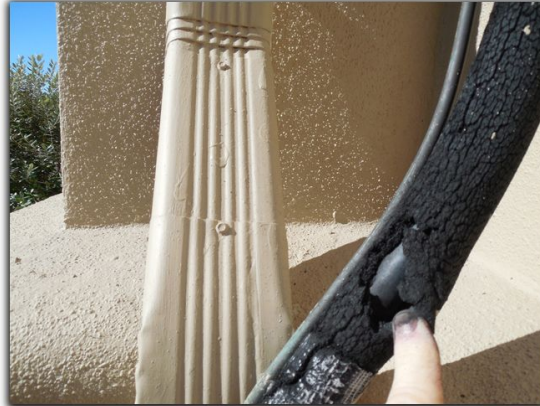
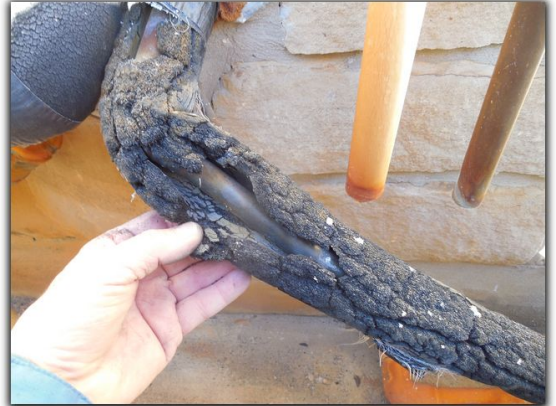
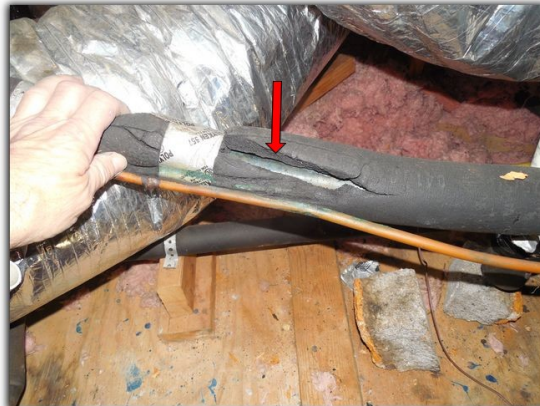
- Improvements to the insulation on both A/C system refrigerant and drains lines advised at outdoor as well as indoor locations in attic. Insulation helps prevent moisture formation and potential damage. I advise that necessary repairs be performed by service specialist. See examples.

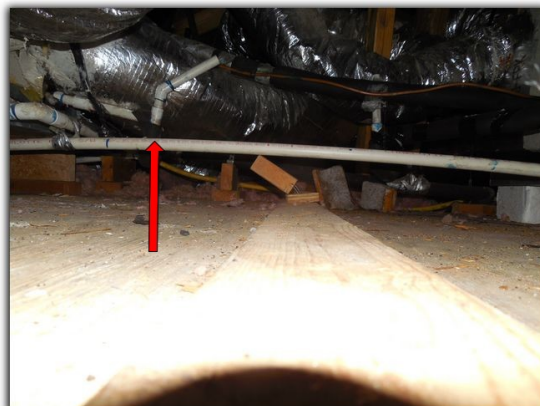
- The upstairs A/C system overflow pan drain pipe lacks gravity flow and/or runs uphill, which will negate performance and may lead to water damage at area below. I advise necessary repairs to be performed by service specialist.

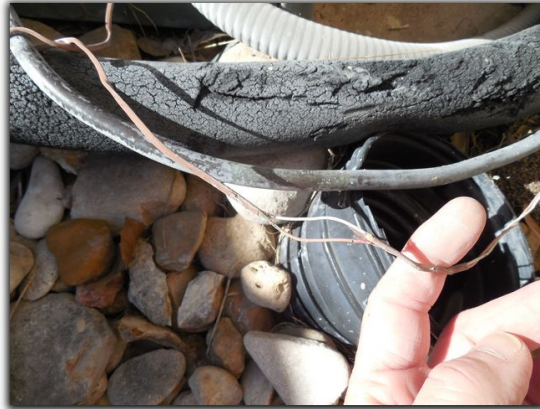
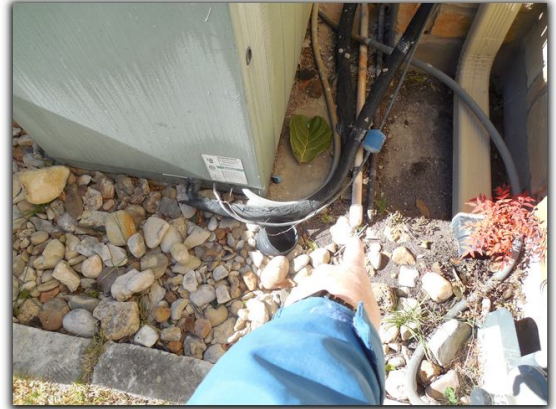
- The low voltage control wiring is not shielded from damage with conduit at both A/C condenser units. Notice that the exterior sheathing is weathered, worn and missing, which creates the potential of low voltage control wiring short. In the event of such, low voltage control components are likely to be damaged. I advise that necessary repairs be performed by service specialist. See example.

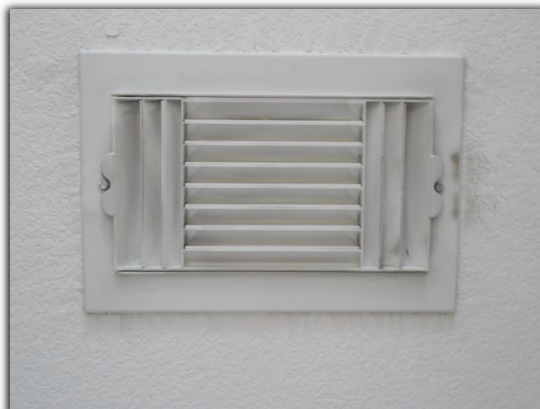
- The majority of both HVAC system supply air discharge registers were closed for unknown reasons. I advise further investigation by a service specialist. See example.

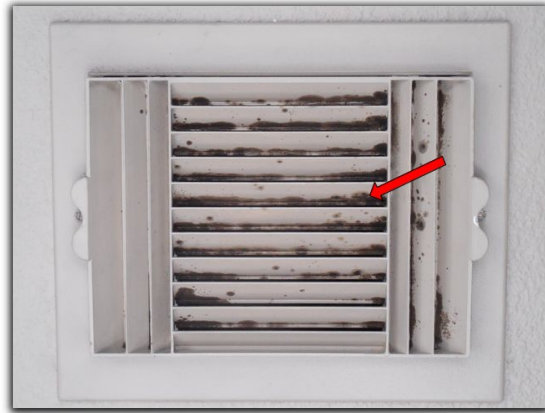
- A mold like substance was observed on the HVAC system supply air discharge registers at more than one home location. I advise further investigation by a service specialist. See example.

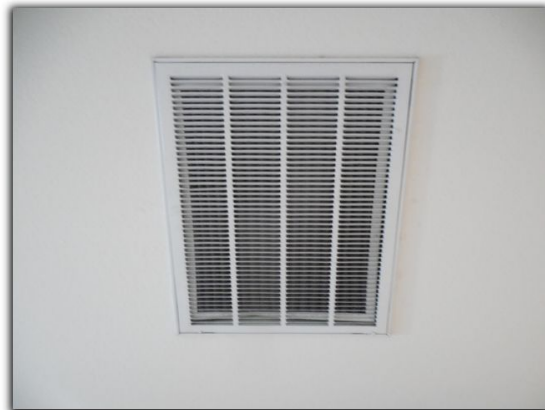
- All of the HVAC system return air filters are dirty, which will negatively impact system performance. I advise filter replacement.

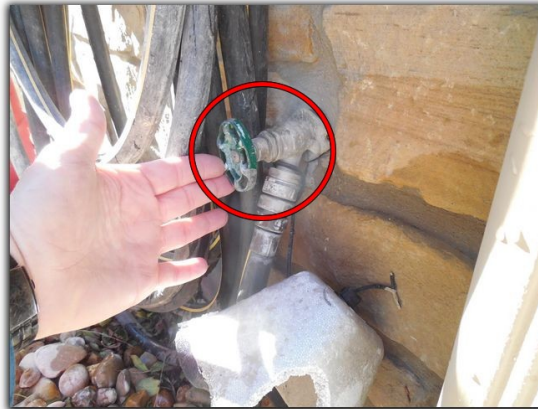
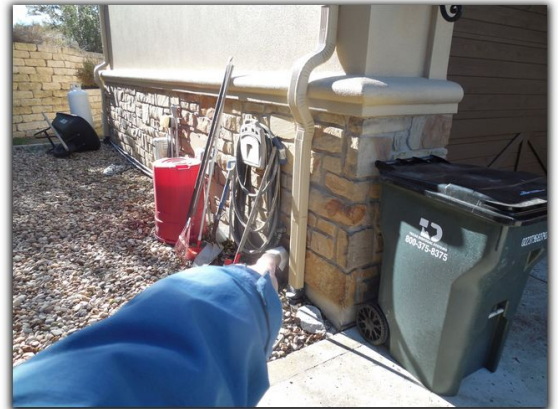
- Water was observed to be leaking back through the vacuum breakers at all exterior wall hose bib locations. All hose bibs also leak at the handle stems when operated. I advise necessary repairs or valve replacements. See example.

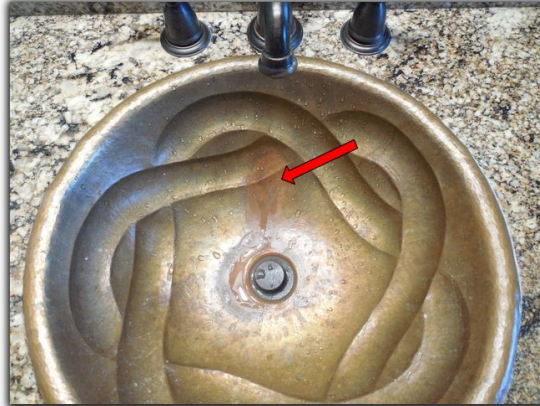
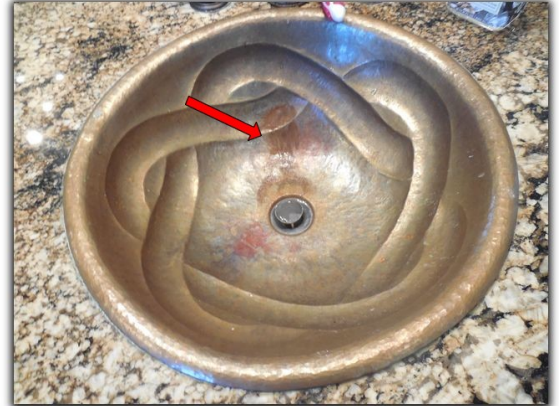
- Rust stains were observed on surfaces of both master bathroom sinks. It is suspected condition may be related to rusted hot water discharge from the water heaters. I advise further investigation by service specialist.

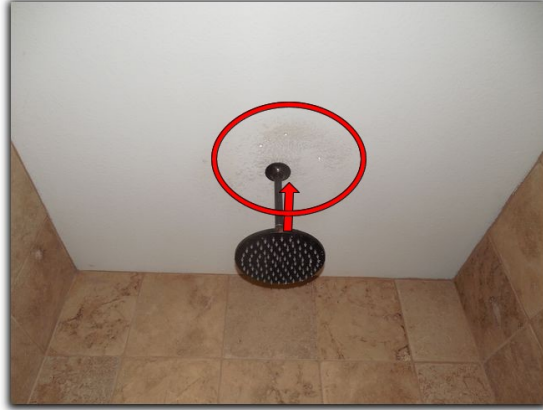
- The overhead shower head in located in master bath has a significant leak and sprays water upward onto the ceiling. I advise necessary repairs by service specialist.
