**Inspection Date :**  
December 20, 2024

**Report Number :**  
2024011002

**Report Prepared By :**  
Leppin Inspection Services  
12411 Painted Bunting Drive  
Austin, TX 78726  
Office : (512) 658-7989  
Email : scott@leppininspects.com

# PROPERTY INSPECTION REPORT FORM

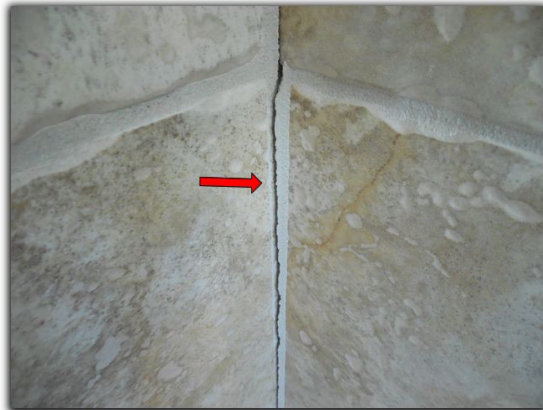
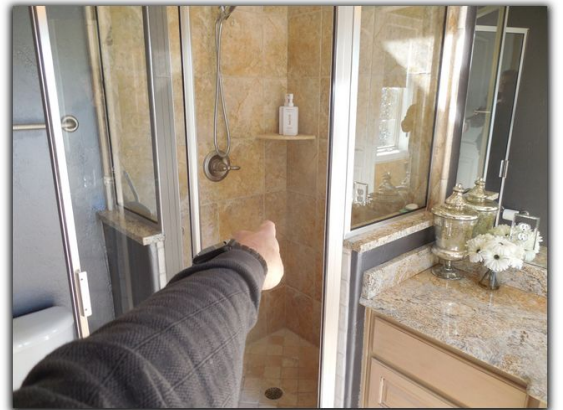
- Shower head and hose both leak in the master shower. I advise necessary repairs by service specialist.
- The plumbing fixture controls and wall jets do not properly perform in master shower. I advise necessary repairs by service specialist.
- The shower tile enclosure grout is cracked and missing at guest bathroom, which should be repaired to prevent potential water damage.

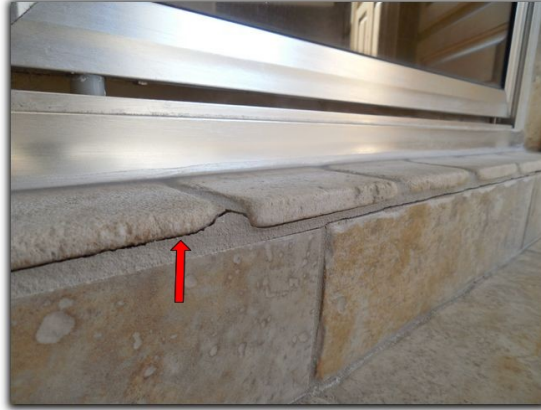
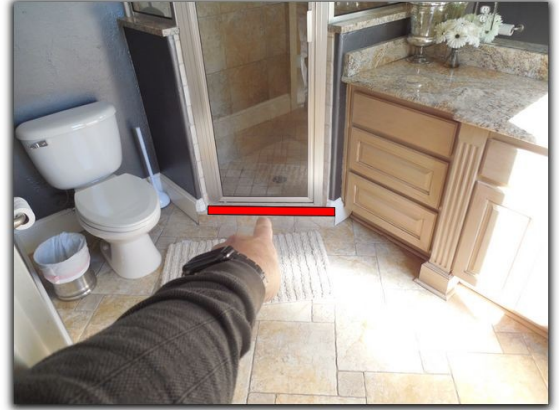
- Grout cracks and loose tile were observed beneath the shower door at guset bath shower entry. I advise necessary repairs by service specialist.

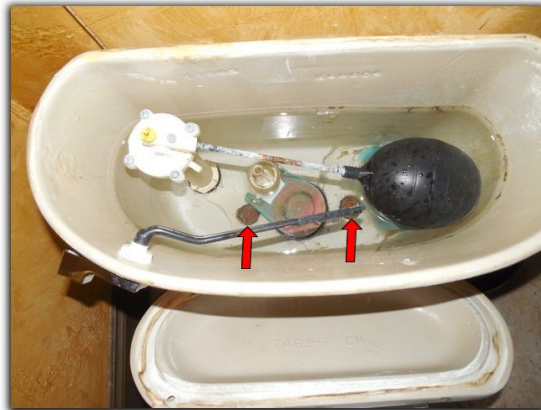
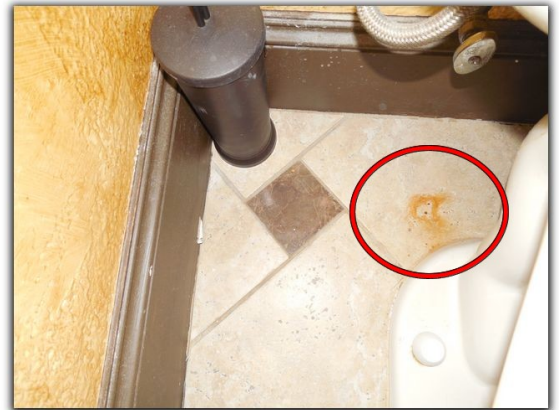
- Toilet tank mount bolts are rusted at most toilet locations, which are conducive to leaks. Find examples at half bath, guest bath as well as the upstairs Jack & Jill bath. Notice moisture related rust stains on tile floor at left side of downstairs half bathroom toilet. I advise necessary repairs by service specialist. See examples.

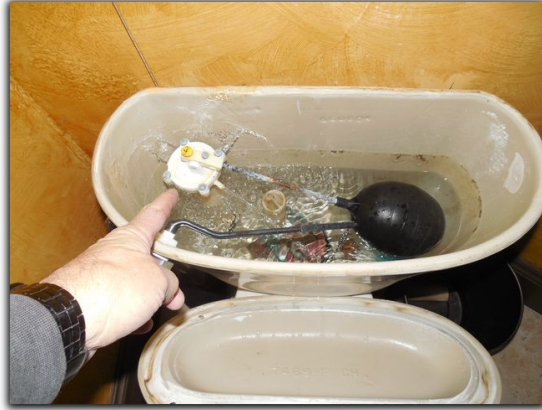
- Toilet tank fill valves leak at most locations. Find examples in half bath, guest bath as well as the upstairs Jack & Jill bath. I advise necessary repairs by service specialist.

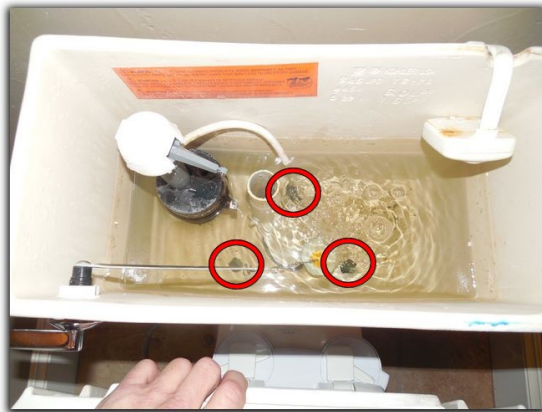
- The mount bolt gaskets are worn inside master bathroom toilet tank, which is conducive to leaks. Repair as necessary.

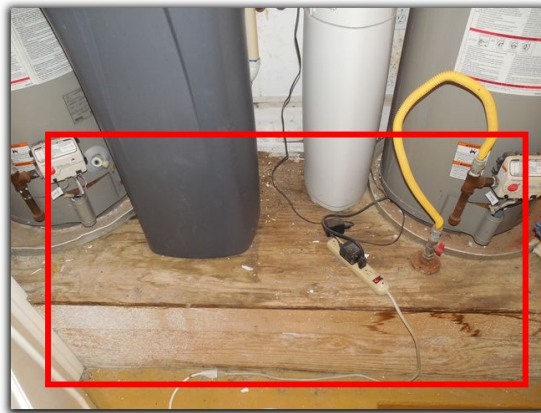
- While no moisture was observed, the platform located under the water heaters was observed to be water stained and damaged. The extent to such at concealed areas near water heater closet is unknown. I advise further investigation necessary repairs by qualified service specialist.

- Walls in water heater closet are moisture stained and significantly damaged. The extent to such at concealed areas or near water heater closet is unknown. It should also be noted that a mold like substance was observed on water heater closet walls. I advise further investigation necessary repairs by qualified service specialist.

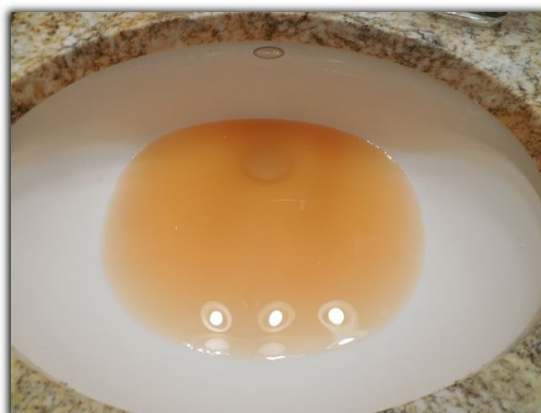
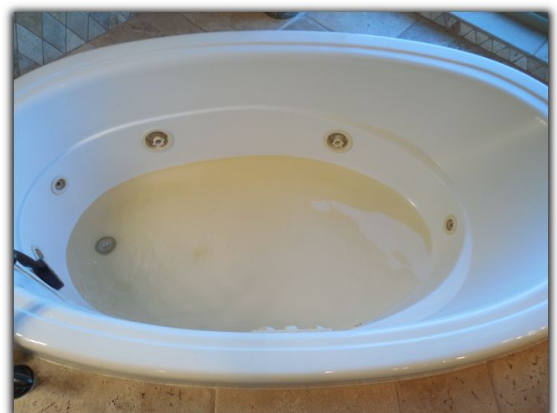
- Hot water discharge was rusted at various plumbing fixtures through-out the home, which may be indicative of water heater failure. I advise further investigation by service specialist. See examples.

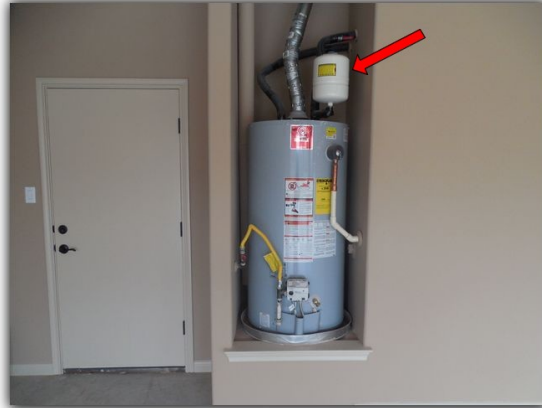
- The water heater lacks expansion tank as required by *current* industry standards, when there is a closed loop system. This condition is created by the installation(s) of a pressure regulator valve, back-flow or check valve. An expansion tank helps to control over-pressure from thermal expansion due to the heating of the water. See example of correct installation below.

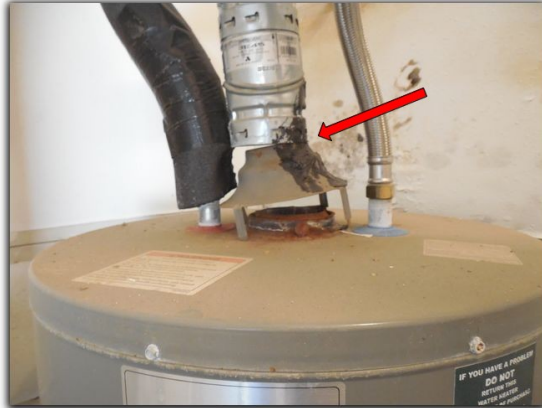
- The vent pipe is not properly positioned and mounted at the top of left side closet water heater, which will allow Carbon Monoxide into the water heater closet. For life/safety reasons. I advise necessary repairs by service specialist.

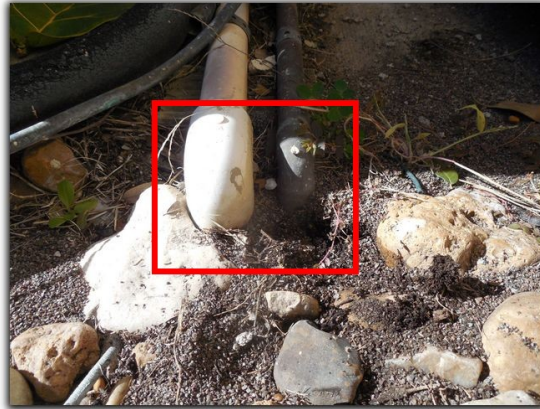
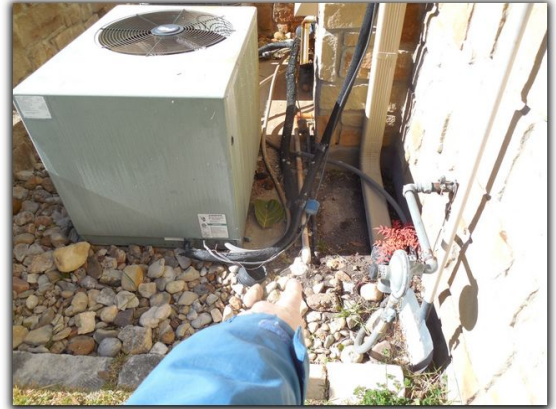
- What may be the temperature and pressure relief valve (TPR) and water heater leak pan drain pipes terminate below grade in yard at right side elevation, which will likely prevent drains from performing. Blockage of the temperature and pressure relief valve (TPR) also creates a hazardous condition and should be corrected for life/safety reasons.

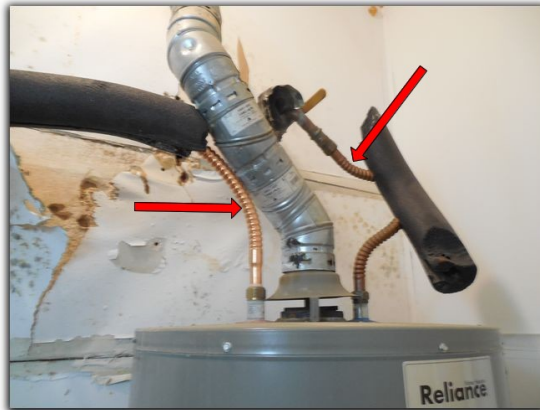
- Exposed piping at both water heaters is not protected from freeze. I advise the installation of insulation.

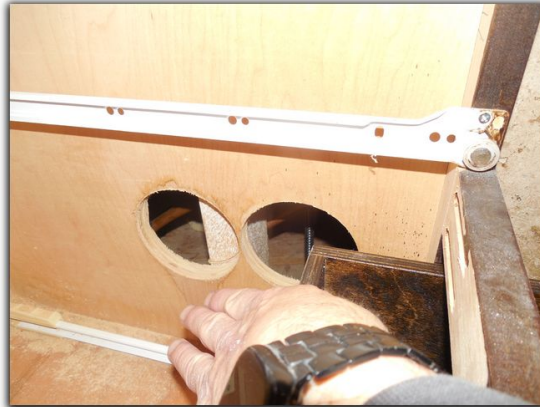
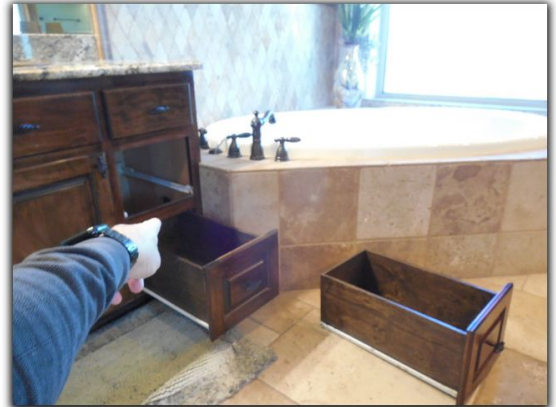
- Inadequate access to the master bath jetted tub enclosure is lacking, which does not provide service access to the mechanical equipment.

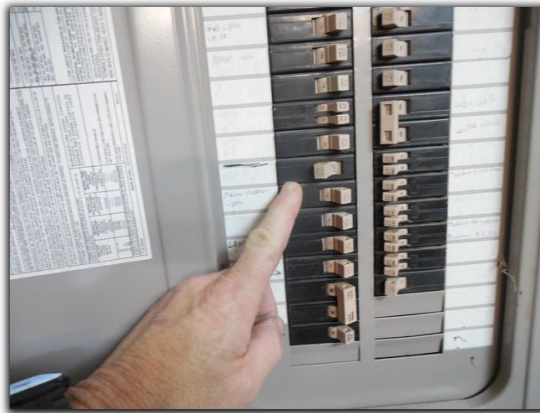
- The jetted tub air switch does not properly function. It did allow me to turn equipment on, however would not allow me to turn the equipment off after test operation. I had to shut the jetted tub system down at breaker located in garage electrical sub-panel. I advise necessary repairs by service specialist.

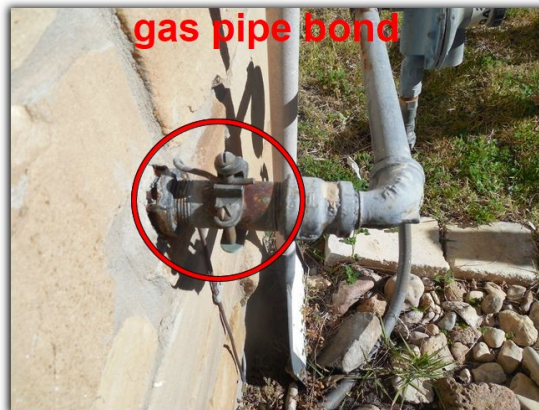
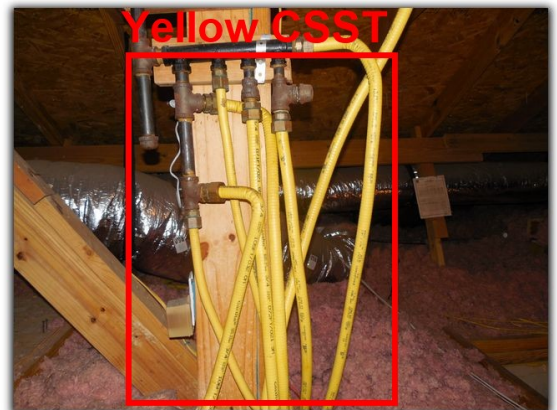
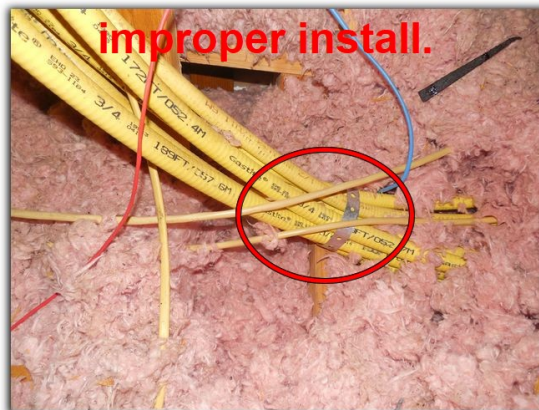
- The gas piping in this house includes Yellow CSST (non-arc-resistant corrugated stainless steel tubing). Proper installation and bonding are required by (the manufacturer(s) / NFPA 54, the National Fuel Gas Code). The lack of proper installation & electrical bonding may increase the potential for lightning strikes to cause arcing at the CSST gas piping that may result in perforation of the piping, gas leaks and fires. Proper CSST piping installation & adherence to the manufacturers bonding instructions should lower the risk of electrical arcing and related damage. While gas pipe bond was observed at the gas regulator valve, it does appear that one or more improper CSST piping installation technique has been implemented and/or notice that CSST piping is in direct contact with electrical conductors or other metallic objects located in attic. For life/safety reasons, I advise you to have the CSST piping installation further evaluated by a Certified CSST Installer. All installation techniques that do not comply with the manufacturers installation instructions should be corrected as necessary. See example.

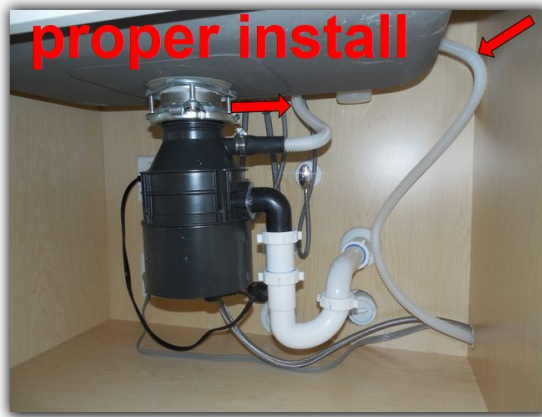
- The dishwasher drain did not have an anti-siphon device and/or sanitary loop installed, which prevents waste-water from the disposal being siphoned back into the dishwasher and contaminating its contents. See correct installation at example picture below.

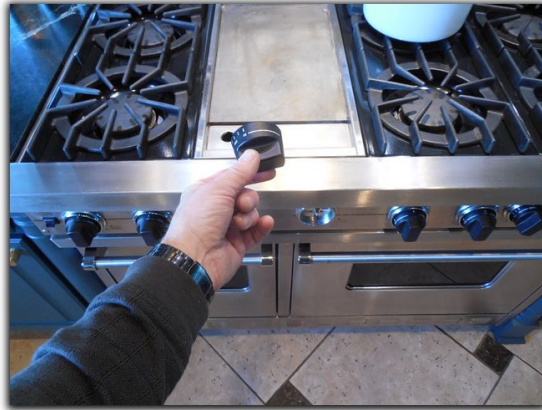
- More than one of the range control knobs are loose and/or will not stay secured to valve control valve stem.

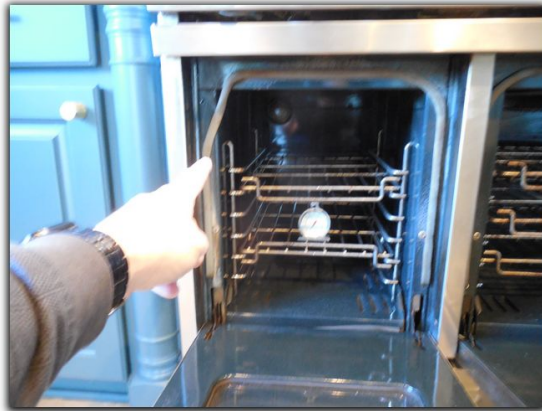
- There was a peculiar odor evident in kitchen during operation of range/ovens. The smaller left side oven was making an unusual sound while burner was lit and/or after flame ignition. I advise further investigation by service specialist.
- Gasket is not secured at upper left corner of smaller range oven door.

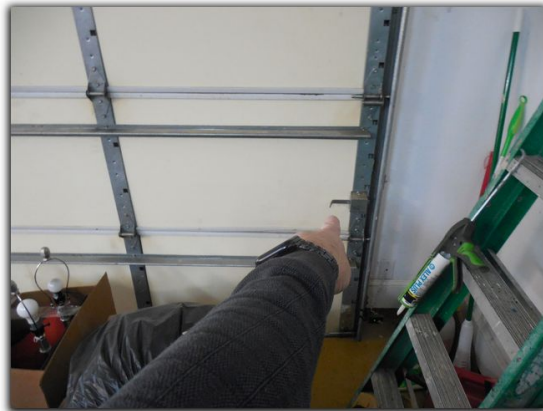
- For *safety* reasons, manual locking mechanisms should be removed or disabled on overhead garage doors that are equipped with an automatic garage door opener to prevent inadvertent actuation of the opener while lock is engaged and subsequent overhead garage door damage. See example.

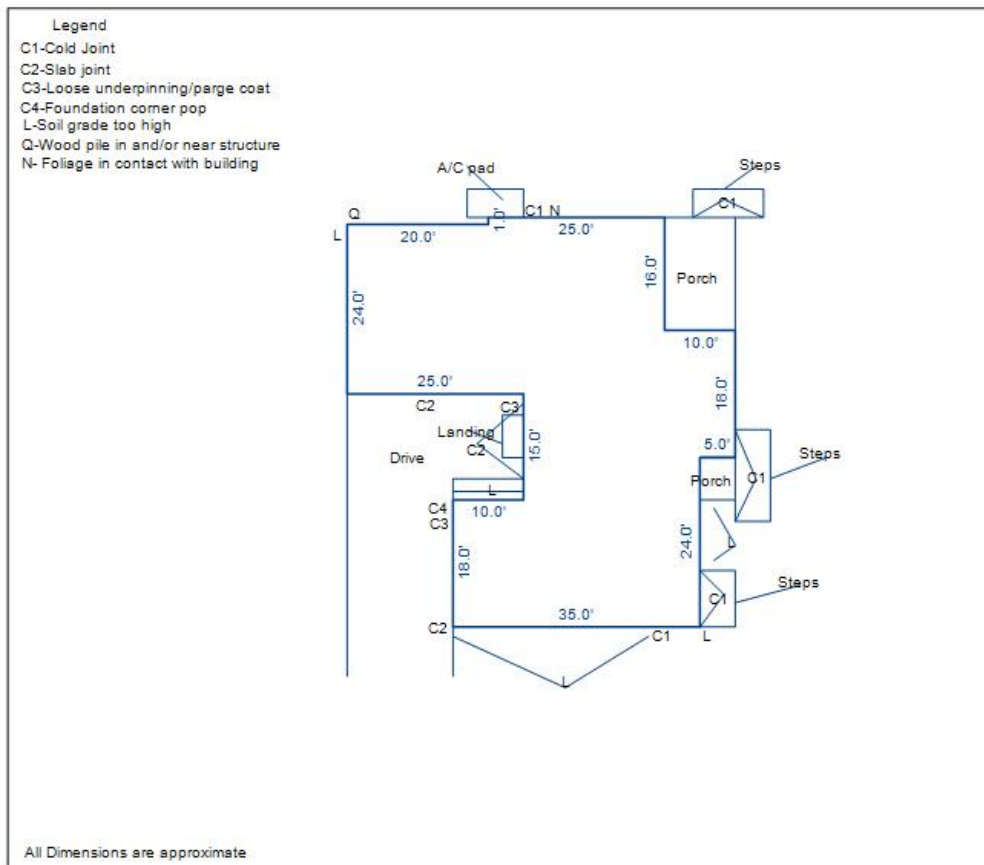
**Diagram of Structure(s) Inspected**

The inspector must draw a diagram including approximate perimeter measurements and indicate active or previous infestation and type of insect by using the following codes: E- Evidence of infestation; A-Active; P-Previous; D-Drywood Termites; S-Subterranean Termites; F-Formosan Termites; C-Conductive Conditions; B-Wood Boring Beetles; H-Carpenter Ants; Other(s) - Specify \_\_\_\_\_

Specify reason: Mechanically correct (remove, trim back etc.) each listed conducive condition illustrated on diagram. Preventative treatment is needed for all areas listed as inaccessible or areas that are not mechanically corrected or correctable. Contact a licensed pest control operator for specific guidance and options on treatments available PRIOR TO CLOSING.
